Re: Asbestos Roof Inspection  
Bolton Public Schools  
108 Notch Road, Bolton, CT 06043  
Atlas Project No. 2438026001

The work was performed in response to the roof replacement project. Sampling was limited to the three (3) main roof fields for the Bolton Center School, 108 Notch Road in Bolton, CT.

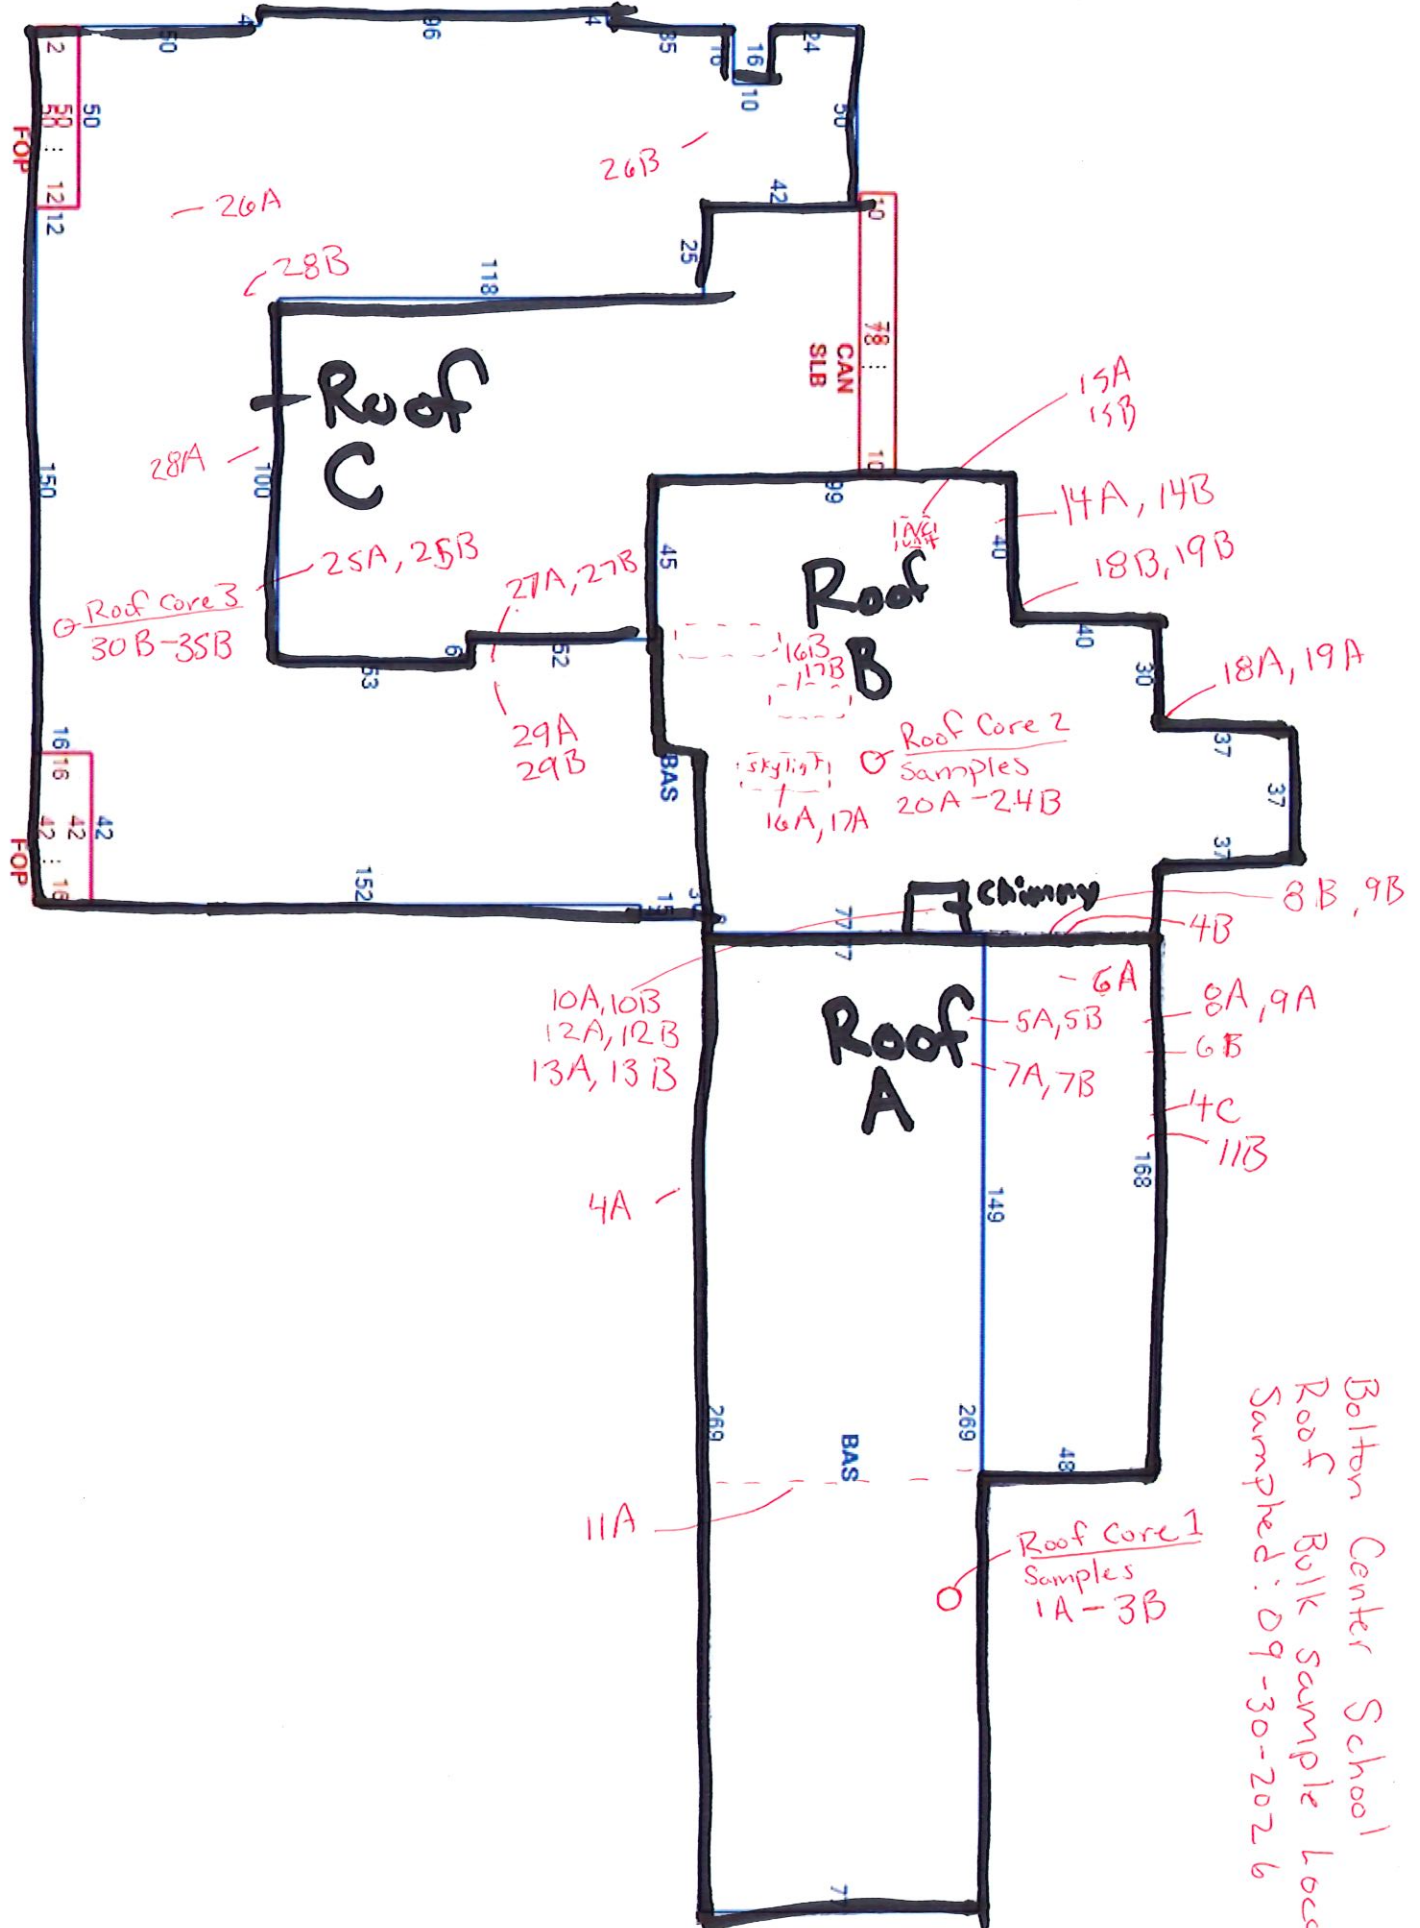
### **SAMPLE LOCATION DRAWING**

- Roof A (Northeast Section) Black Roof Patch at Roof Vents (approximately 25 linear feet).

Based upon these definitions, ACM identified in the building requires removal prior to renovation, demolition, or disturbance. The State of Connecticut Department of Energy and Environmental Protection (CTDEEP) regulations require the proper disposal of all ACM, regardless of categorization.
