# Gymnasium Wall Study

**BOLTON CENTER SCHOOL  
TOWN OF BOLTON, CT**

**Prepared: May 8, 2014  
Revised: May 21, 2014**

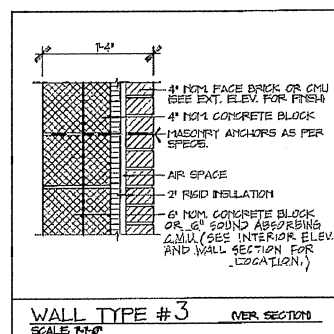
Fig. 1

This type of wall, referred to as a cavity wall, provides a drainage path for moisture in the wall to weep holes located at the base of the wall. The wall types show a  $\frac{3}{4}$ -inch air space, which is significantly

The wall type sections in Figures 1 and 2 do not include a moisture barrier in the wall system. Photos taken of the destructive wall tests done for the previously mentioned exterior study revealed that the face of the rigid insulation had an adhered moisture barrier material. It is unknown whether this material is an air barrier, vapor retarder, weather-resistive barrier or a combination thereof.

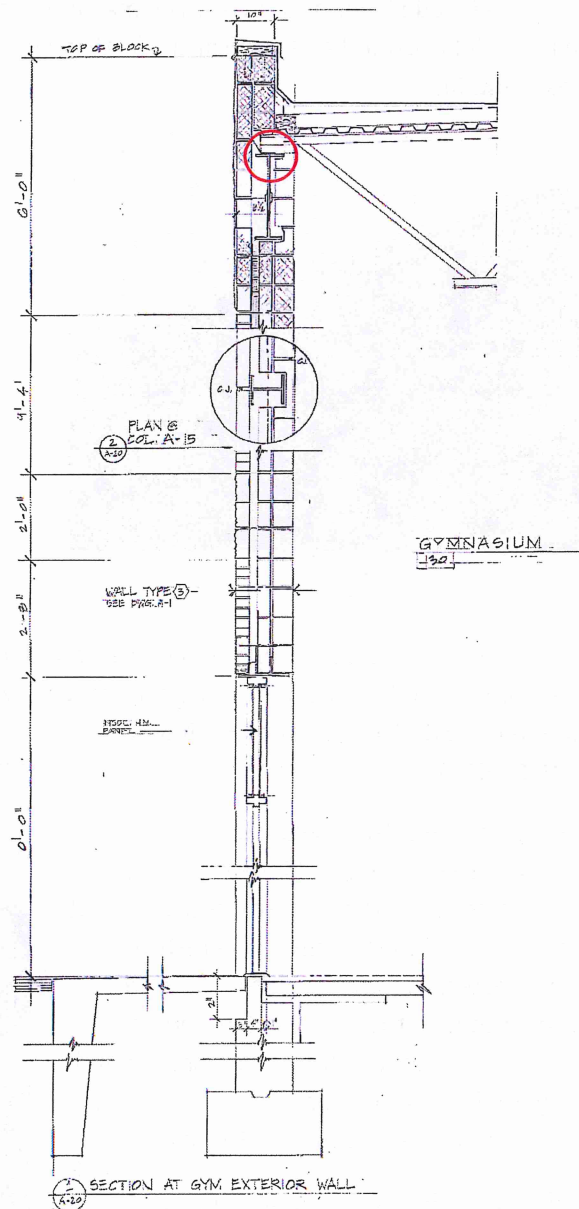
Fig. 4

The wall at the gymnasium extends two stories tall. It does not contain any window openings, but does have openings for mechanical louvers. The architectural wall section in Figure 4 shows the construction of the wall. However, it neglects to show a structural steel tube at elevation +14'-0". The steel framing plans show this tube and include it in a section detail. The tube transmits wind forces from the wall to the adjacent steel columns. This wall section also does not provide information about the construction of the wall between roof joist seats (red circle). The wall does not contain any relieving angles that would interrupt the air space, but the airspace and insulation terminate below the bottom of the parapet. The air space that would allow moisture to drain in the wall does not appear to extend the full height of the wall.

The wall section indicates that the parapet is composed of 6-inch backup CMU supported by a steel beam and 4-inch façade CMU vertically supported by the masonry below. The architectural detail appears to show mortar between the 6-inch backup CMU and the 4-inch façade CMU. In this detail, the mortar restricts the 4-inch façade CMU from moving up and down independently from the

6-inch CMU supported by the steel beam, which will deflect due to snow load on the roof.

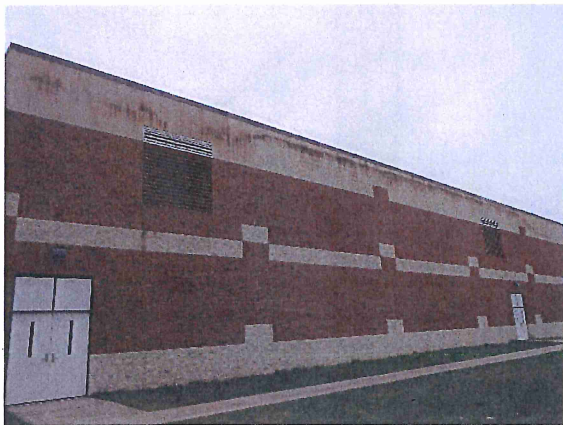
Fig. 5

The upper portion of the east wall of the gymnasium shows signs of significant deterioration of the outer 4-inch façade layer of the wall. The masonry, covered by a layer of pargeing (a thin coating), contains both horizontal and vertical cracks through the masonry joints and the masonry units (See Figures 5 and 6).

The vertical cracks are consistent with movement due to expansion and contraction in the material in the horizontal length of the wall. The horizontal cracks indicate that the masonry has experienced tension in the exterior face of the unit in the vertical direction.

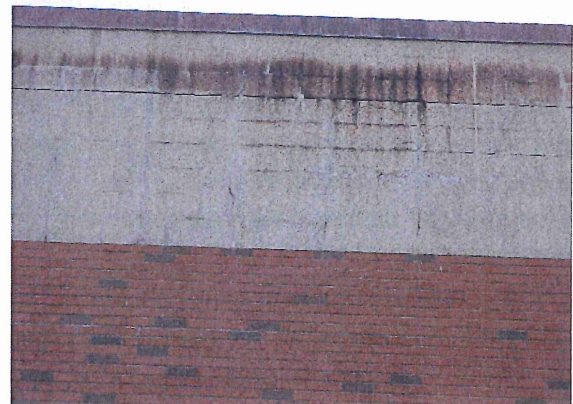
Fig. 6

Figure 6 also shows the presence of efflorescence and staining. Efflorescence is white staining, caused by water moving through a wall, which transmits dissolved salts from the masonry materials to the surface. When the water evaporates, the salts are left behind causing white staining. Both efflorescence and staining are indications of moisture movement through the façade masonry and joints.

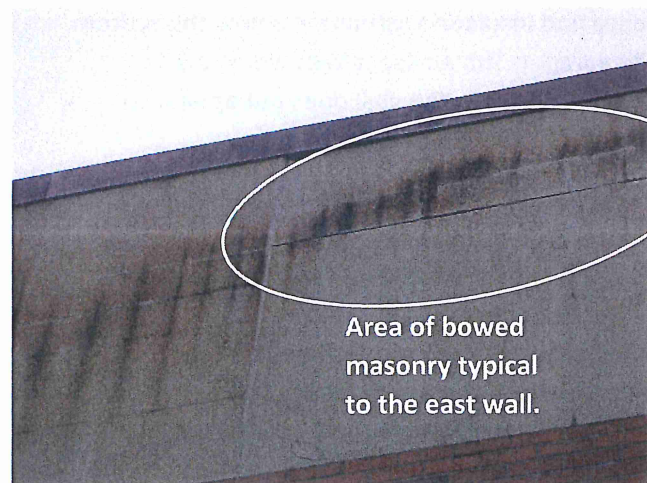
Fig. 7

Near the top of the wall at approximately two feet to three feet below the coping, the wall

bows outward (See Figure 7). This location corresponds to approximately the top flange of the steel beam supporting the roof joists and the backup CMU of the parapet. Cracking, staining and protrusion of the mortar in the horizontal joints accompany the bowed masonry.

Measurements of the displaced masonry indicate that the greatest protrusion occurs horizontally for approximately 80 feet starting approximately 25 feet from the southeast corner. The horizontal distance from the top of the wall to the face of the bulge is approximately  $\frac{1}{2}$  inch to  $\frac{3}{4}$  inch. The wall below the pargeted CMU does not exhibit any bowing or concavity.

3. Initiate a destructive investigation of the masonry at the bowed area below the parapet to determine the condition of the masonry ties. This work could be scheduled during cold periods in order to determine the presence of ice in the wall cavity.
4. Conduct visual inspection of the masonry at two-month intervals to check for spalls, excessive cracking, additional joint movement and loss of mortar at joints.

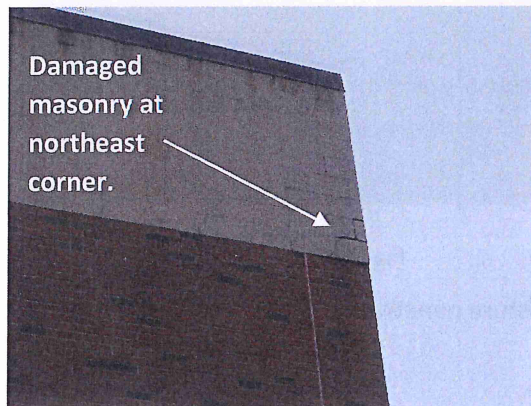
Fig. 8

At both the north and south corners of the east gymnasium wall, the exterior façade contains spalls or masonry that appears to be unstable. This masonry requires repair to prevent it from becoming a falling hazard (See Figures 8 and 9). The damaged areas occur in the pargeted CMU and accompany a loss of mortar at the joints. The damaged areas do not extend into the brick below.

1. Repair to the roof membrane at the parapets to ensure a moisture barrier from rain and snow on the roof.
2. Repair the two small areas of masonry with spalls at the southeast and northeast corners of the gymnasium wall.

It should be noted that the only immediate repair that is necessary is item number 2. There is a slight risk that the loose masonry could fall onto passing pedestrians. The area below these spalls should be barricaded off with safety tape prior to this repair. The other recommendations noted should be completed in the next two years.

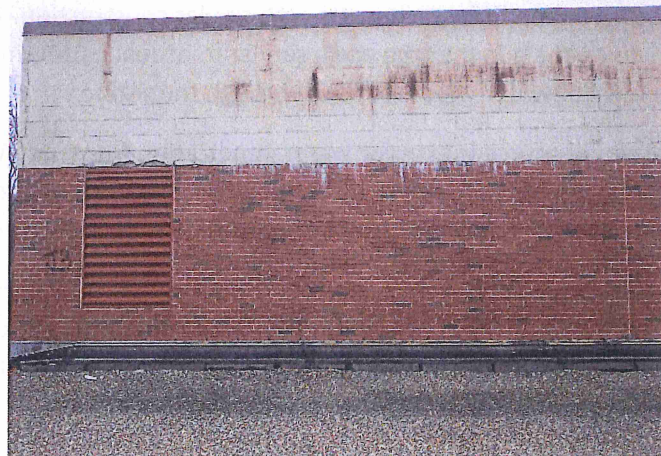
Fig. 10

Similar cracking, staining and efflorescence are present at the north gymnasium wall in the pargeted CMU above the brick (See Figure 10). The south wall above the sloped roof also has cracking. However, these walls do not exhibit the same bowing outward that the east wall does. In addition, the upper portion of each of the walls terminates at a lower roof with weep holes located just above the lower roof.

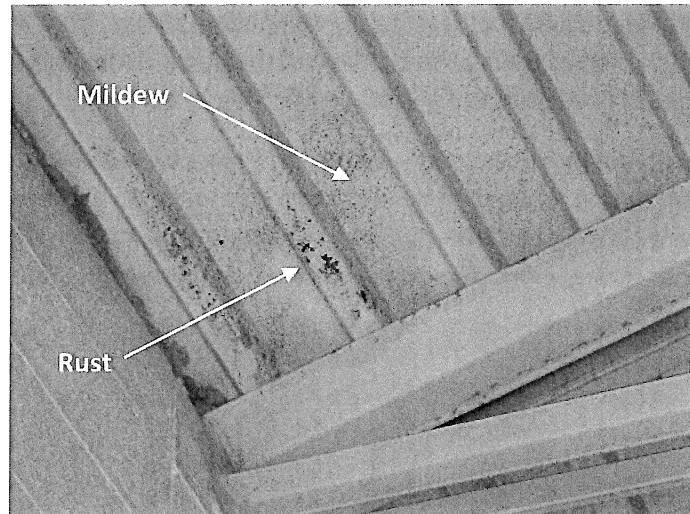
Fig. 11

In addition to exterior observations and measurements, CME conducted an inspection of the interior of the building both at the gymnasium and at areas adjacent to the gymnasium. Inspection of the underside of the deck in a portion of the classroom wing at the exterior wall adjacent to the gymnasium showed no evidence of water. However, inspection of the underside of the deck in the gymnasium showed areas of light rust and mildew. The rust and mildew was located on both the steel acoustic roof deck and the roof joists in areas adjacent to the exterior wall (See Figure 11).

These areas also correspond with the marked locations of moisture penetration at the roof from the thermal scan.
