A Report  
to the  
Bolton Heritage Farm Commission  
concerning

**The Bolton Heritage Farm**

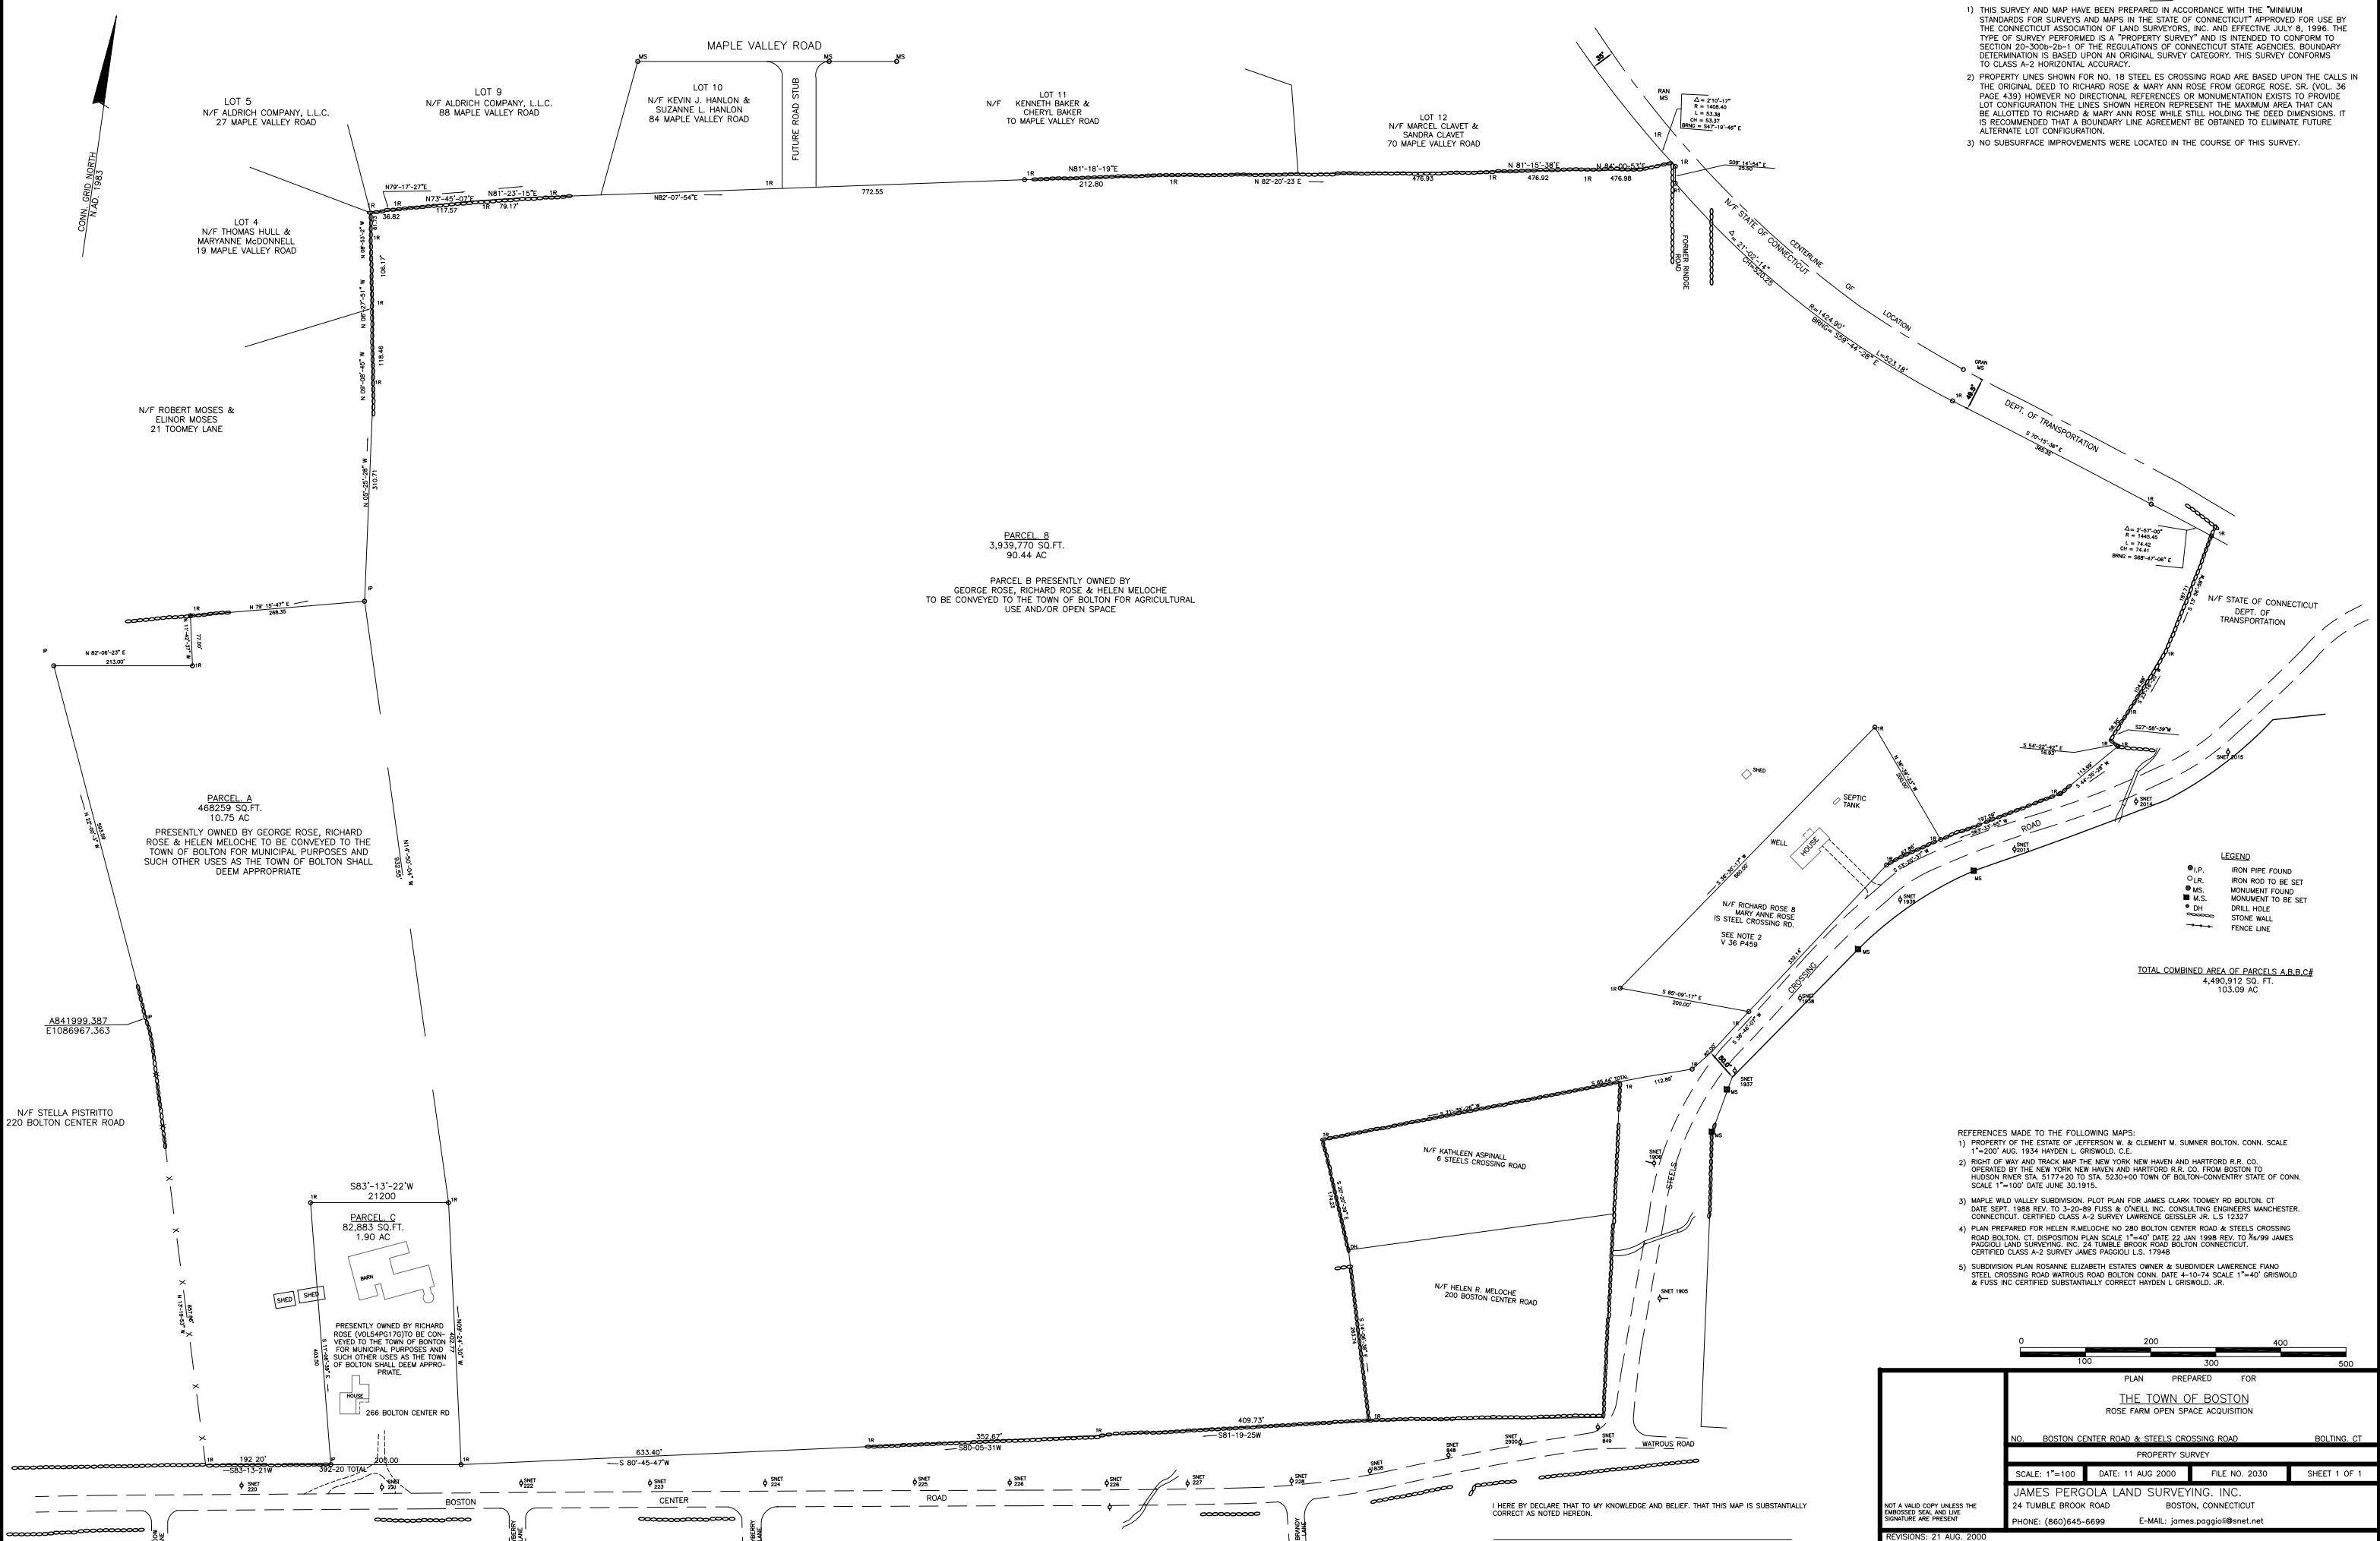
**PARCEL B**  
3,939,770 SQ.FT.  
90.44 AC

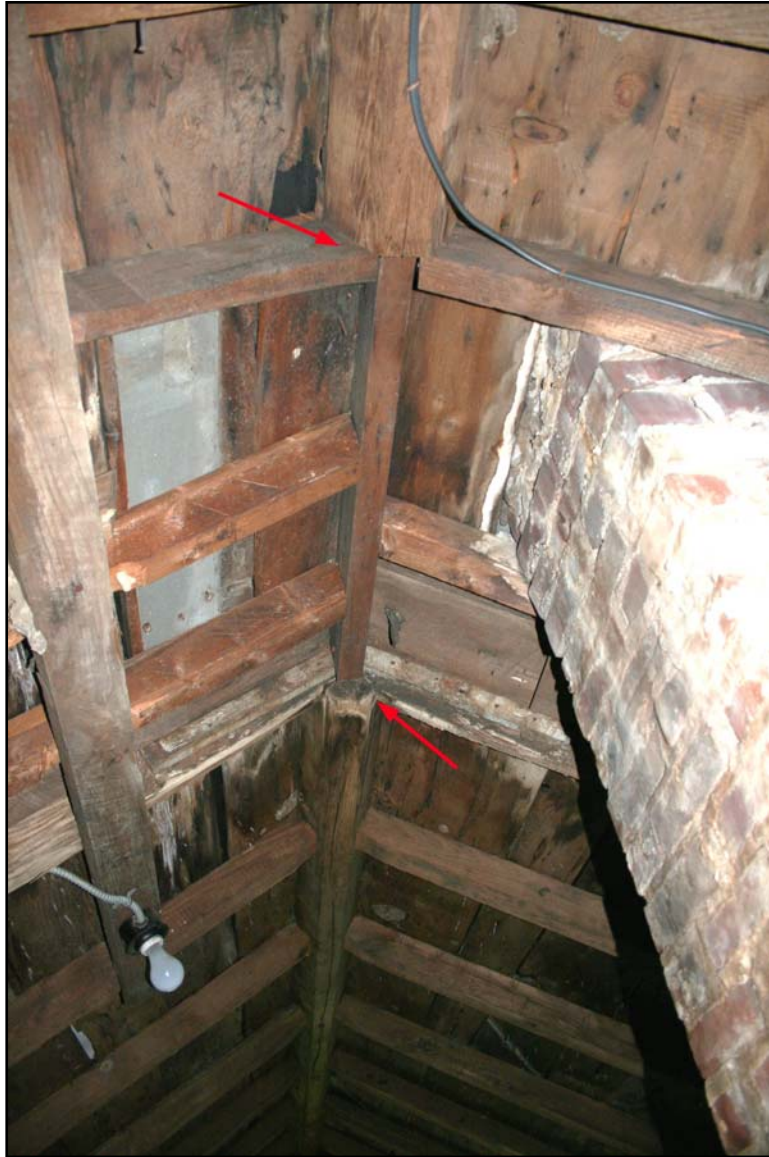
**Photograph House-8:**

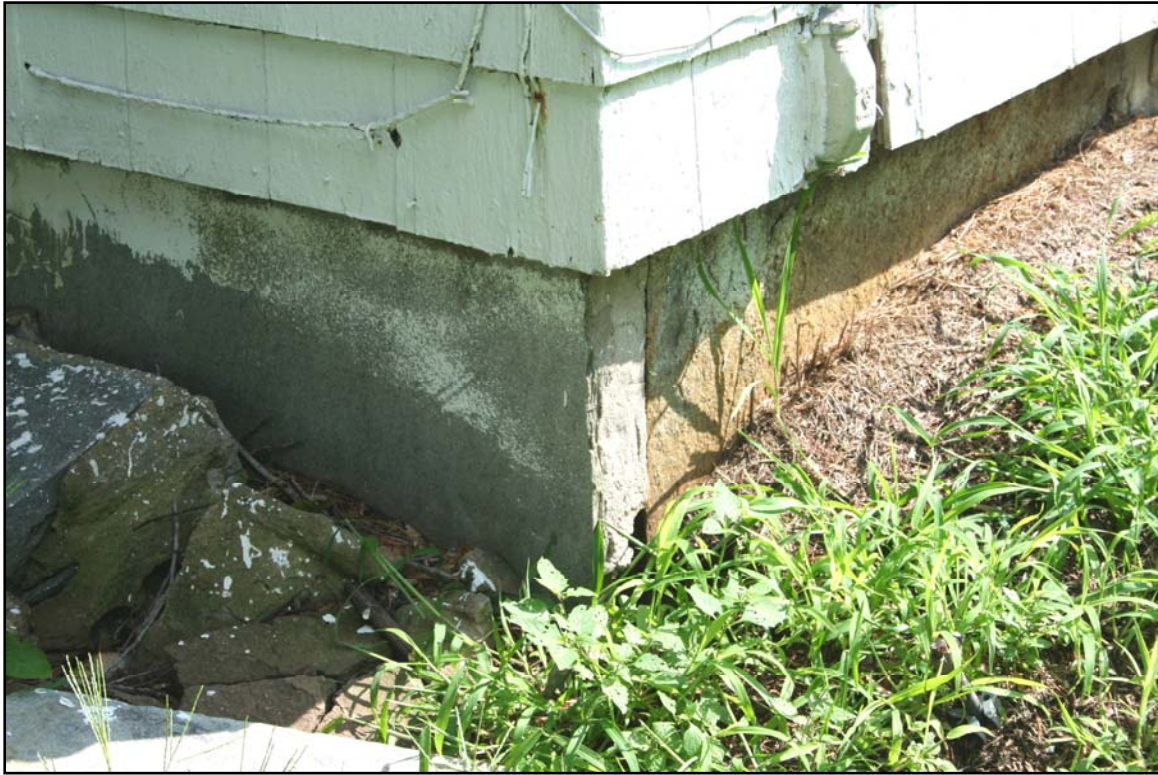
**Photograph House- 9:**

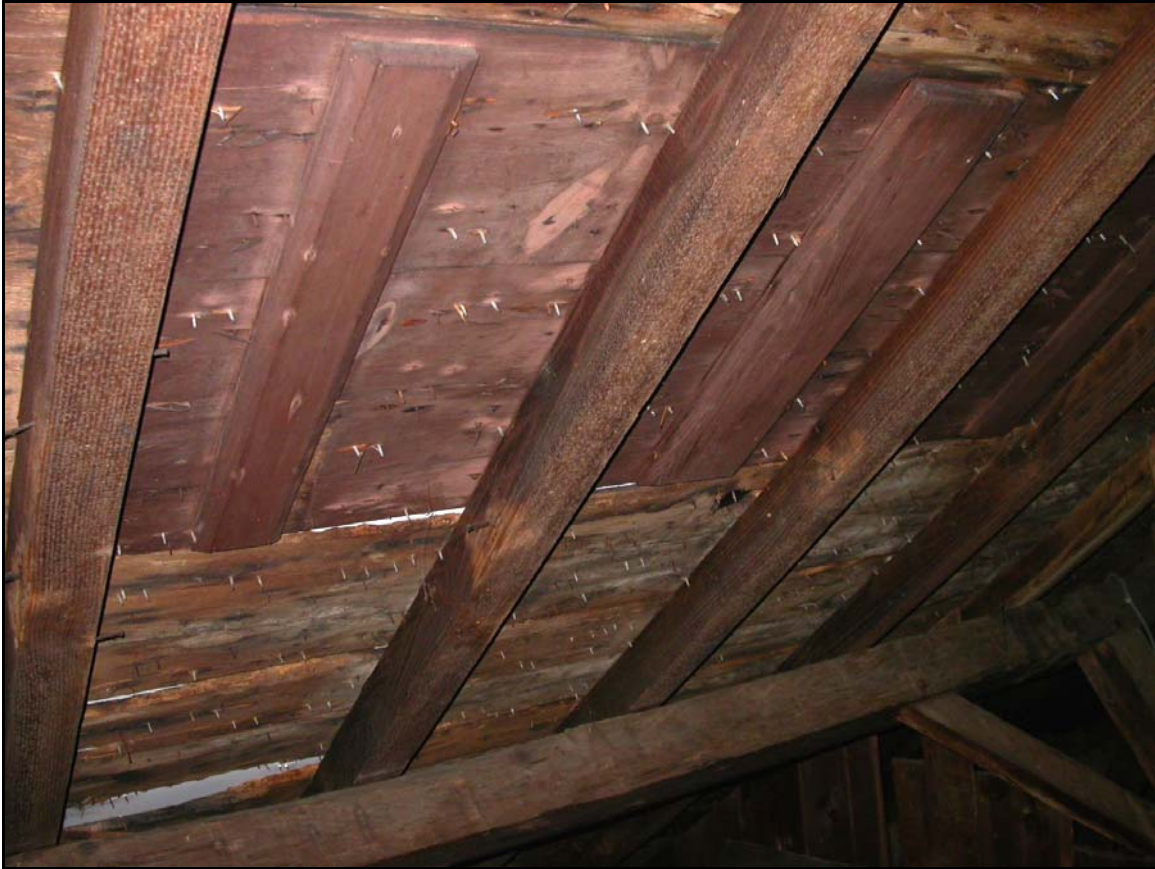
**Photograph House-10a:      Cornice molding on the main part of the house.**

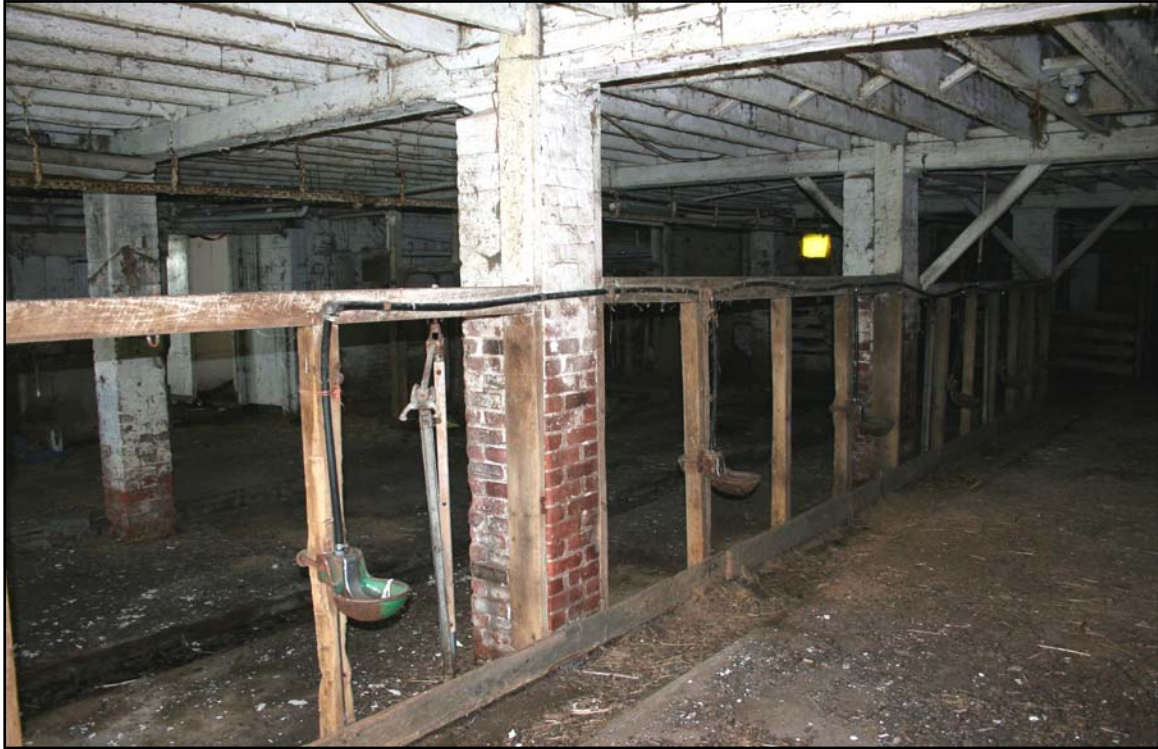
**Photograph Barn-8:**

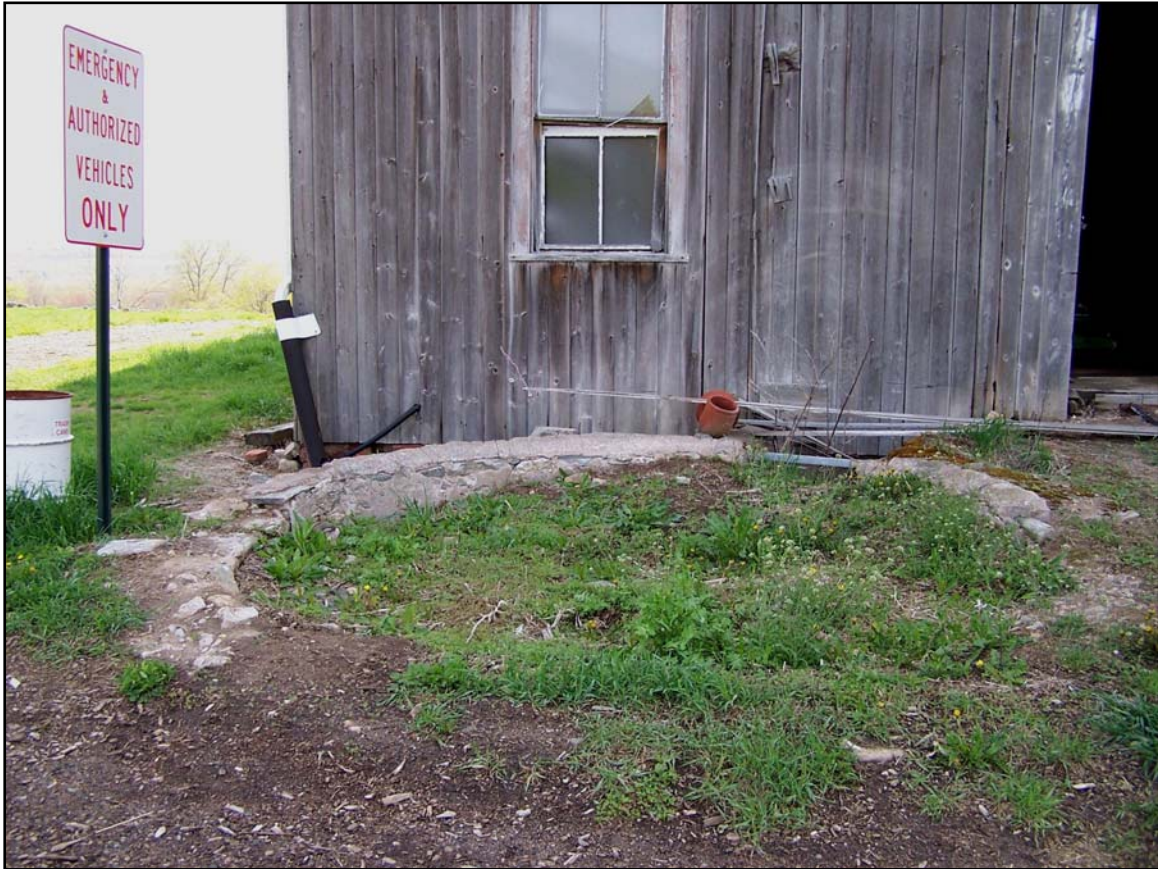
**Photograph Barn-9:**

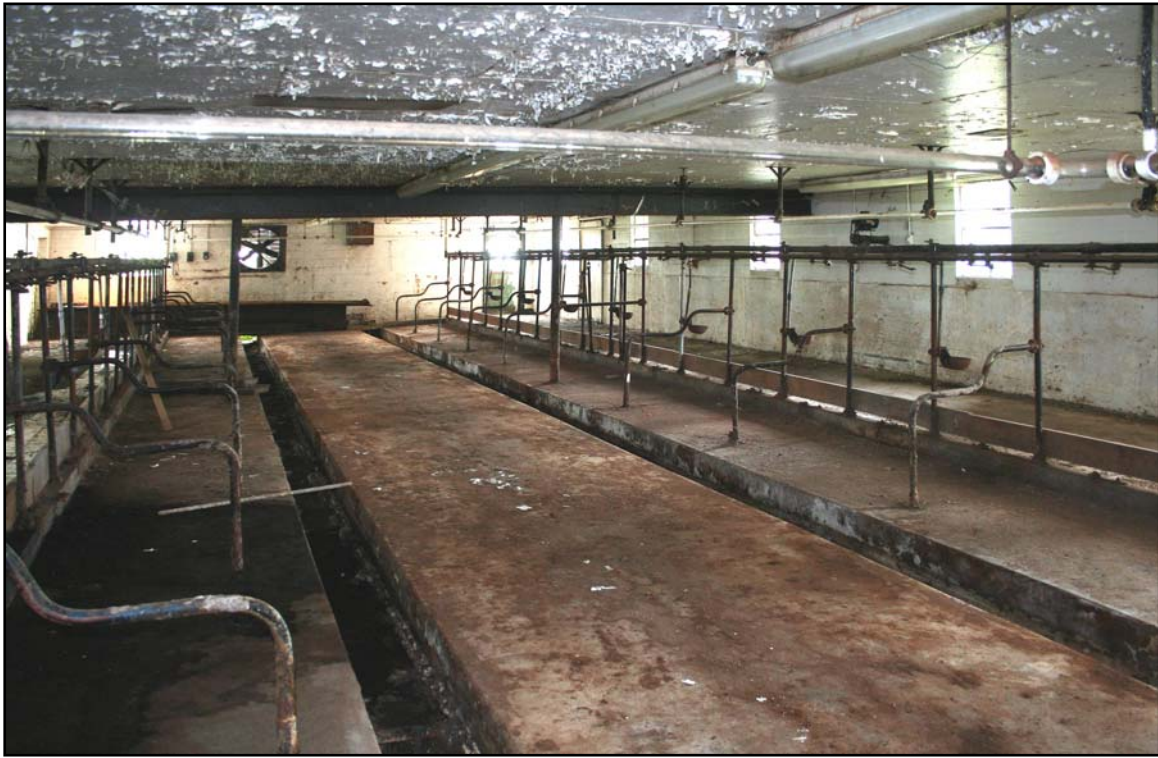
**STRUCTURAL CONDITION ASSESSMENT OF HOUSE AND BARN**

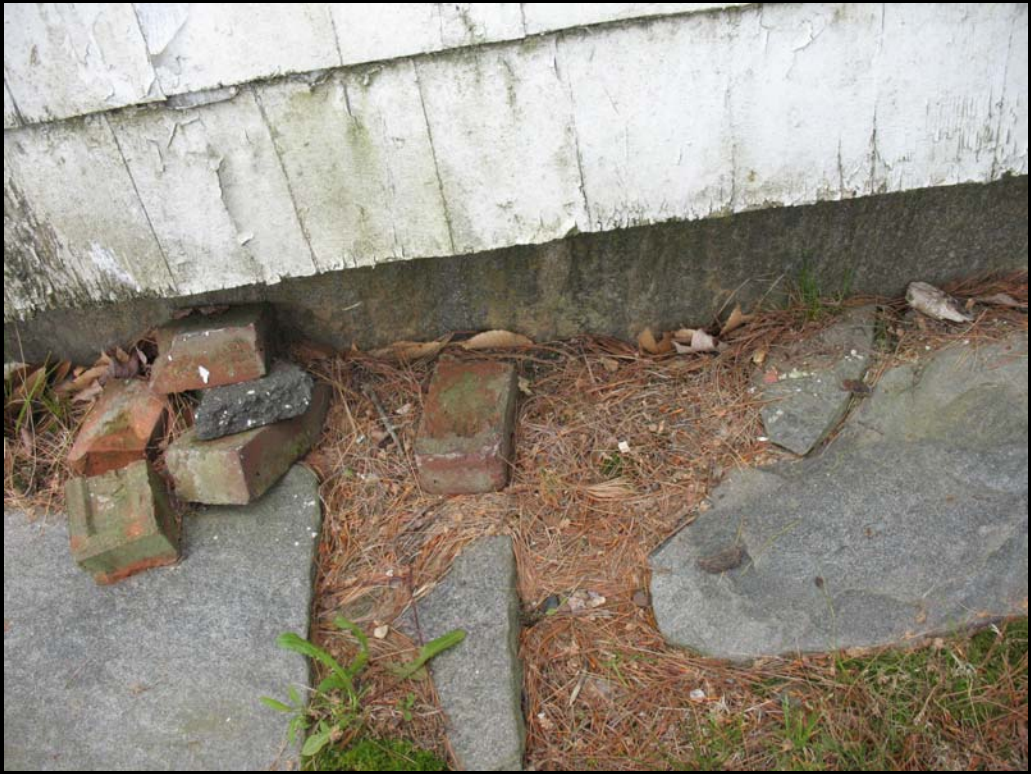
Photo EP3 – Projected shingles from recessed foundation wall.

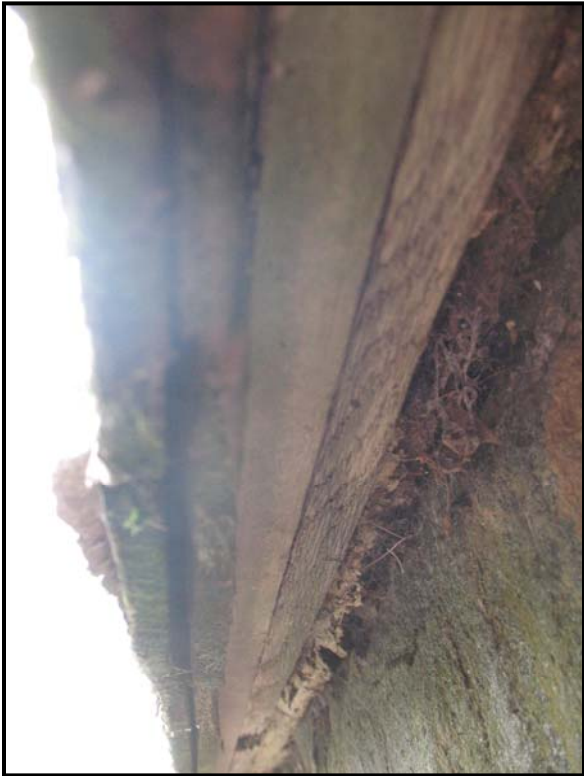
Photo EP4 - Base furring boards on old water table?

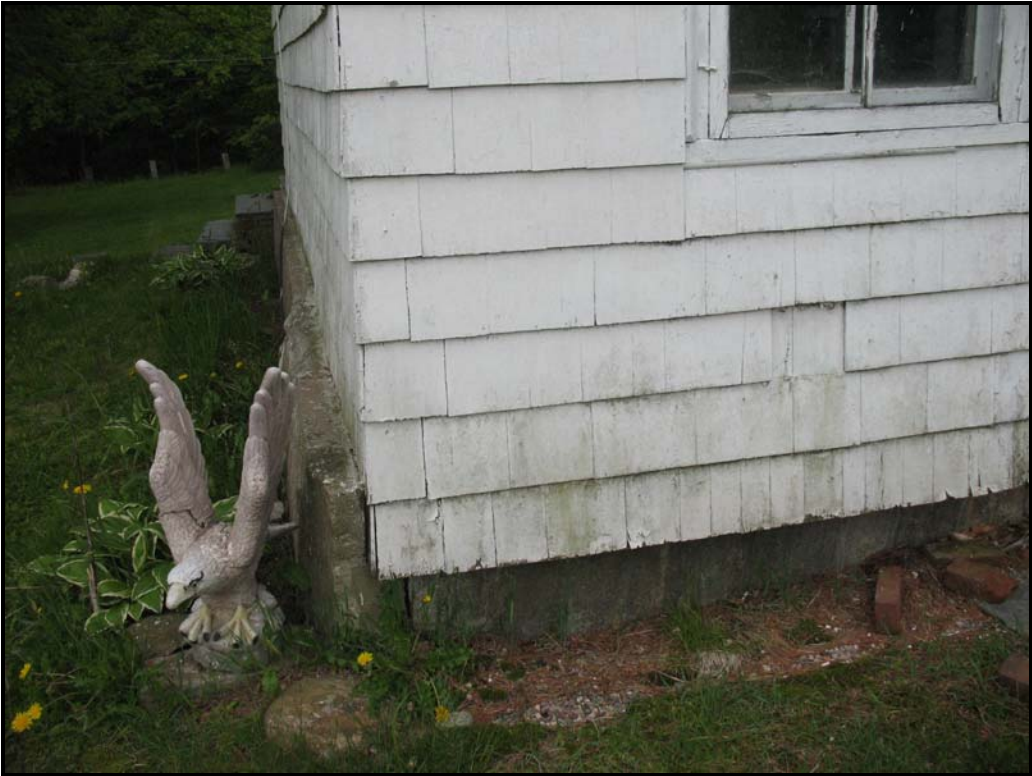
Photo EP5 – Cast-in-Place concrete foundation wall fascia at east side.

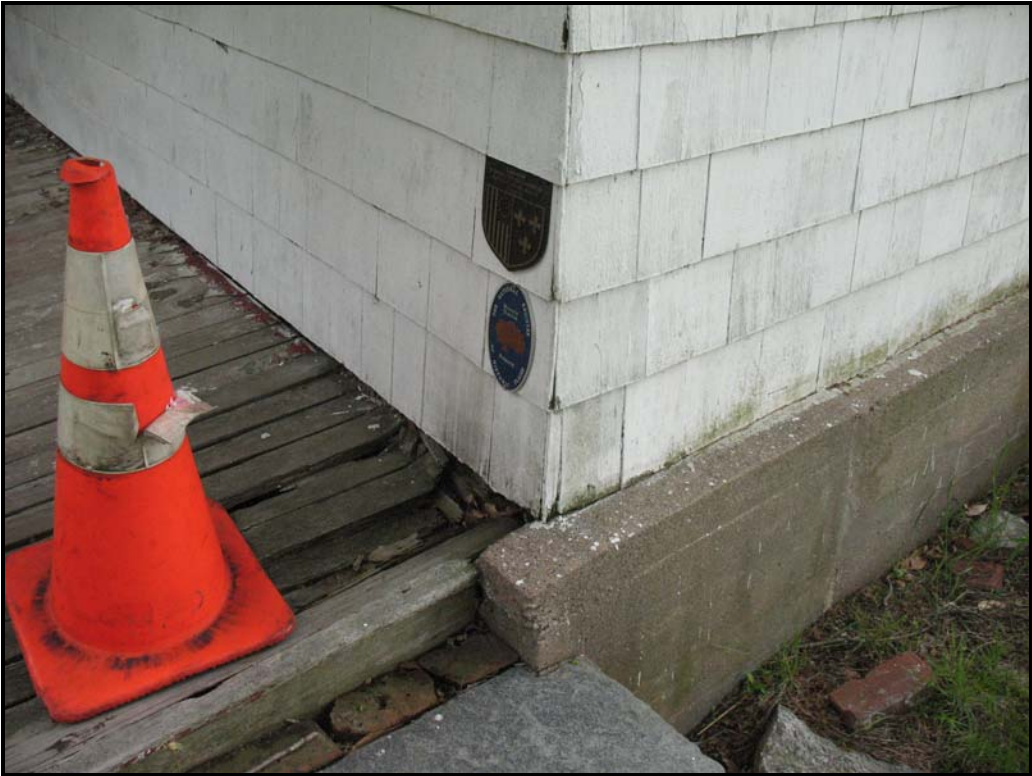
Photo EP6 – Concrete foundation fascia at deck and rotted deck.

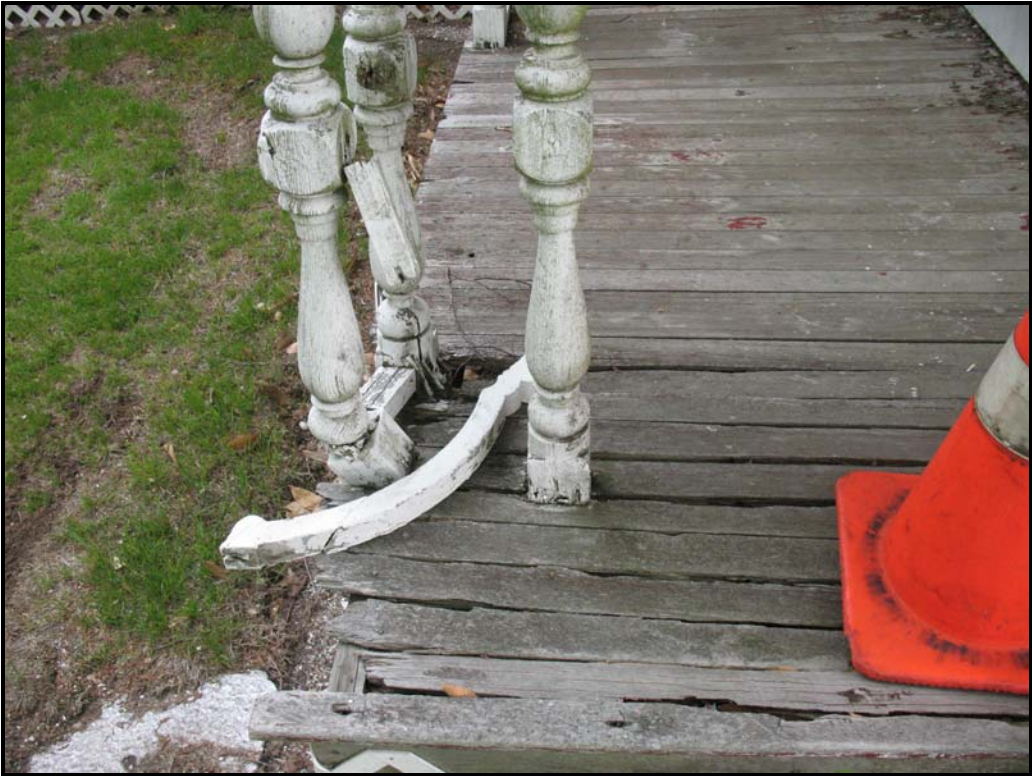
Photo EP7 – Deck corner rot with buckled porch columns.

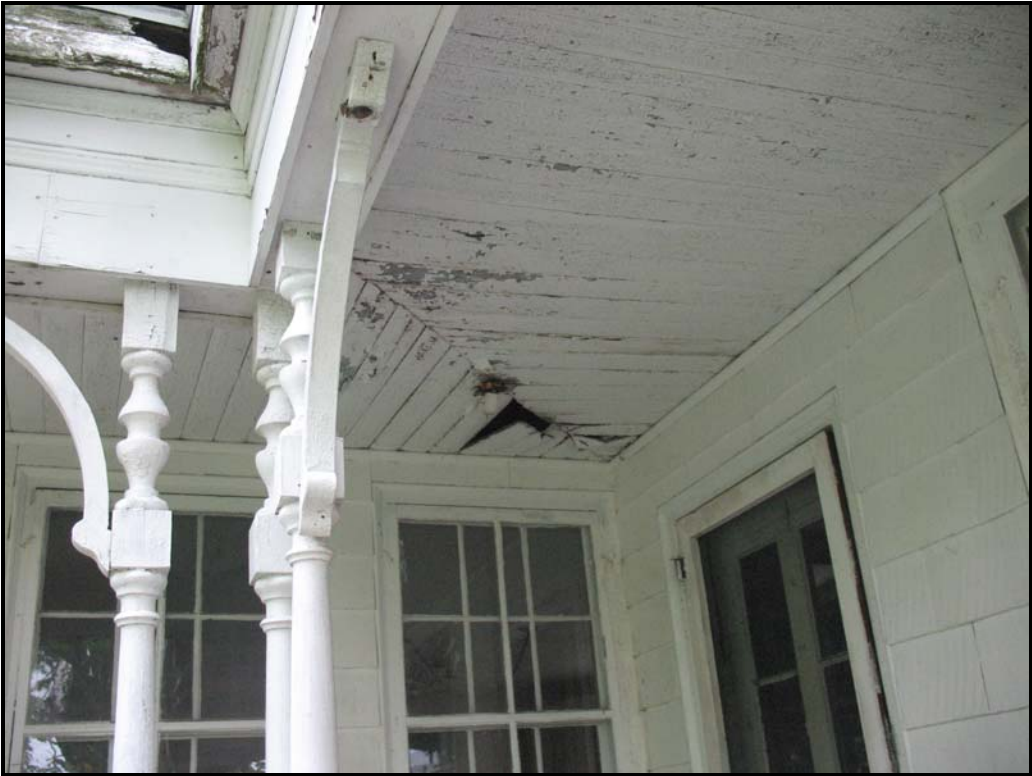
Photo EP8 – Deck ceiling rotting due to wall leaks above.

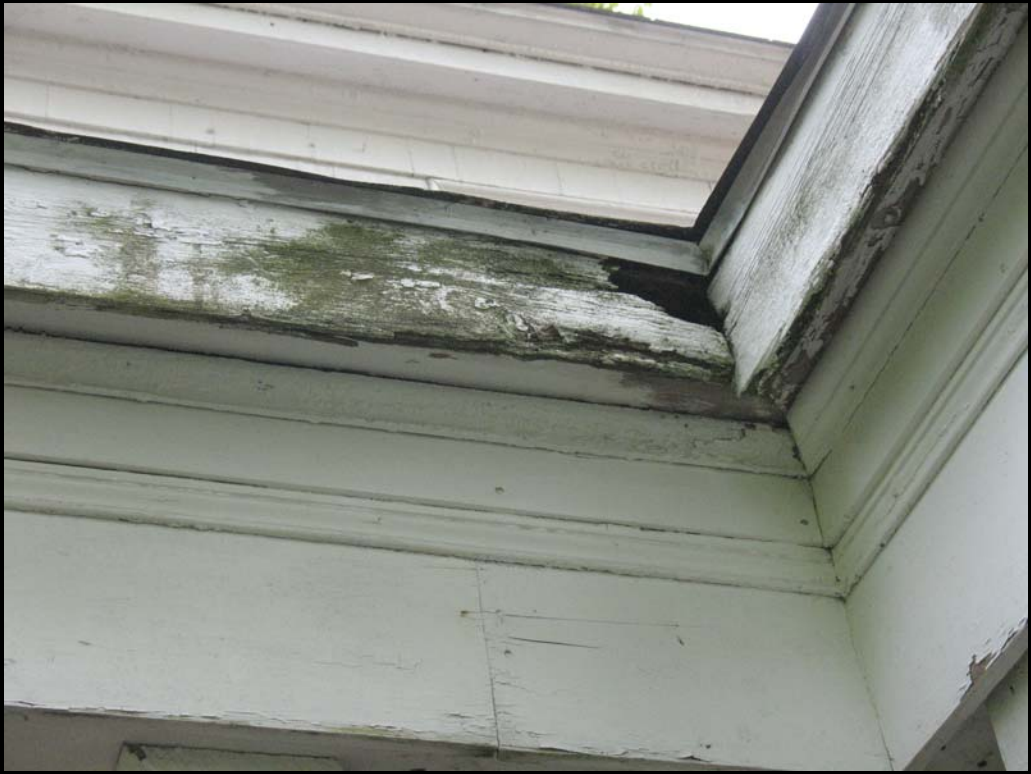
Photo EP9 - Deck roof fascia boards; rotted through.

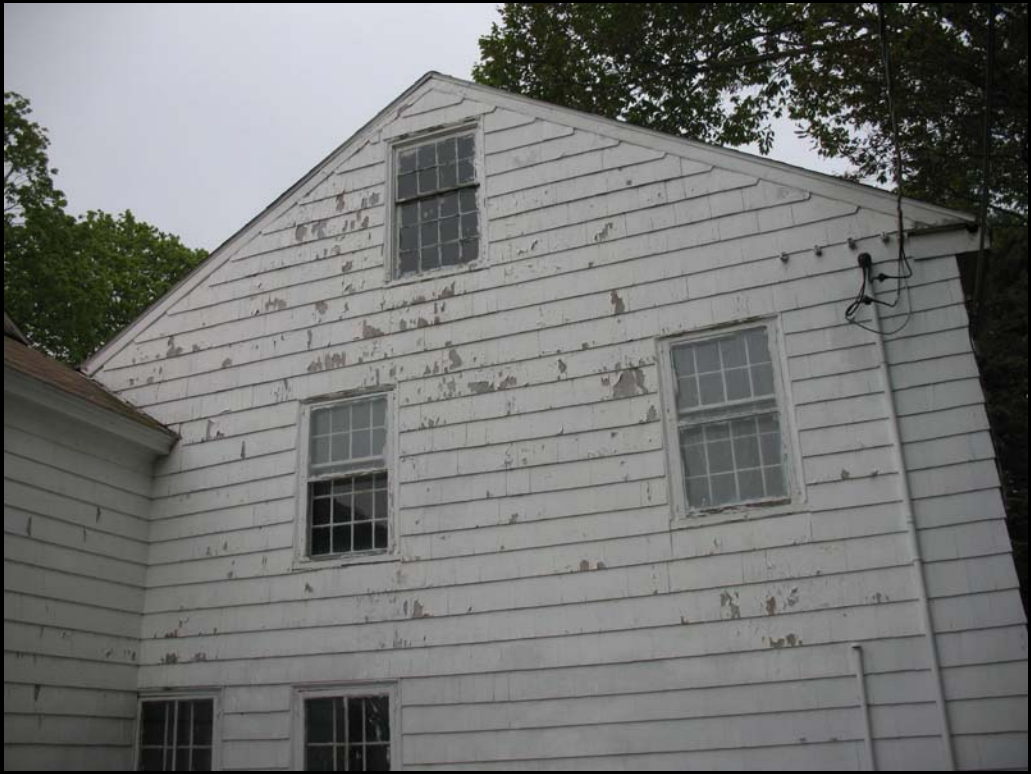
Photo EP11 – Paint peeling due to trapped moisture in shingles.

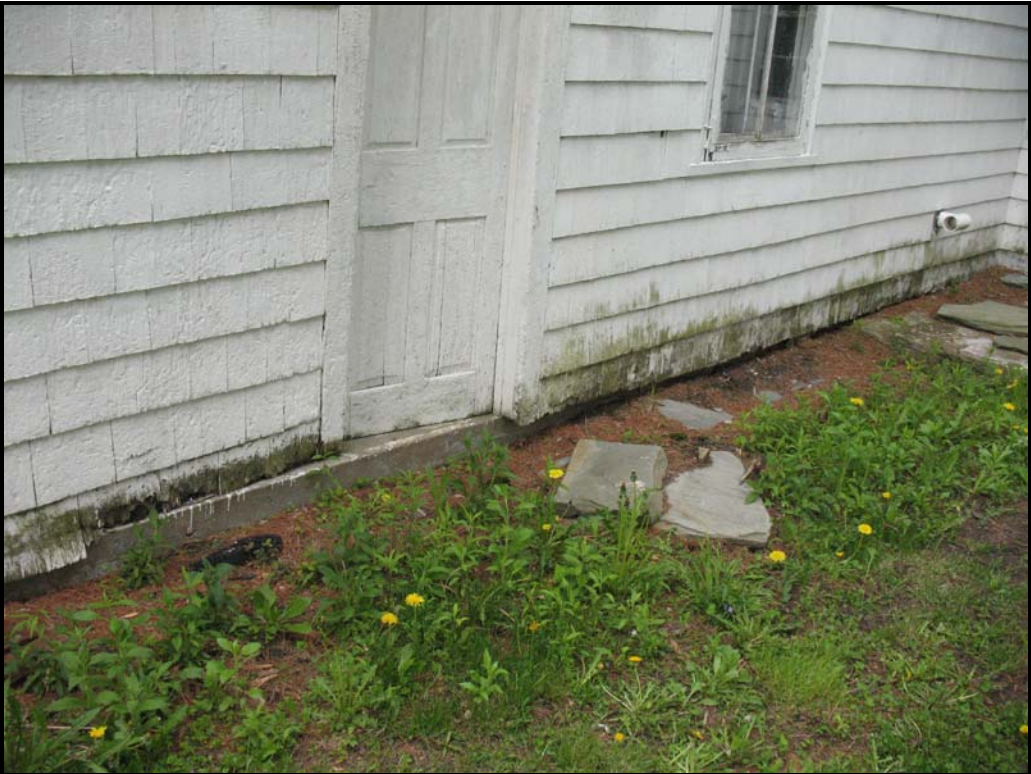
Photo EP12 – Base course shingle rotting due to roof runoff splash zone.

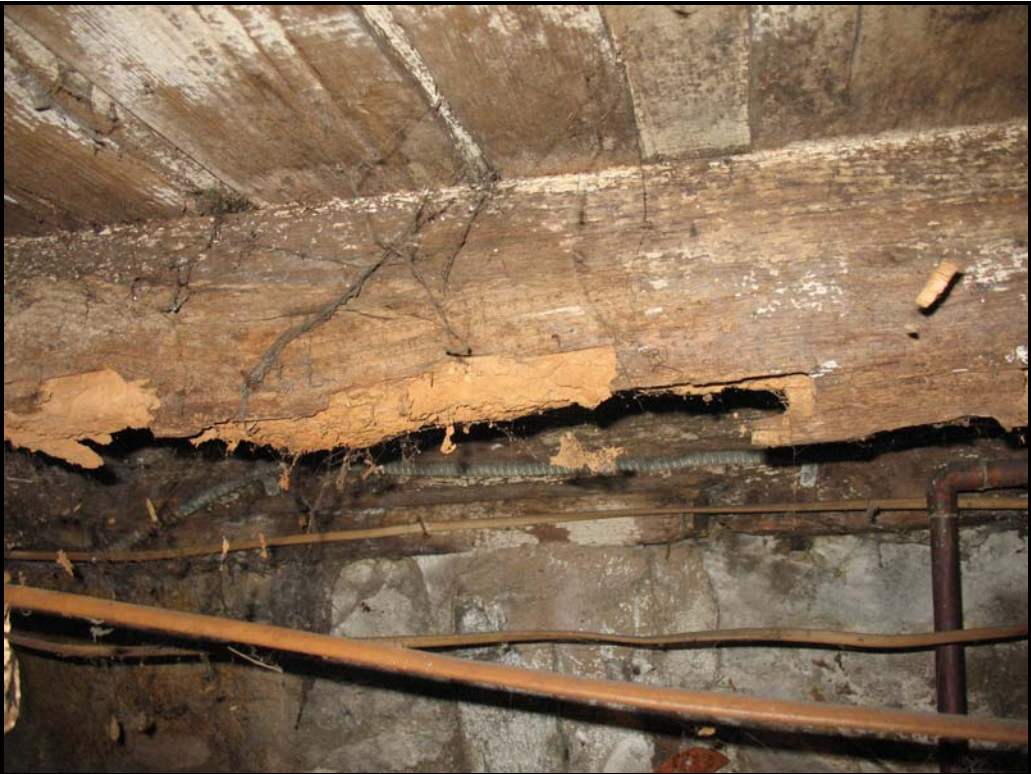
Photo B2 – Main House first floor joist with severe powder post beetle damage.

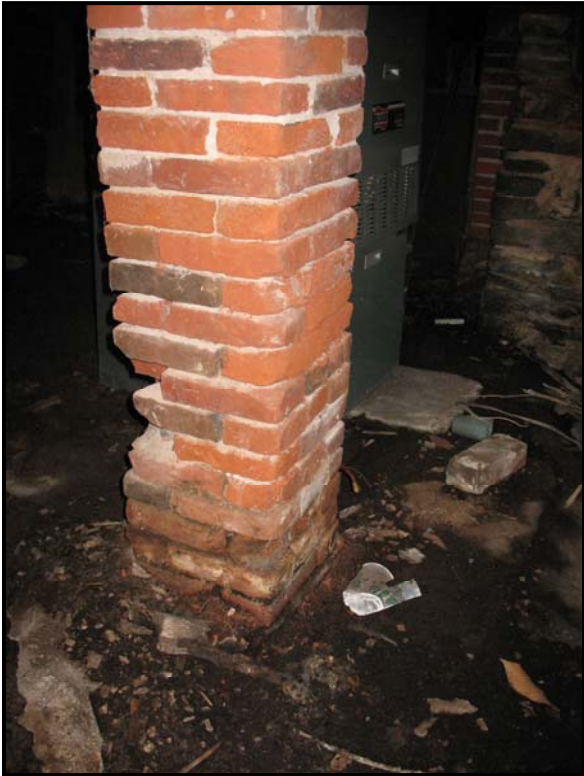
Photo B3 – Heavy brick pier damage at Main House.

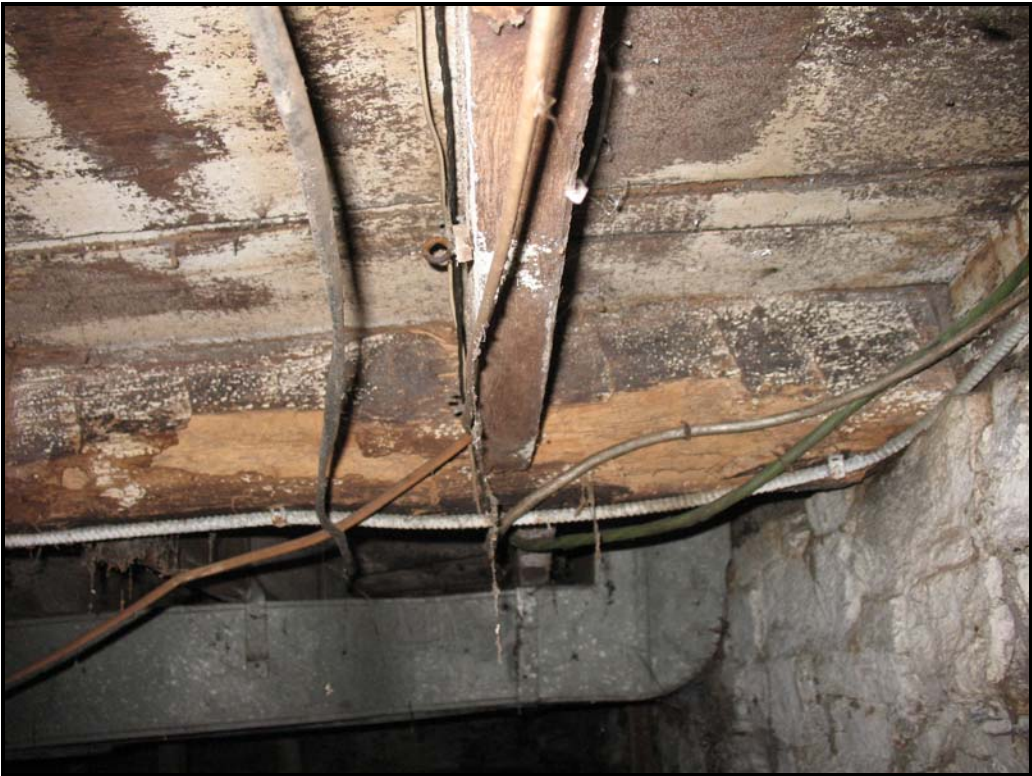
Photo B4 – Main House girder damage at front (south) wall.

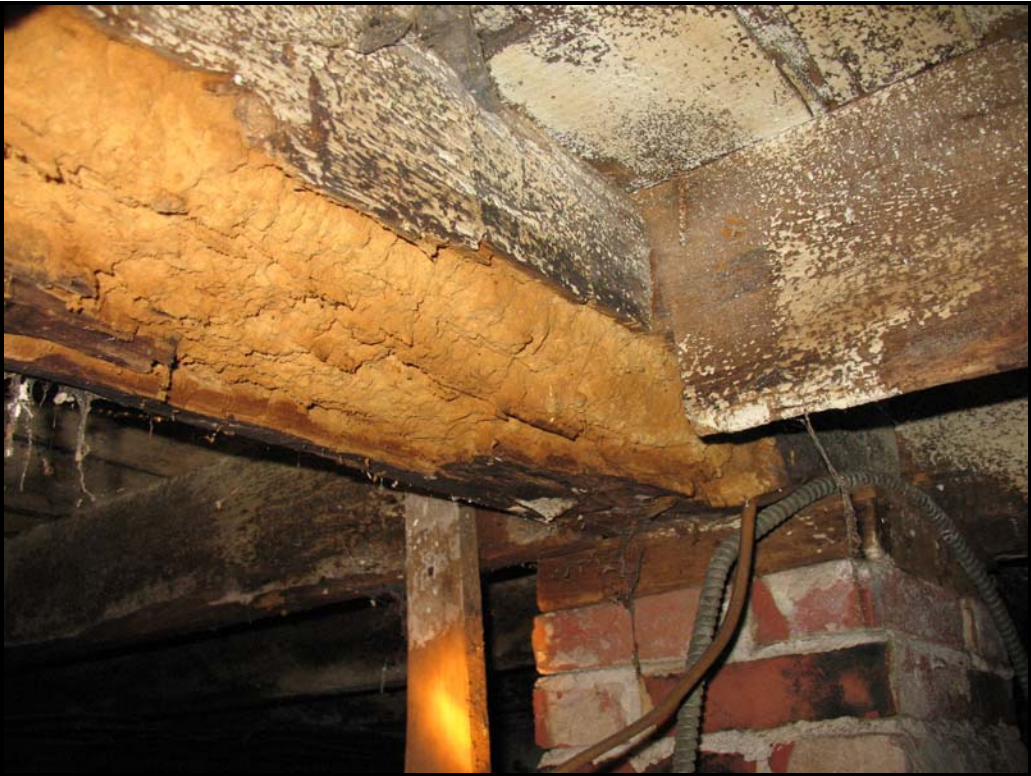
Photo B5 – Main House girder with heavy powder post beetle damage.

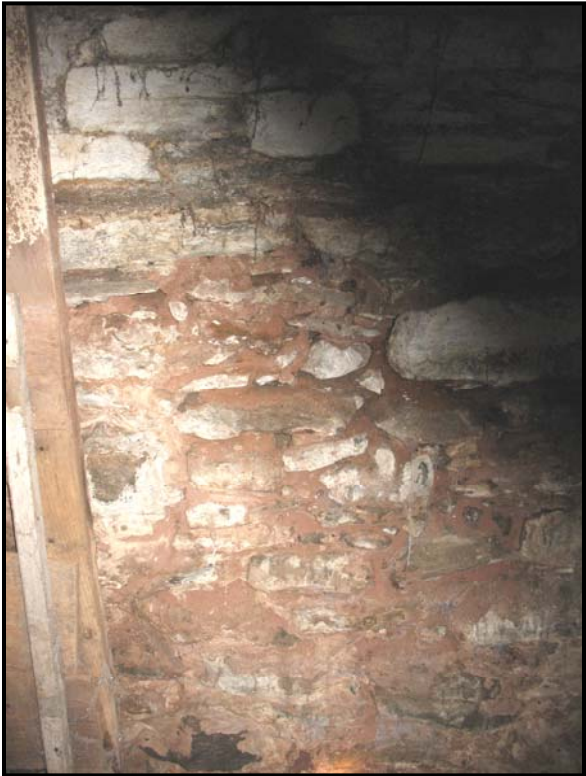
Photo B6 – Main House foundation wall with mud or lime mortar.

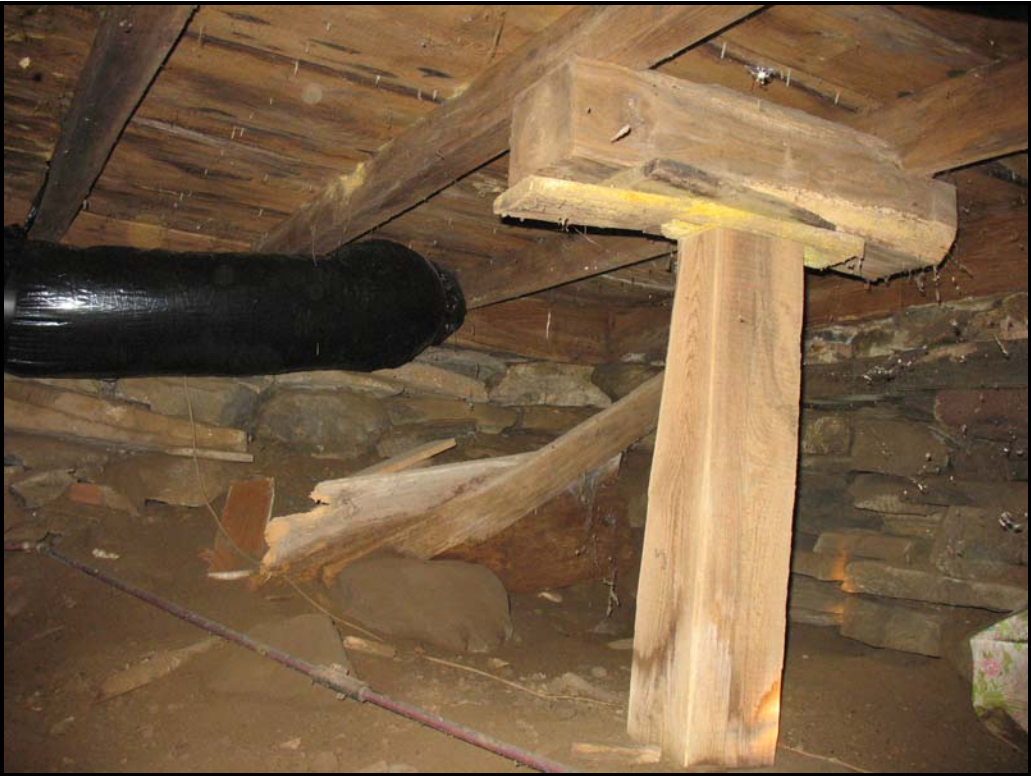
Photo B7 – Addition with first floor old joist shoring system.

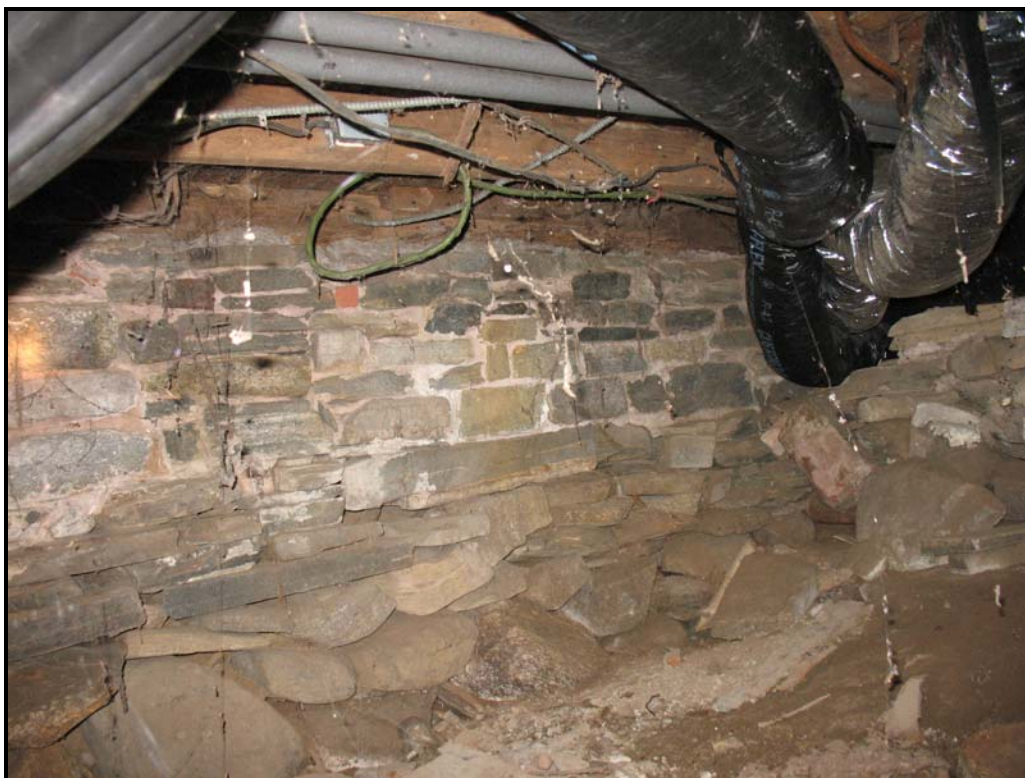
Photo B9 – Addition stone foundation wall with brick capping.

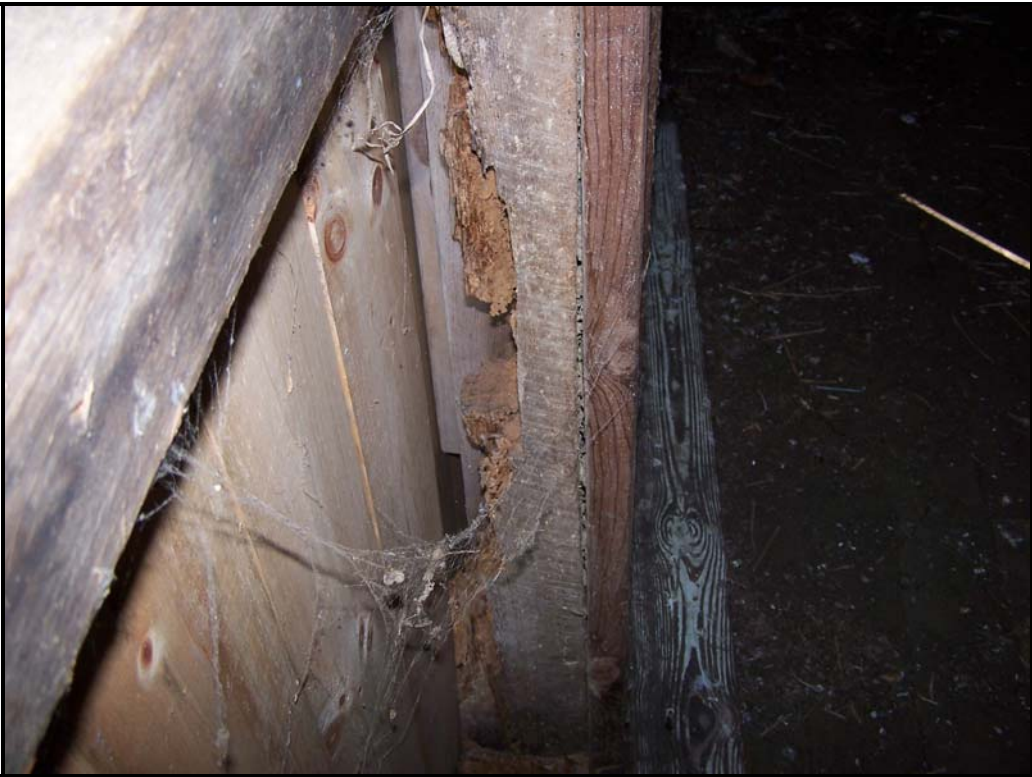
Photo BN2 – Main barn exterior post with powder post beetle damage.

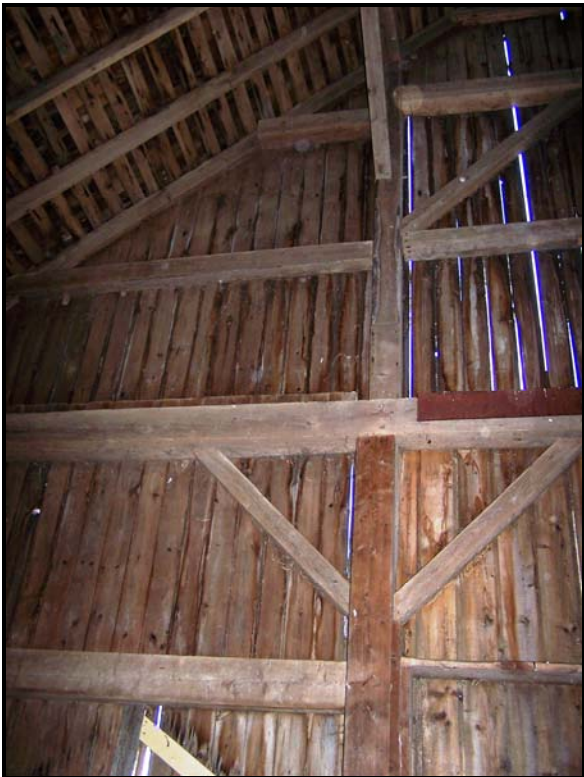
Photo BN3 – Main barn typical end wall framing with airspaces.
