A Report  
to the  
Bolton Heritage Farm Commission  
concerning

**The Bolton Heritage Farm**

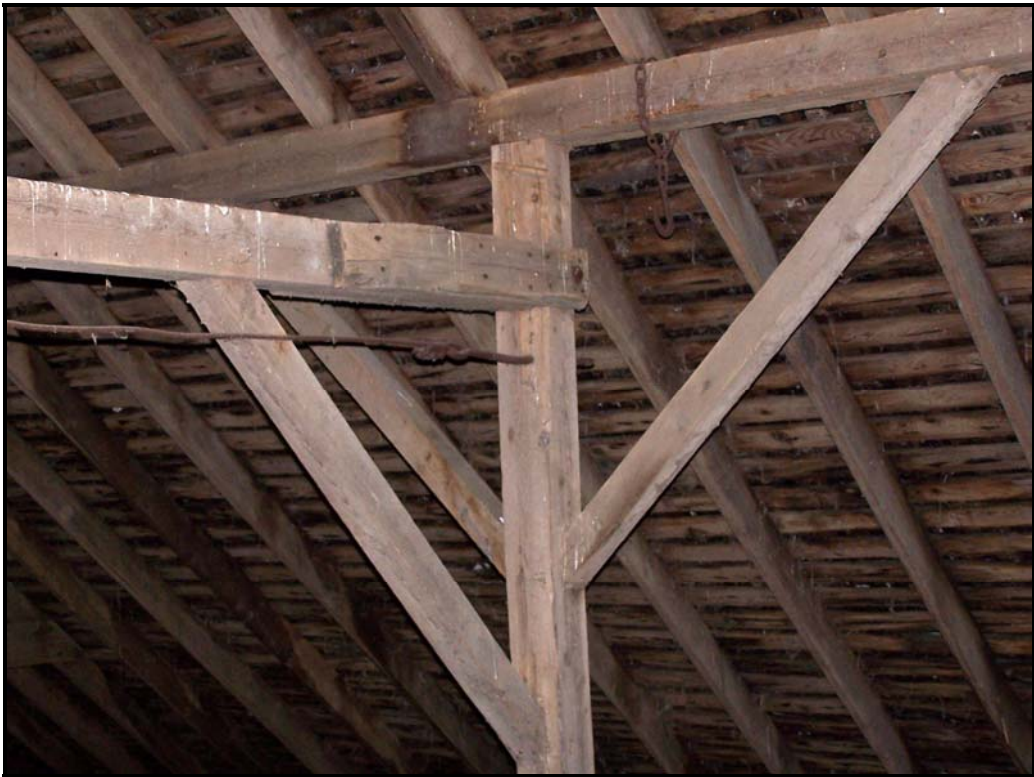
Photo BN5 – Main barn cross frame showing scabbed on repair pieces at timber end connections.

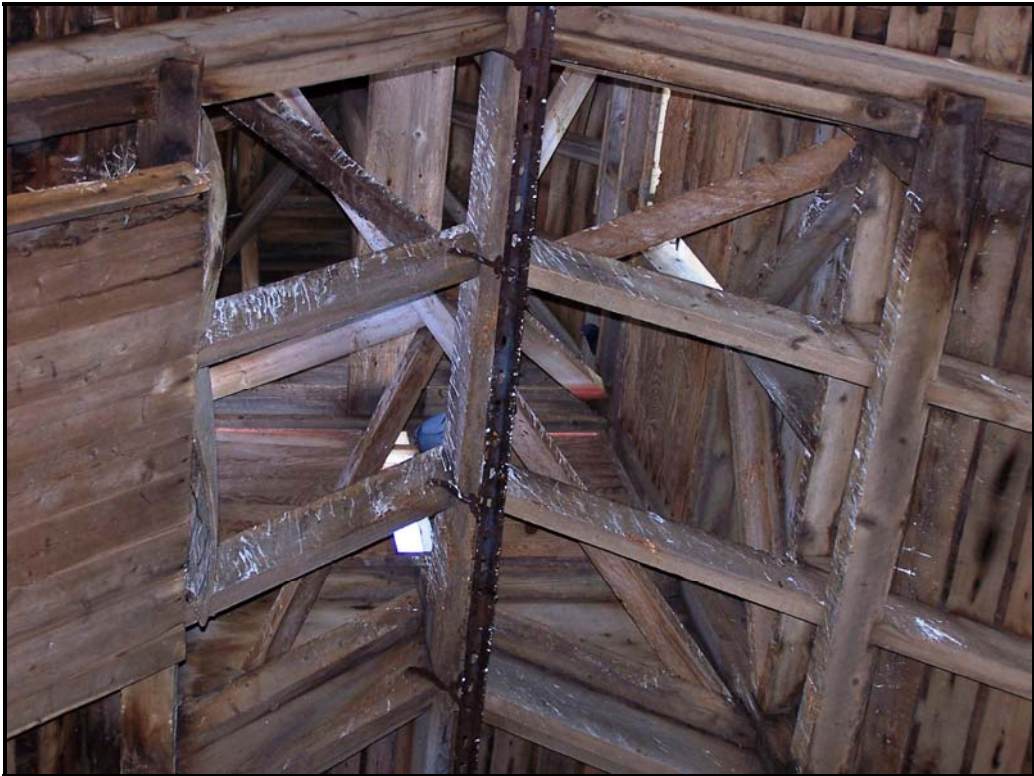
Photo BN6 – Main barn center roof cupola framing.

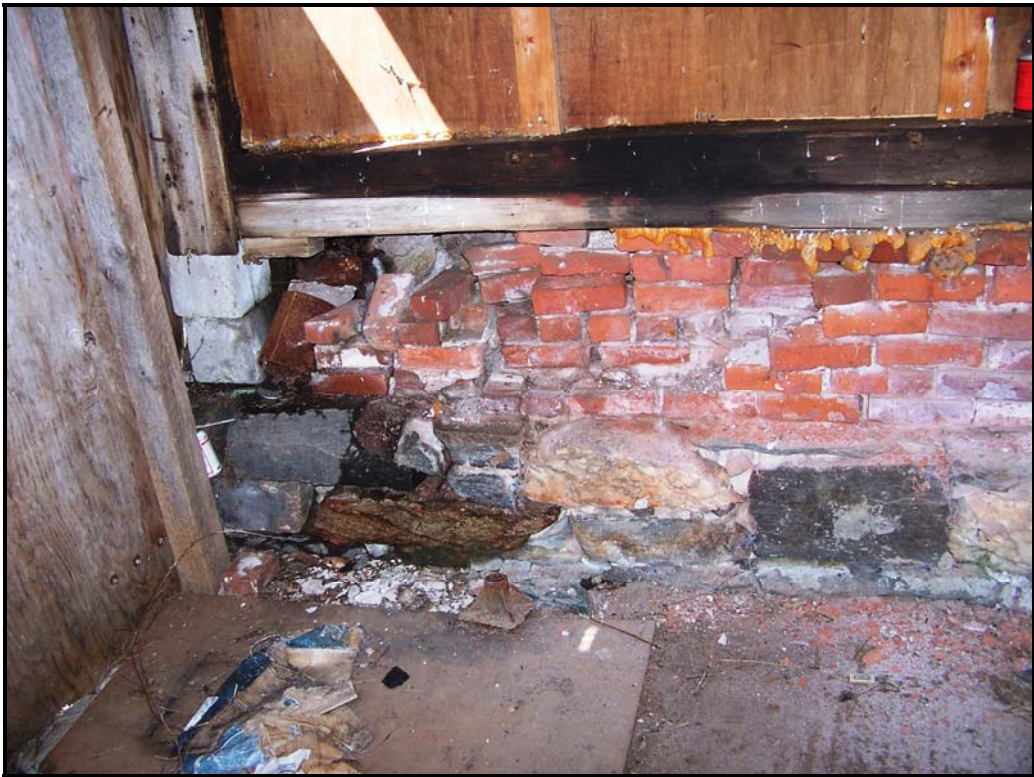
Photo BN11- Collapsing front foundation corner on the south shed building.

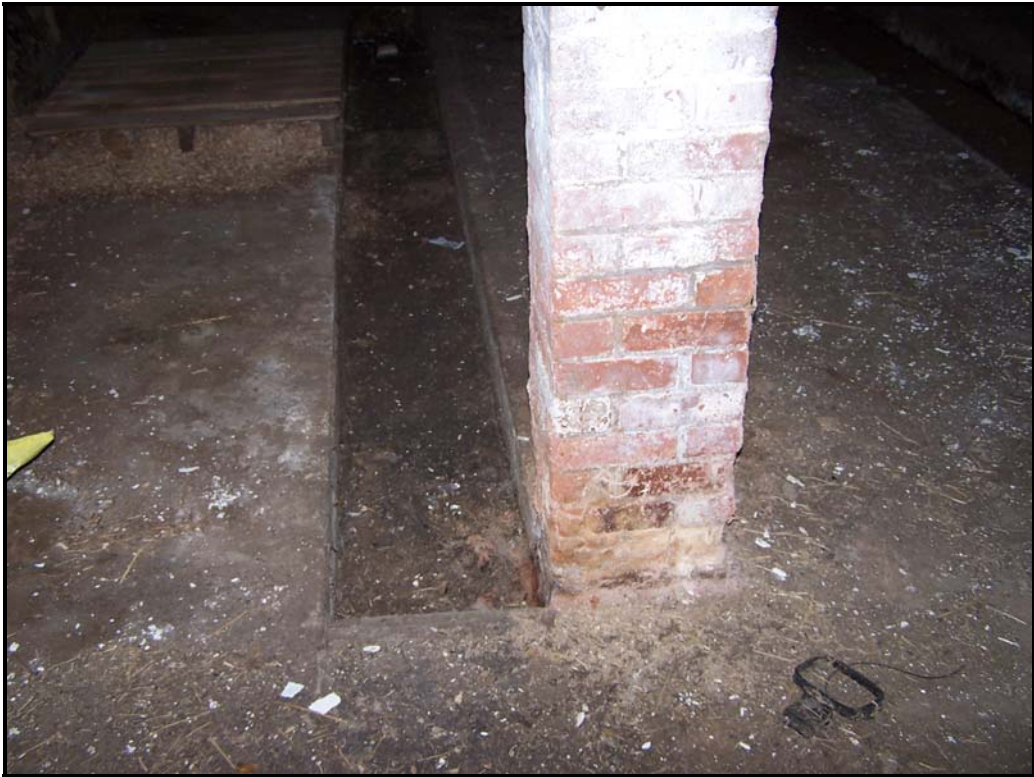
Photo BN12 – Deteriorating base of main barn basement brick pier.

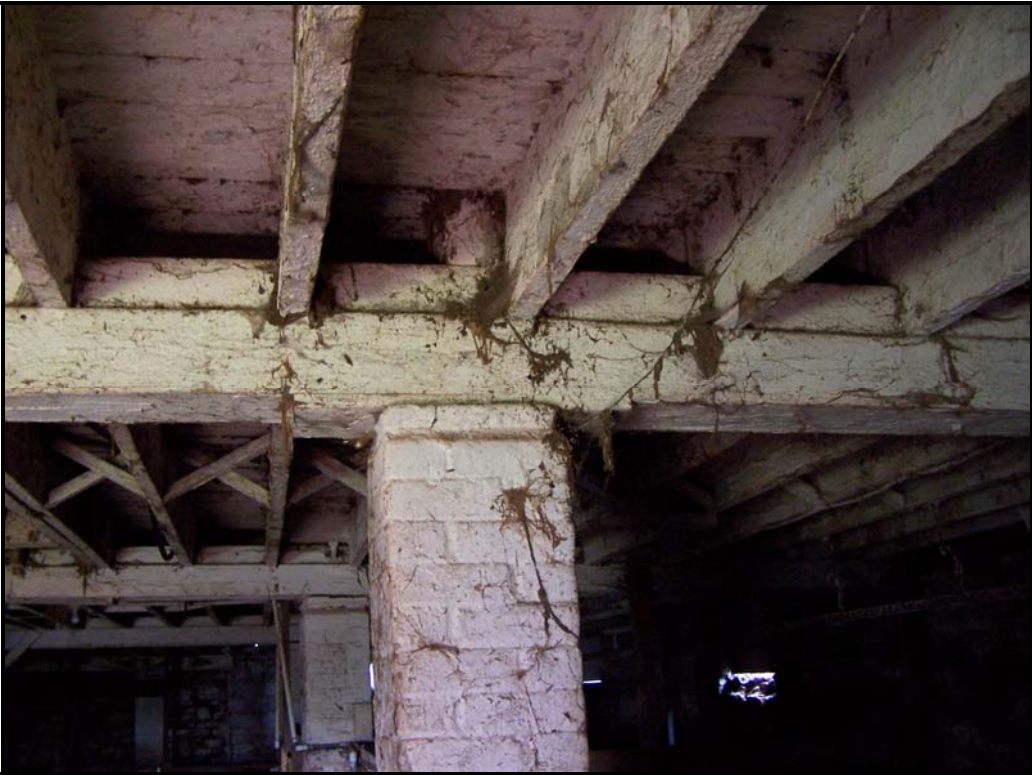
Photo BN13 – Top of main barn basement supporting brick pier.

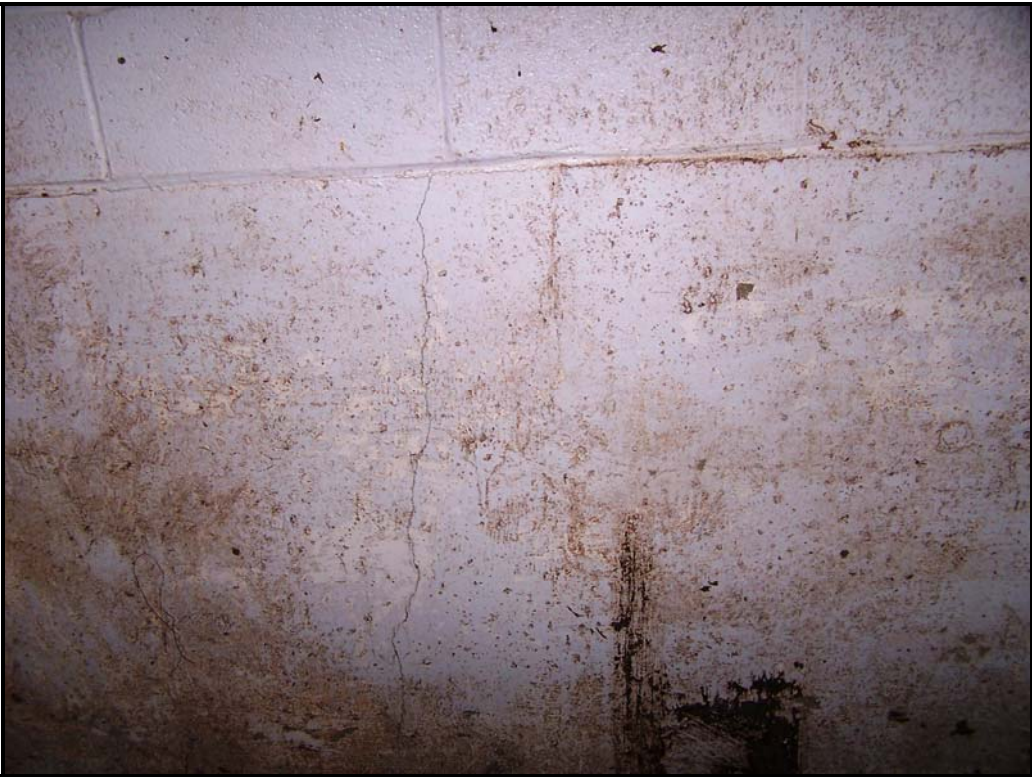
Photo BN18 – Minimal shrinkage crack in new milking barn foundation wall.

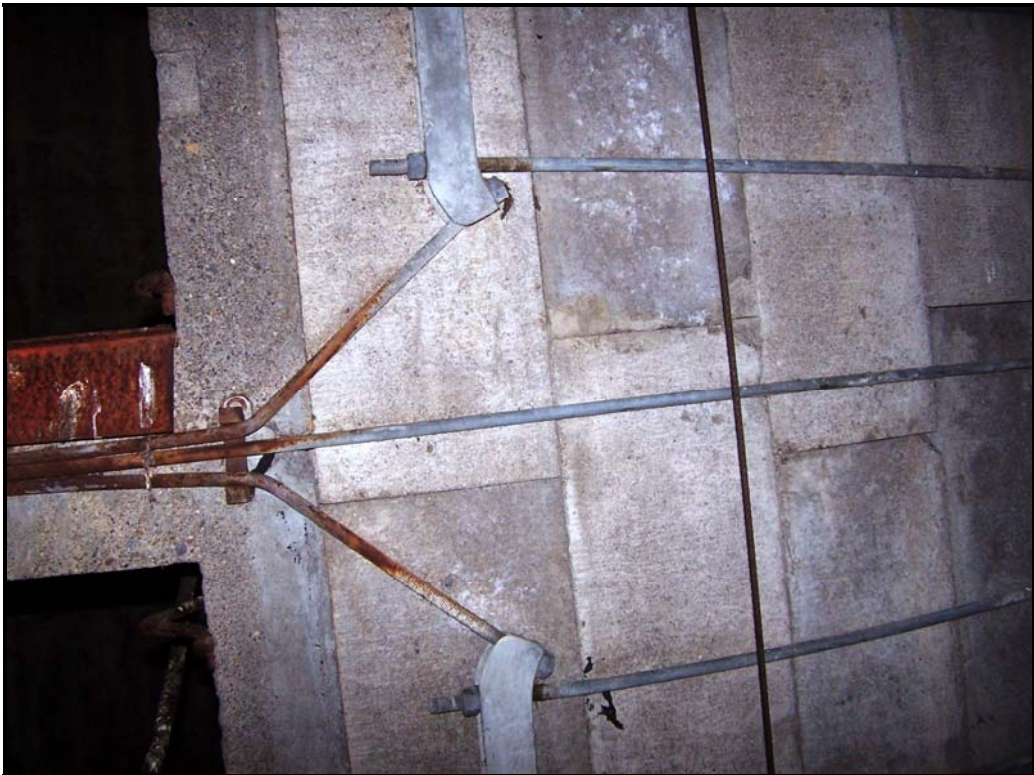
Photo BN19 – General construction photo of concrete block with rod tension ties.

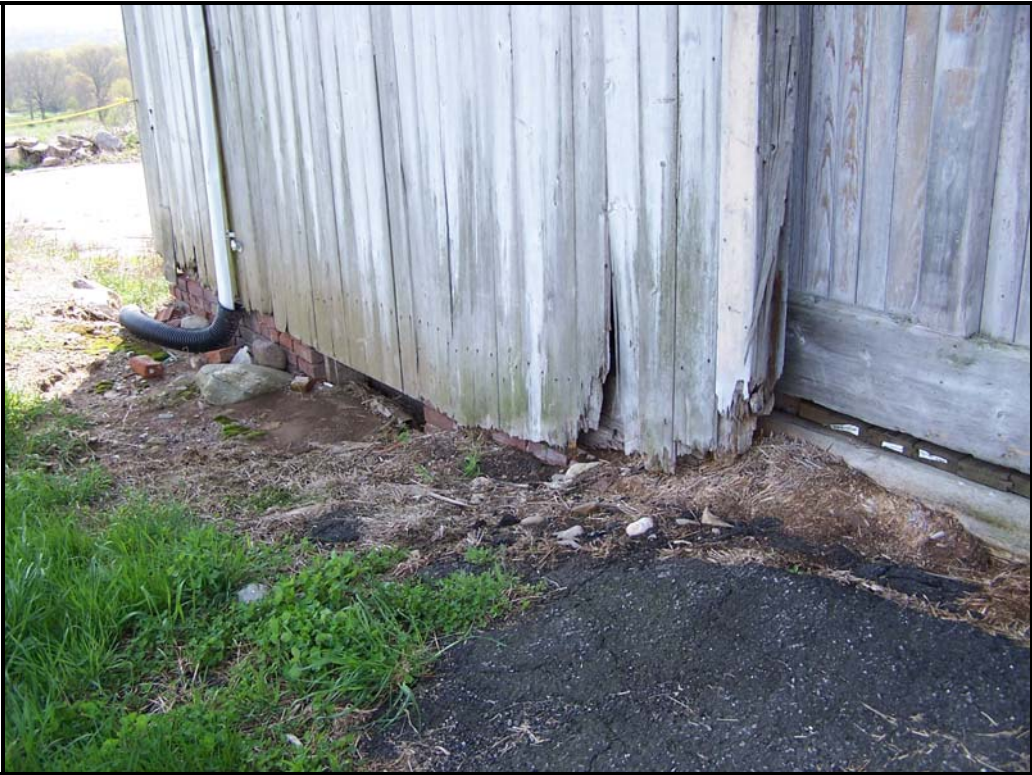
Photo BN21- 1908 barn foundation walls at corners needing repair.

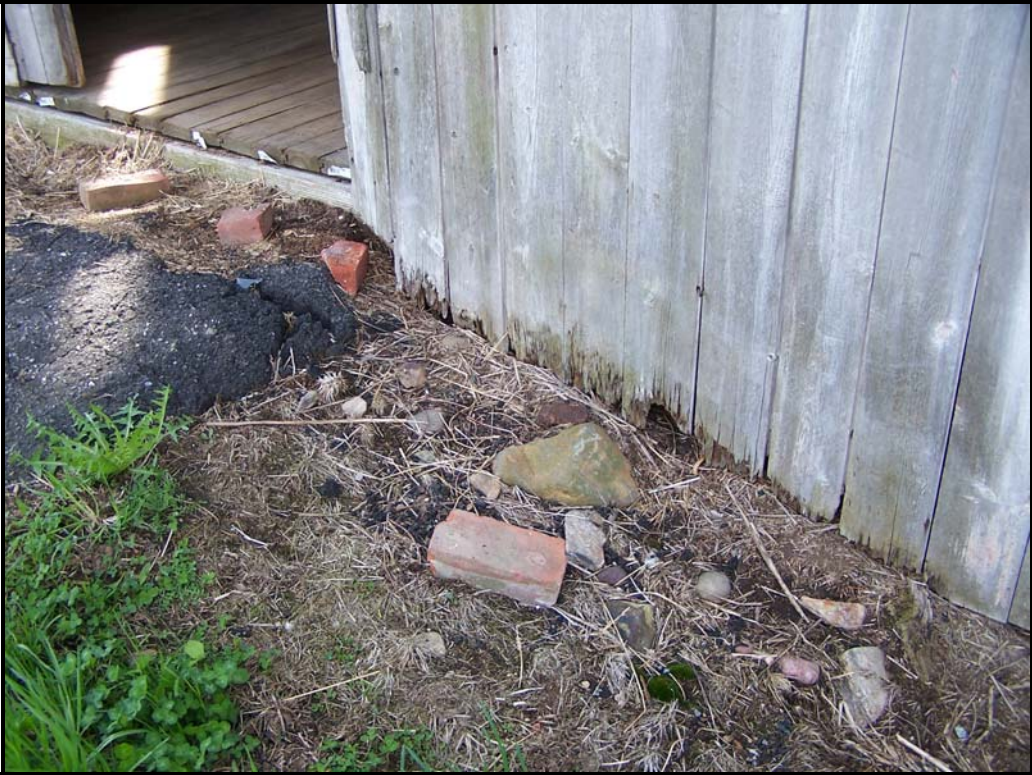
Photo BN22 – 1908 barn exterior wall with damage to adjacent raised soil grade.

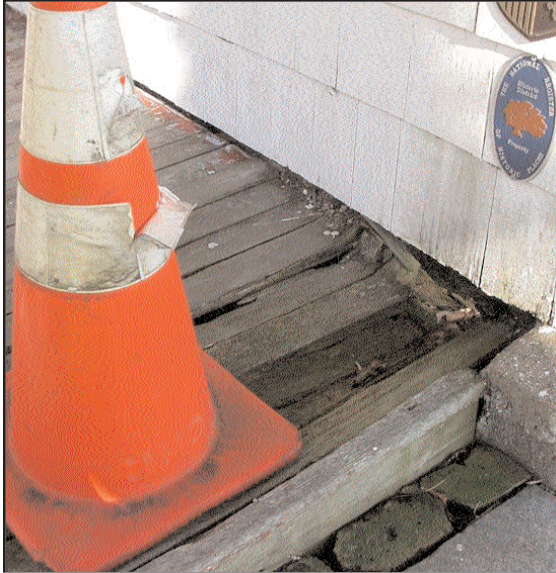
Figure 1: Deterioration of porch structure and finish.

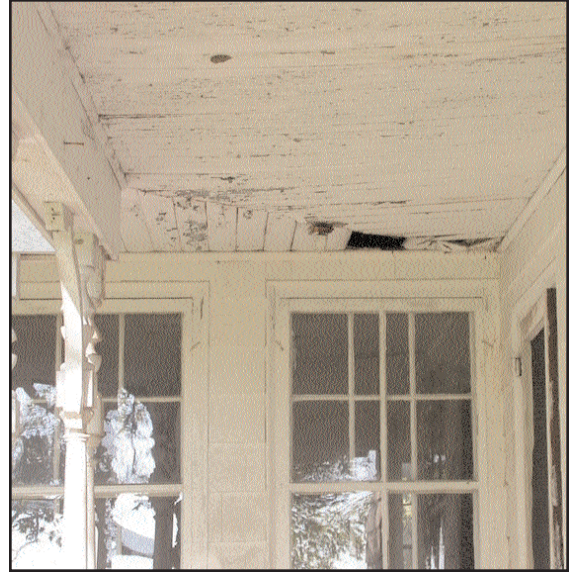
Figure 2: Deterioration of porch ceiling

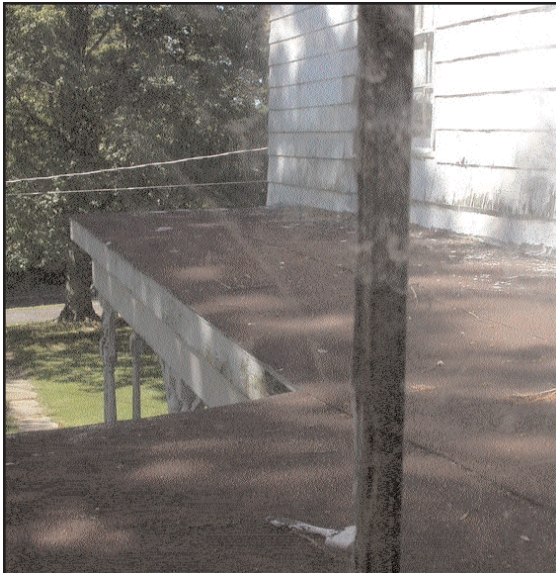
Figure 3: Porch roof past the end of its' useful life. Porch roof structure deteriorated. New sidewall flashing needs to extend under siding.

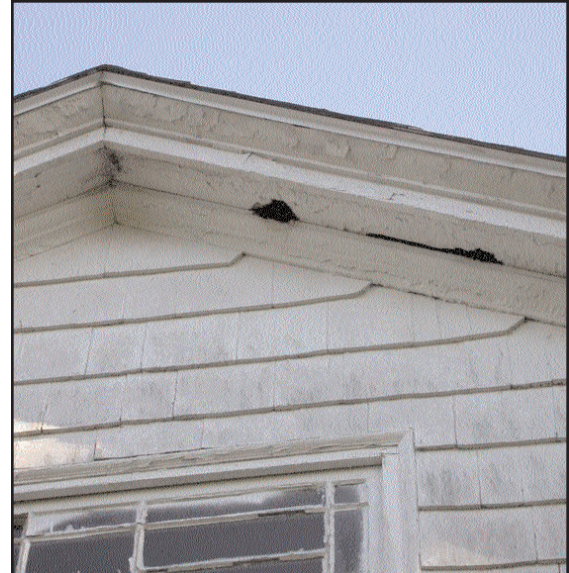
Figure 4: Eave at south wall of main house is badly deteriorated. The best time to rebuild an eave is when the roof is replaced.

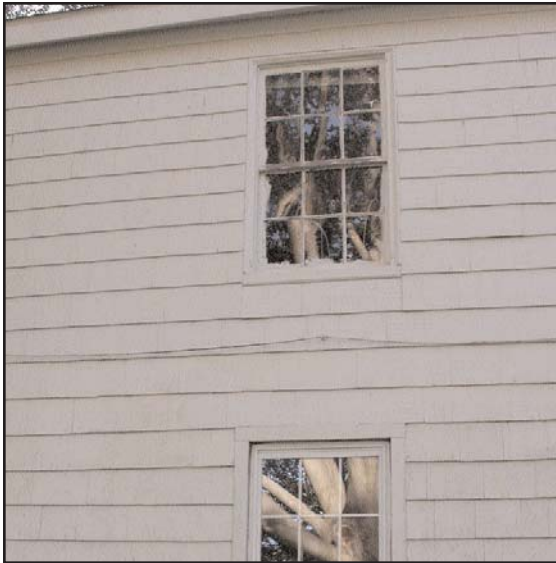
Figure 5: Shingle siding over existing clapboard siding causes window trim to become partially recessed resulting in deterioration of window frames / sills. Note installation of vinyl replacement window on first floor north wall. Shingle siding should be removed for practical as well as aesthetic reasons.

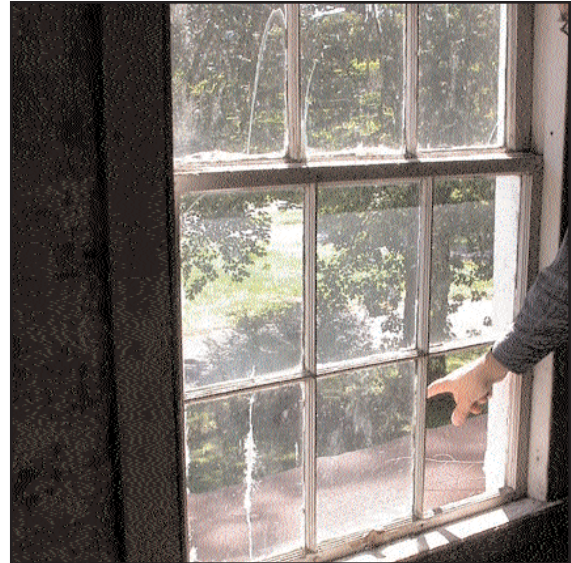
Replace broken or missing glazing (this window pane on east side of second floor fell out of frame and as found on porch roof).

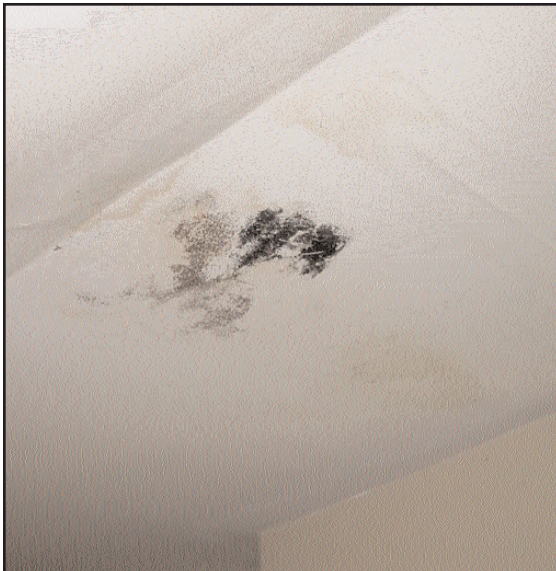
Mold on second floor ceiling of kitchen ell. In an unheated building mould will grow on the paper cover of gypsum wall-board.

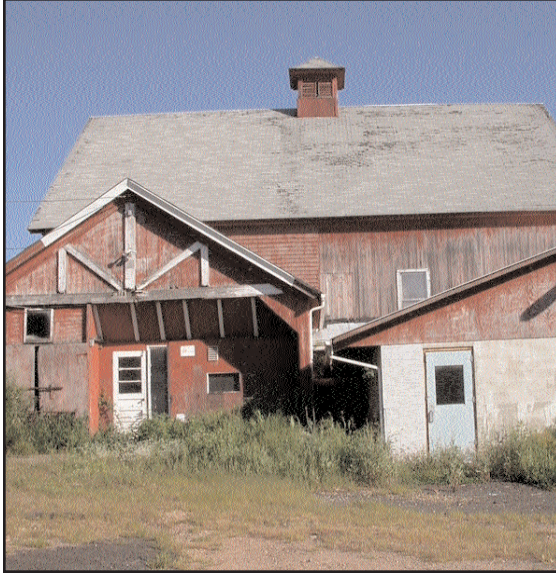
Figure 1: Deterioration of barn roof.

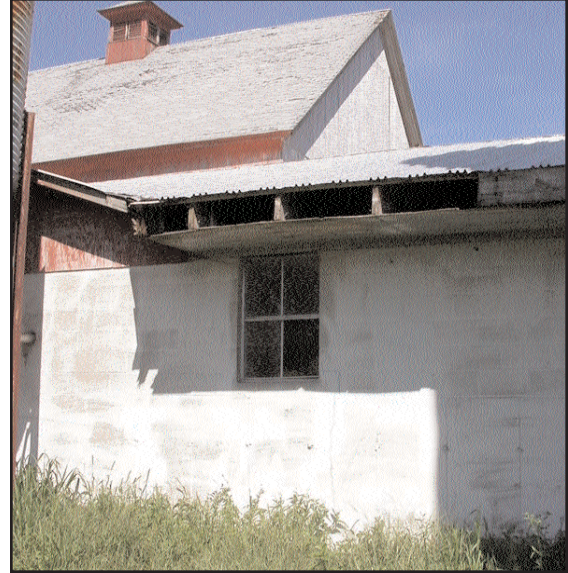
Deterioration of eave on south side of 1980 barn.

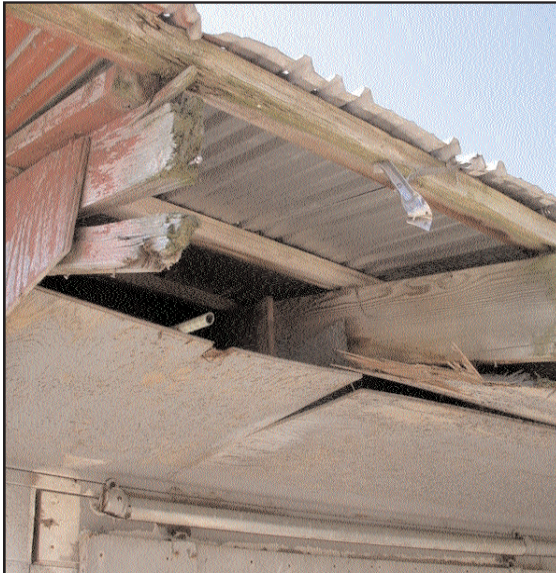
Deterioration of eave on north side of 1980 barn.

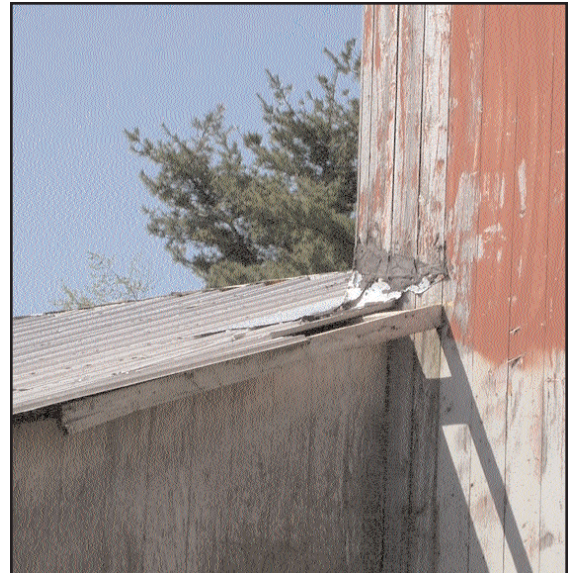
Deterioration of eave and sidewall flashing.

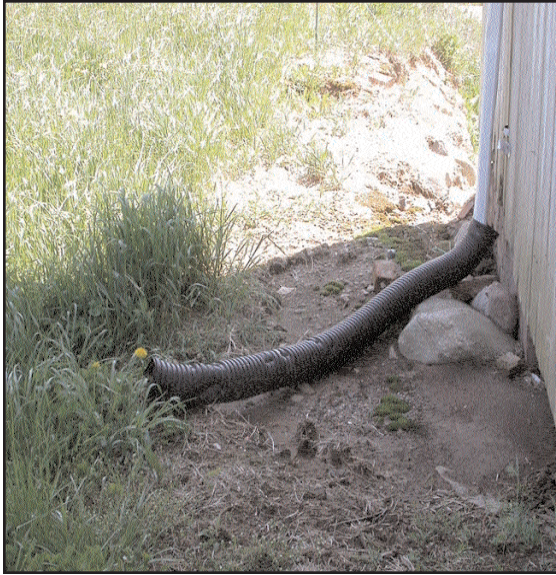
Rainwater leader terminates "uphill". Rainwater leaders to be connected to fence drain and connected to drywell.

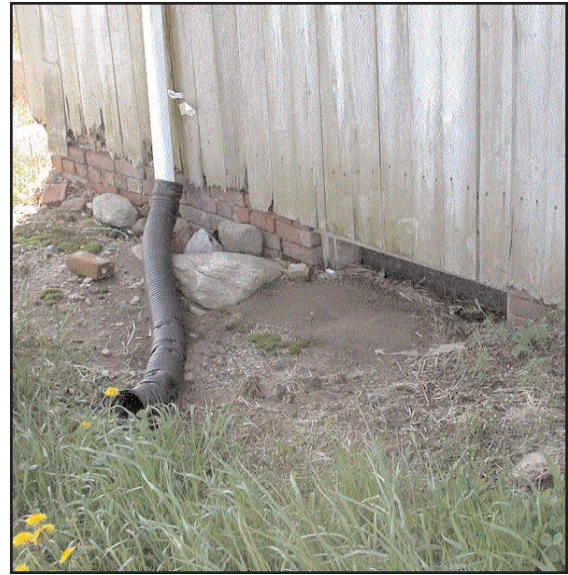
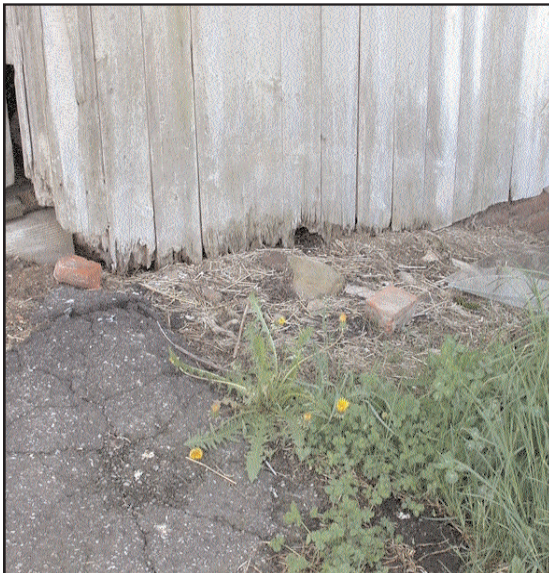
Deterioration of siding adjacent to ramp area north side. Grade/ramp access to be reworked to remove grade from wood cladding / framing.

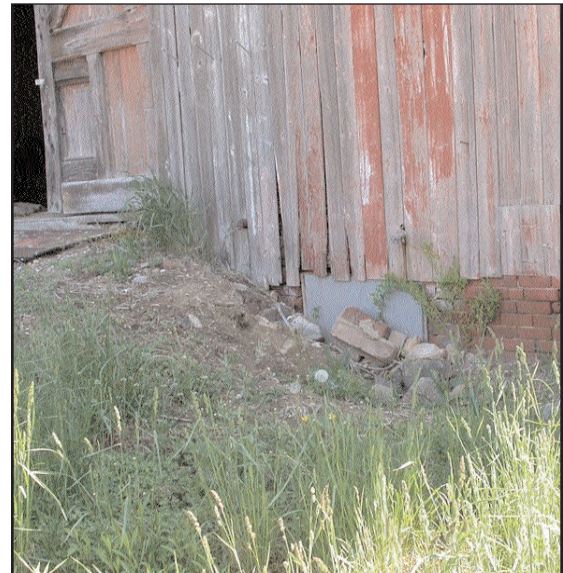
Deterioration of siding adjacent to grade west side.

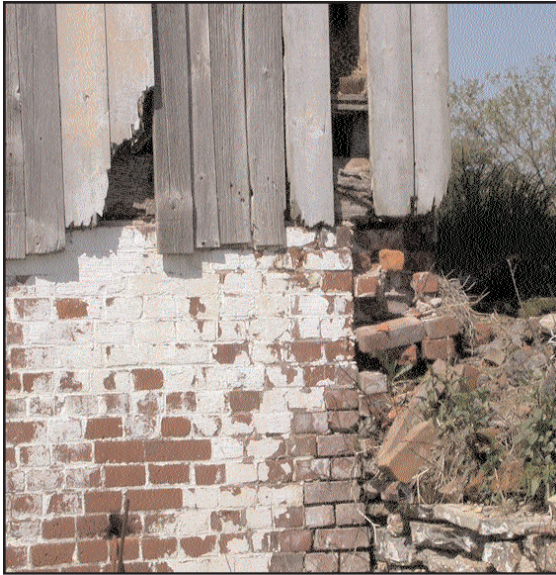
South east corner of 1908 barn. Note severe deterioration of masonry foundation and siding.

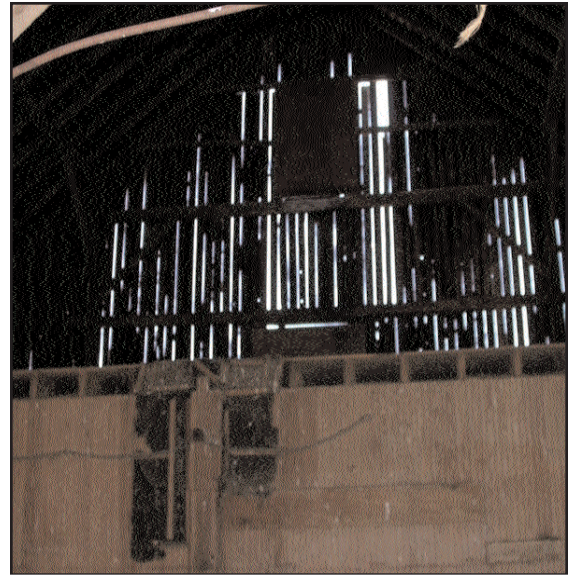
West gable end of 1908 barn.

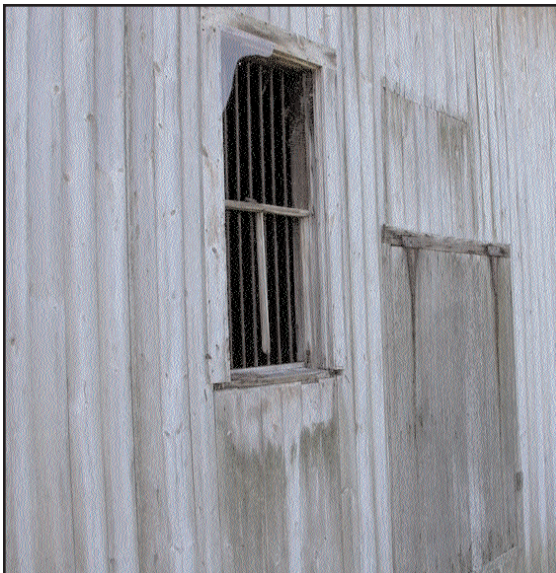
Window opening with deteriorated enclosure.
