Town of Bolton
Notch Road Municipal Center
104 Notch Road, Bolton, Connecticut

BVH Project No. 21-18-009

Existing Facility Study
Building Systems Review

August 27, 2018

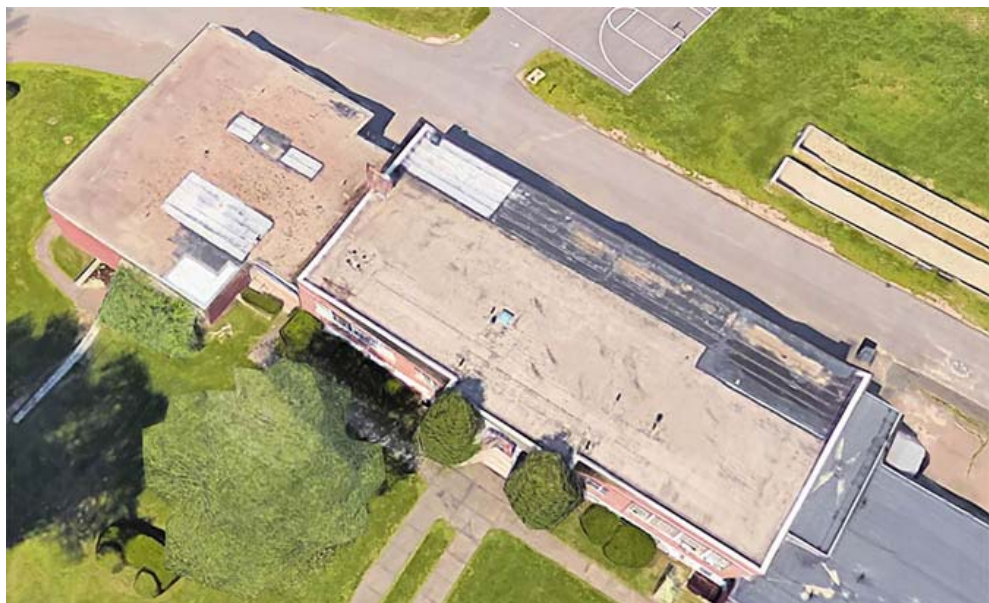
1. The built up roofing system is well beyond its useful life and requires complete replacement. It is last known to have been replaced around 1990 and has been patched in various locations since that time. Evidence of active and past water intrusion is visible in the rooms below and likely contributing to a deterioration of the roof system membranes, as well as likely creating mold and deteriorated conditions in concealed areas. There is an inconsistent mixture of ballasted stone regions and un-ballasted regions in the same roof zones. Ballast is typically an integral element of particular roof assemblies.
2. The only roof drains in the Center Section are along the east edge and have insufficient capacity for the area of roof served. Numerous leaks are evident from within the building and water damage and mold are both likely to be issues.

Aerial View of Roof

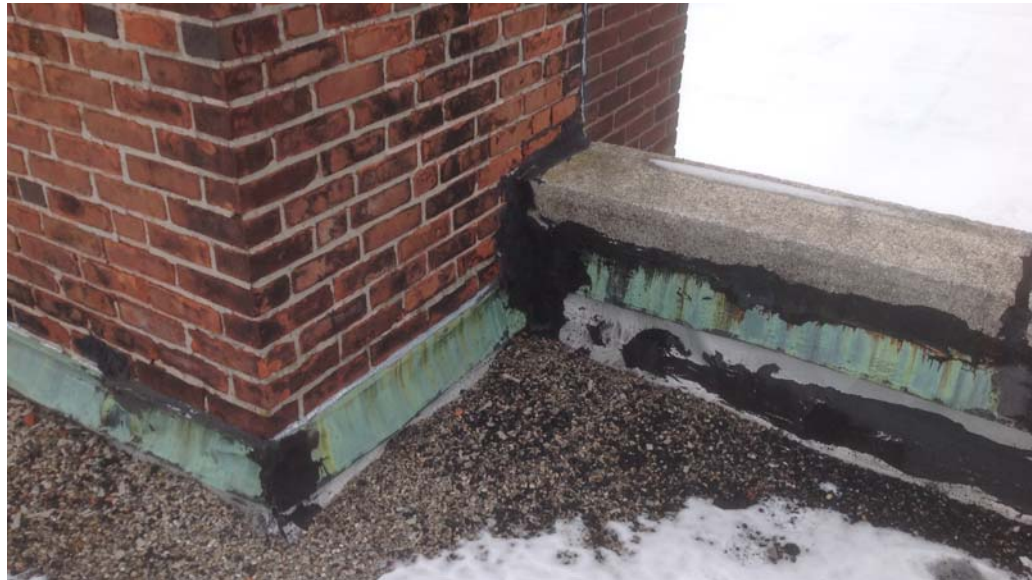
Roof and Parapet at Chimney Stack

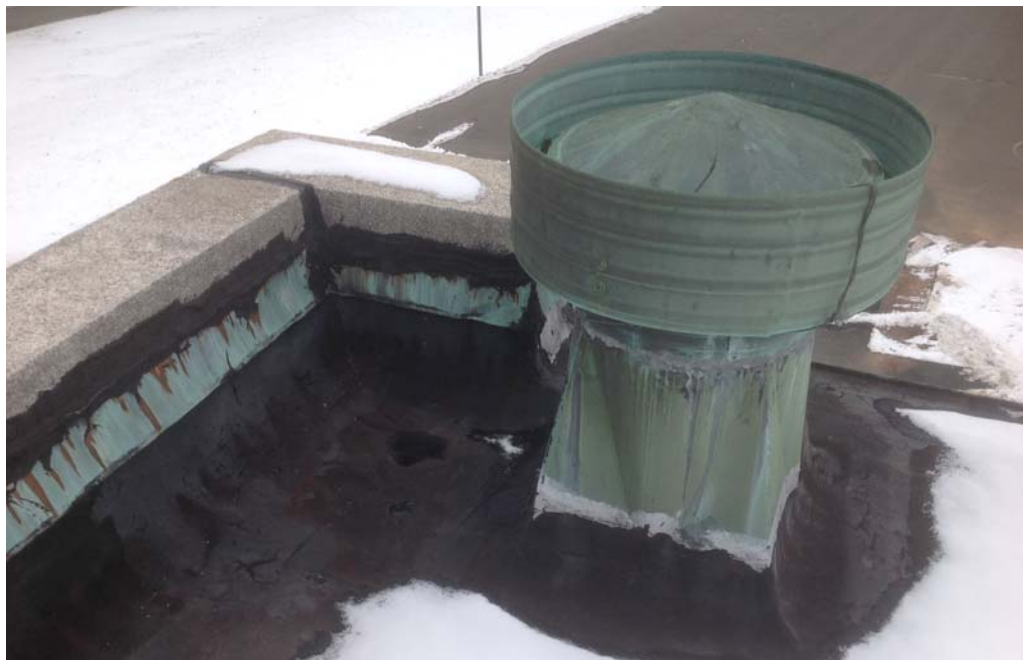
Roof Vent and Parapet

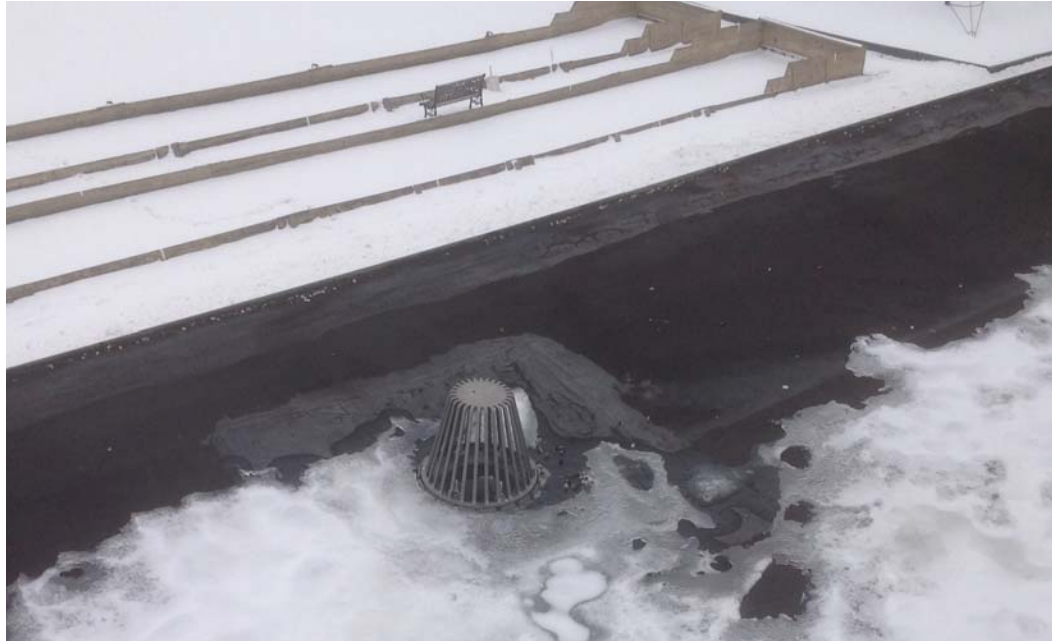
Roof Drain at East Edge

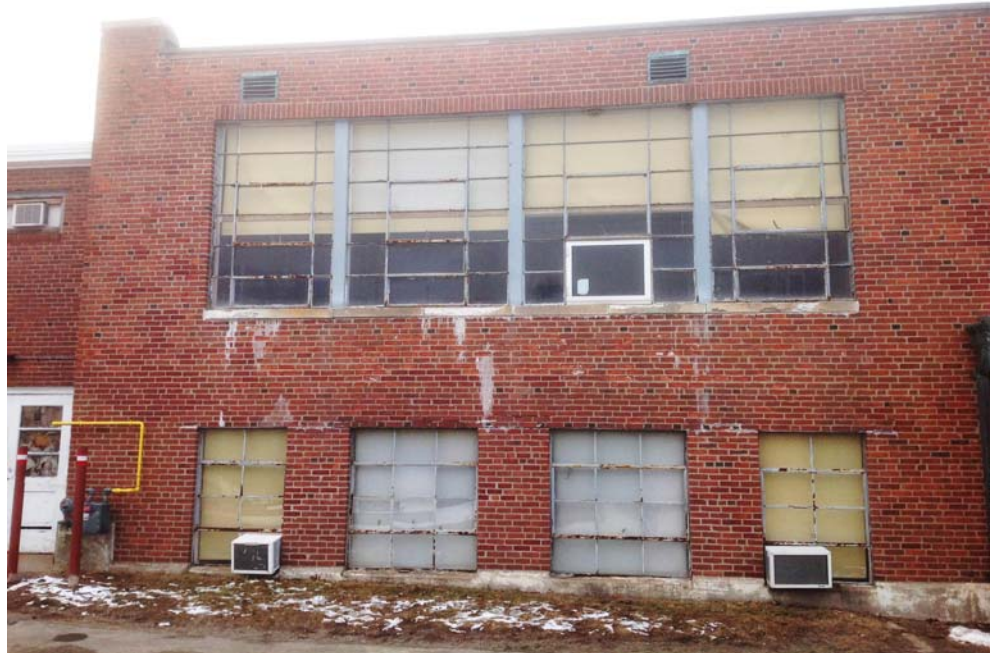
1. The exterior wall is a combination of brick and concrete masonry units (CMU). The interior was observed to be an inconsistent mixture of these elements throughout the building, with numerous patches evidently intended to be covered up but only painted and therefore visible. The general construction is a 12" masonry bearing wall consisting of 4" face brick and 8" CMU in a stack bond. The majority of concrete sills below the windows are cracked and deteriorated, and need replacement. Efflorescence is visible below most of the windows and is an indication of extensive water intrusion.

View at East Elevation

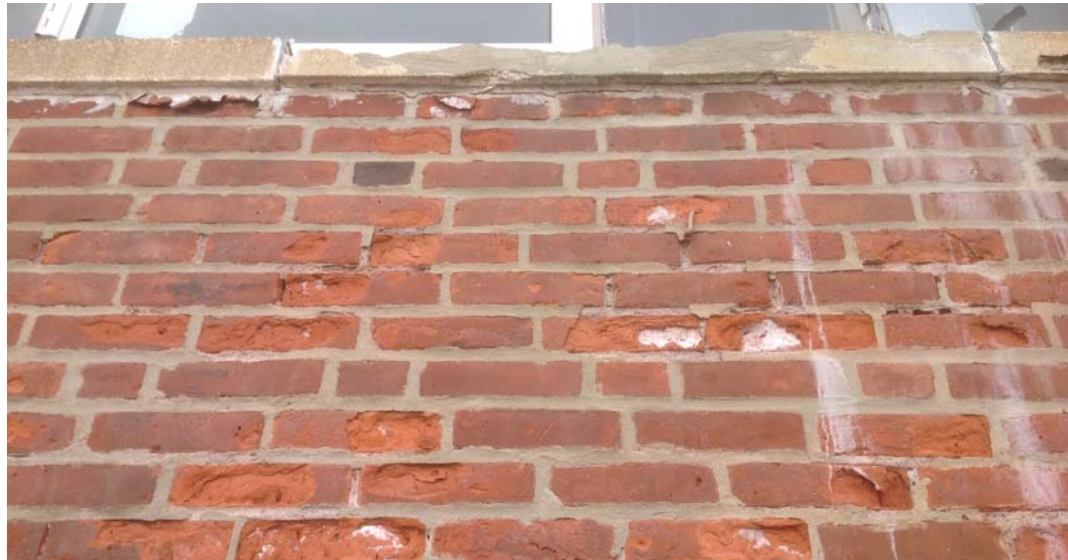
2. The brick surface masonry is in very poor condition with a very high percentage of areas with spalling of the brick surface. Spalling, as with efflorescence, is an indication of moisture entering brick, concrete, or natural stone and forcing the surface to peel, pop out, or flake off, and is a sign of water penetration into the walls. The mortar has also deteriorated in many areas. Since the walls are structural as well, the structural integrity of the walls may be impacted, so covering up the wall with a stucco or exterior insulation finish system may not be a viable solution. Further investigation of the CMU wall should be performed. The brick façade should be replaced completely if the building is renovated.

Brick Spalling and Concrete Sill Deterioration

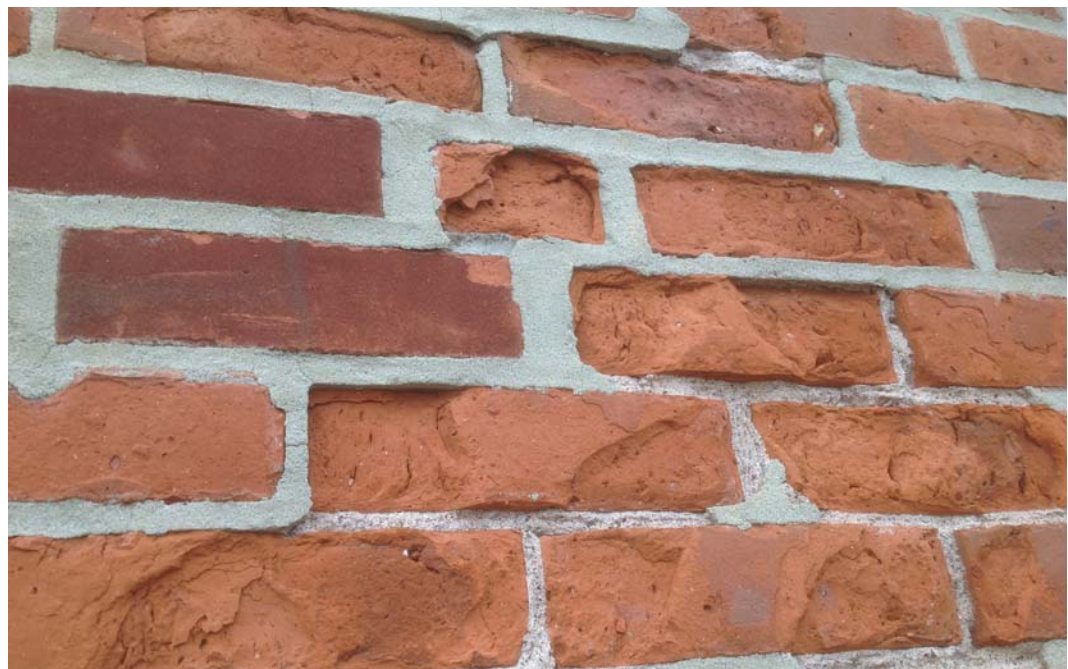
Close Up of Brick Spalling

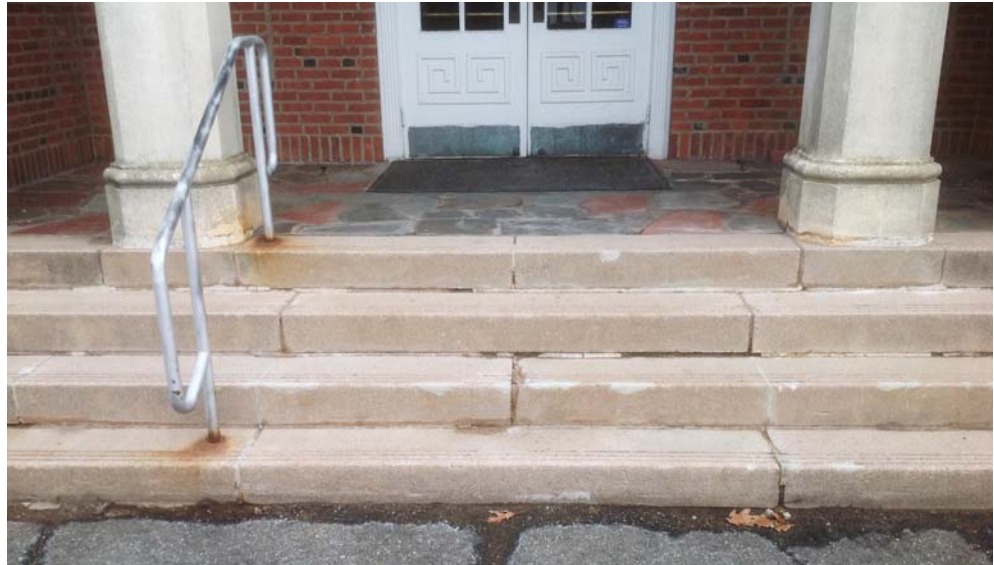
1. The main stairs could be repaired, but addressing accessibility issues with exterior ramps would require the stairs to be moved and rebuilt. Overall

the entrances are in fair condition, but the door and hardware would need to be replaced to meet accessibility requirements.

Stairs at Main Entrance

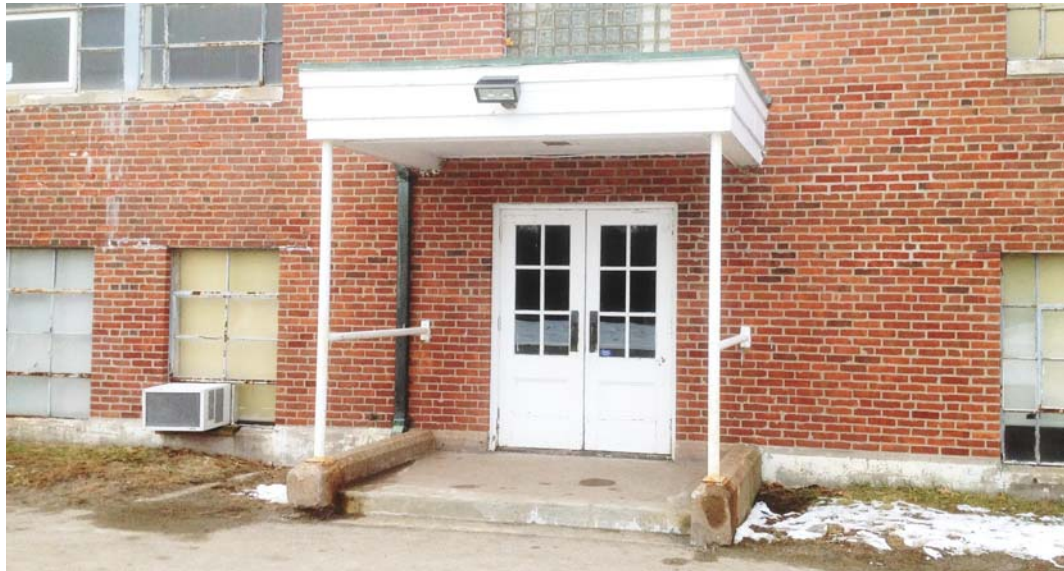
**Stair Egress Canopy at East Side
(Note - Single Riser is Not Permitted by Code)**

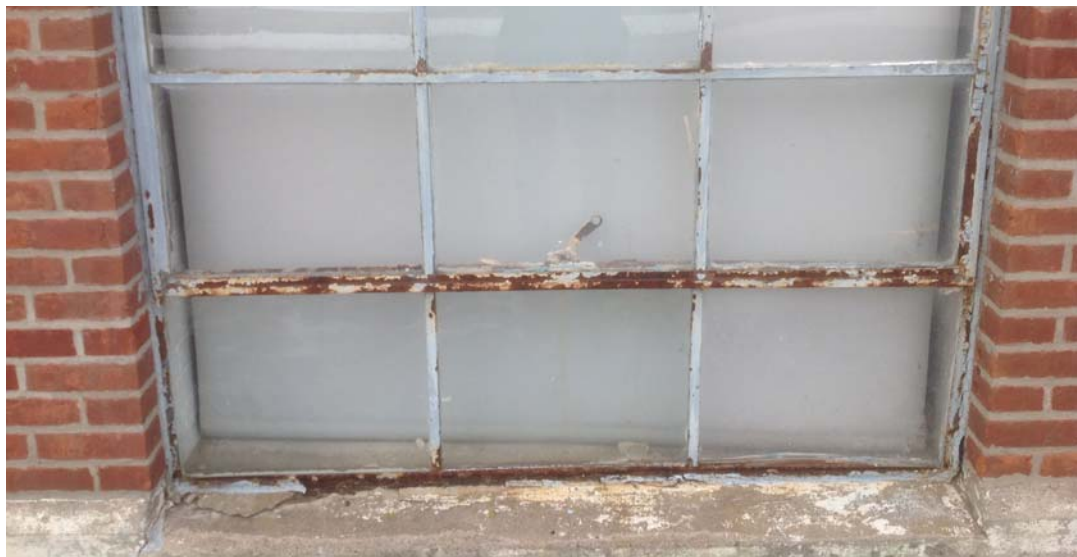
1. The windows are a mixture aluminum and steel framed window types, single and double glazing, and awning and double hung units. The doors are typically of wood and most are in fair to poor condition. The exterior sealants are in poor condition and most have failed.

Close-Up of Typical Steel Window Condition

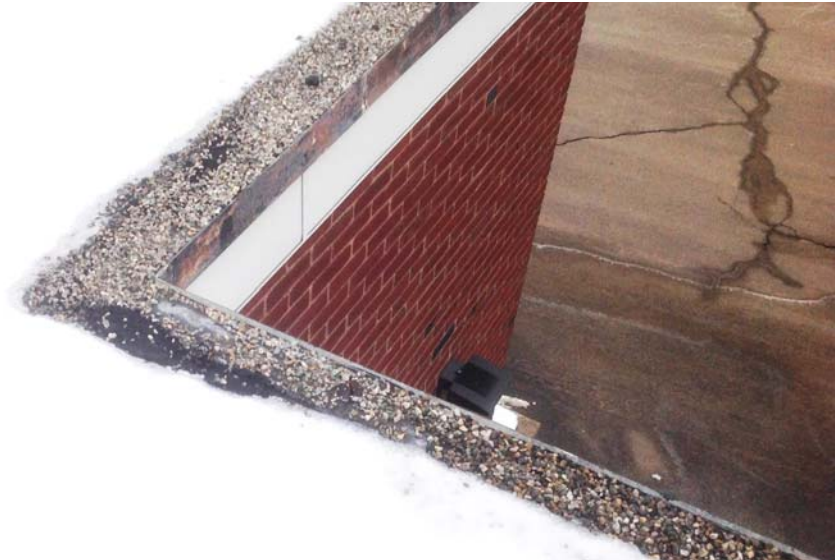
1. Similar to the Center Section, the built up roofing system is well beyond its useful life and would require complete replacement. Our understanding is the roof was replaced around 1990 and has been patched in various locations since that time. Numerous leaks are clearly evident and significant in numerous rooms below. Water damage and mold are anticipated to be extensive in multiple areas.

North Wing Roof Edge

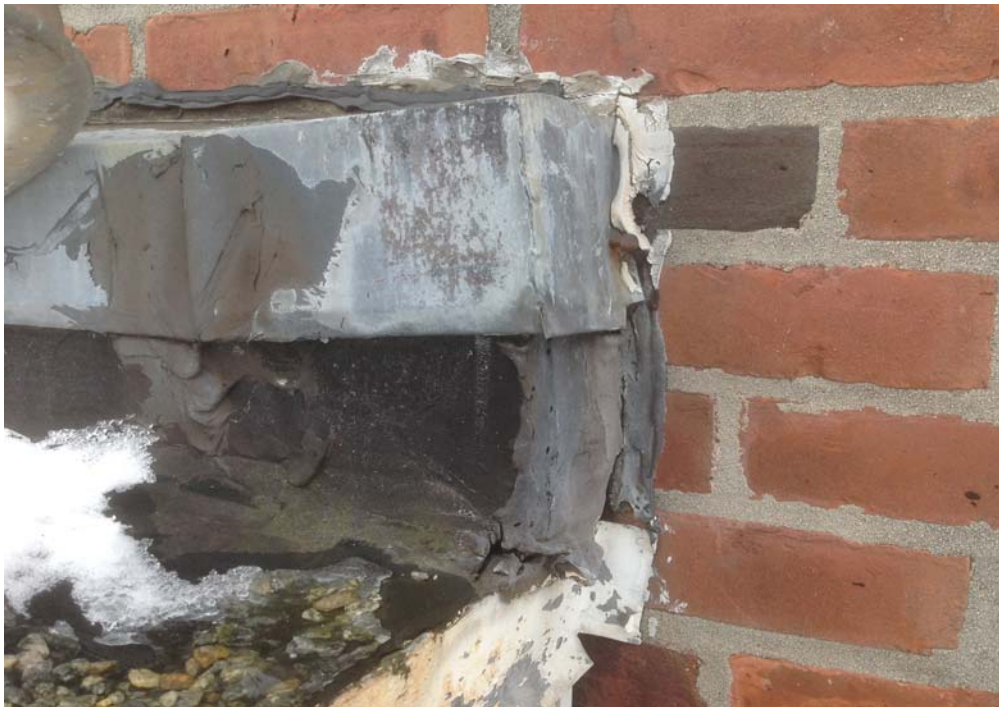
North Wing Roof Joint Against Center Section

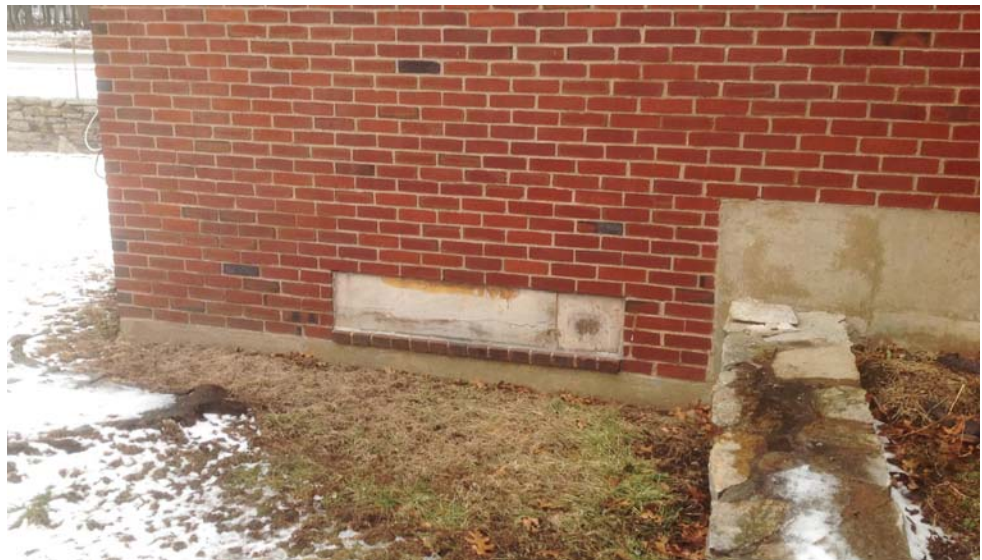
1. The brick and CMU masonry in the North Wing, as well as the limestone infill panels and sills, are generally in better condition than those of the Center Section, with less spalling or signs of efflorescence.

North Wing Lower Level at West Side - Brick and Infill Panel

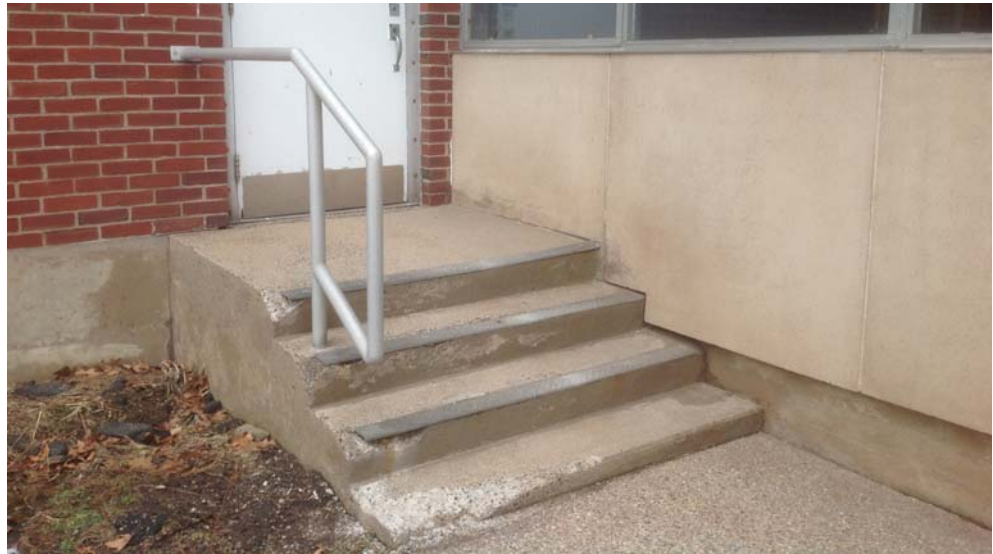
1. Stair tread have deteriorated and handrails are either lacking or do not meet current code requirements. Some of the steps have settled and do not meet code requirements for size uniformity. These exits do not meet accessible egress requirements.

North Wing Upper Level Stair at West Side

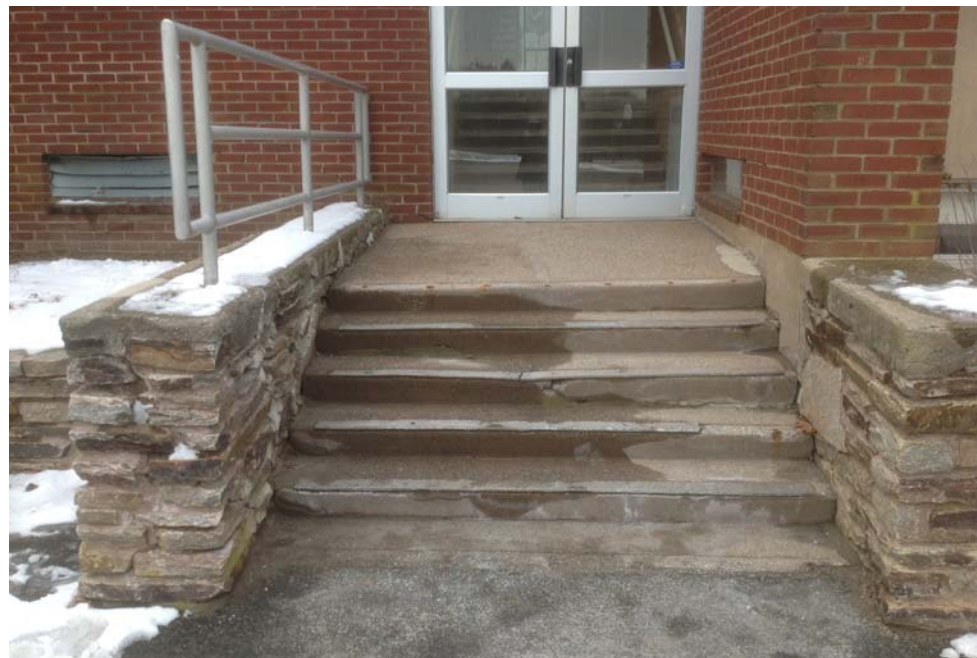
North Wing Lower Level Exit Stair

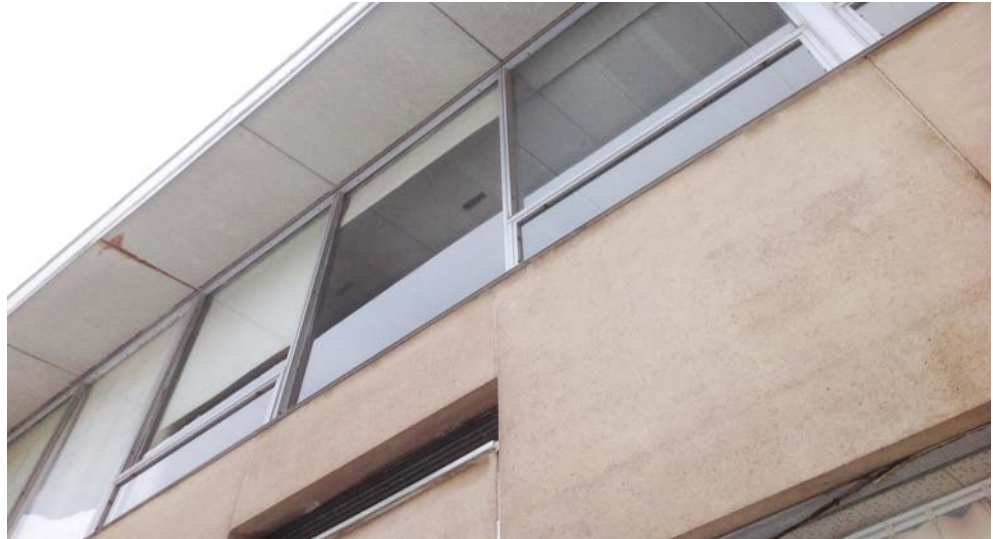
1. The curtainwall on the north side consists of a two-story, single glazed aluminum system with operable units and transoms panels. Other areas have smaller units from the same system. The exterior sealants have failed and are falling out in many areas, with mold and deterioration anticipated.

North Wing Curtain Wall

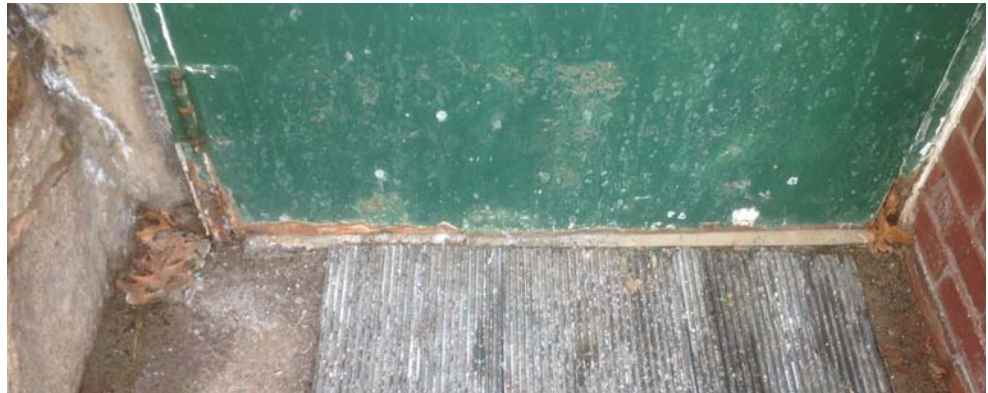
North Wing Lower Level East Door - Rusted Door and Frame Bottom

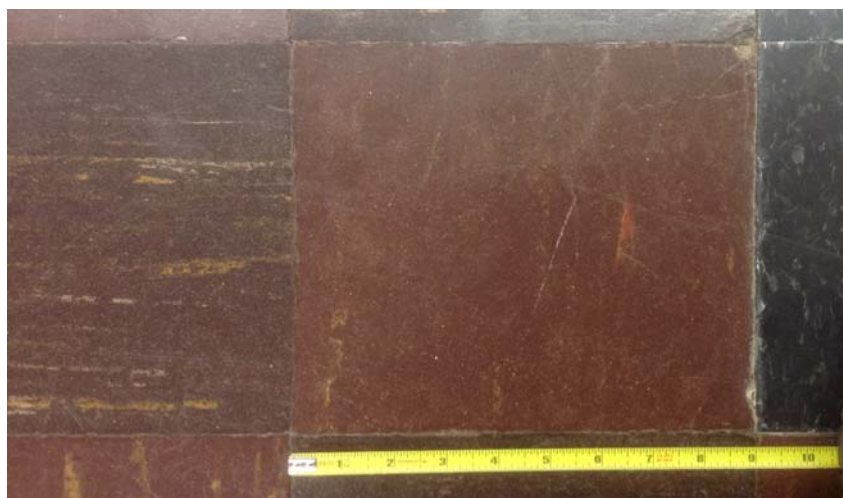
1. Many of the floor finishes are original and composed of vinyl asbestos tiles (VAT) and also vinyl composition tiles (VCT). Some rooms have carpet installed over the VAT. Most of the flooring is beyond its useful life and should be replaced.

Typical Original VAT Flooring

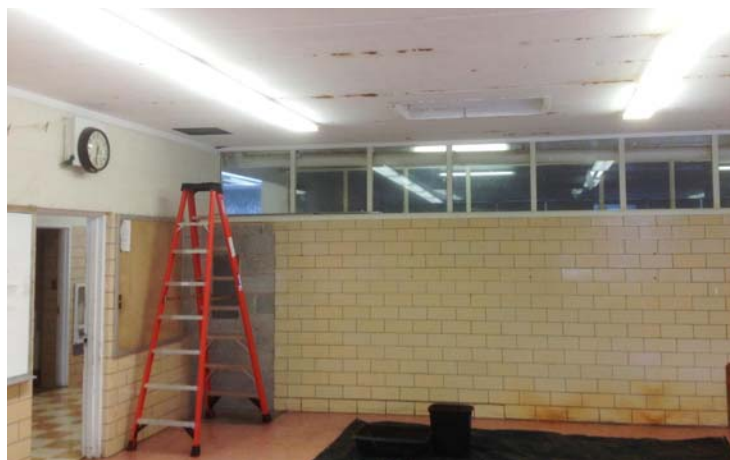
Upper Level Classroom Showing Water Damage

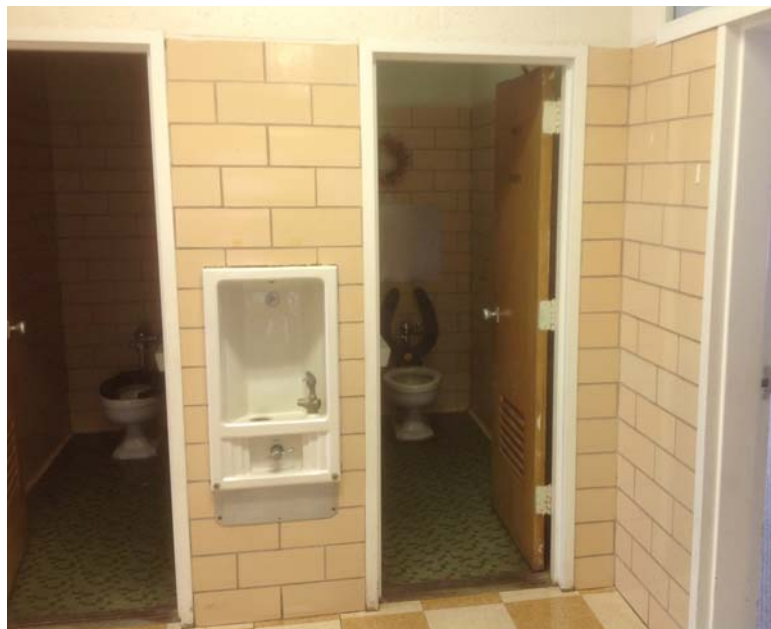
1. There are very small inaccessible toilet rooms on each level with tile floors and structural glazed tile wainscot on the perimeter.

Lower Level Toilet Rooms

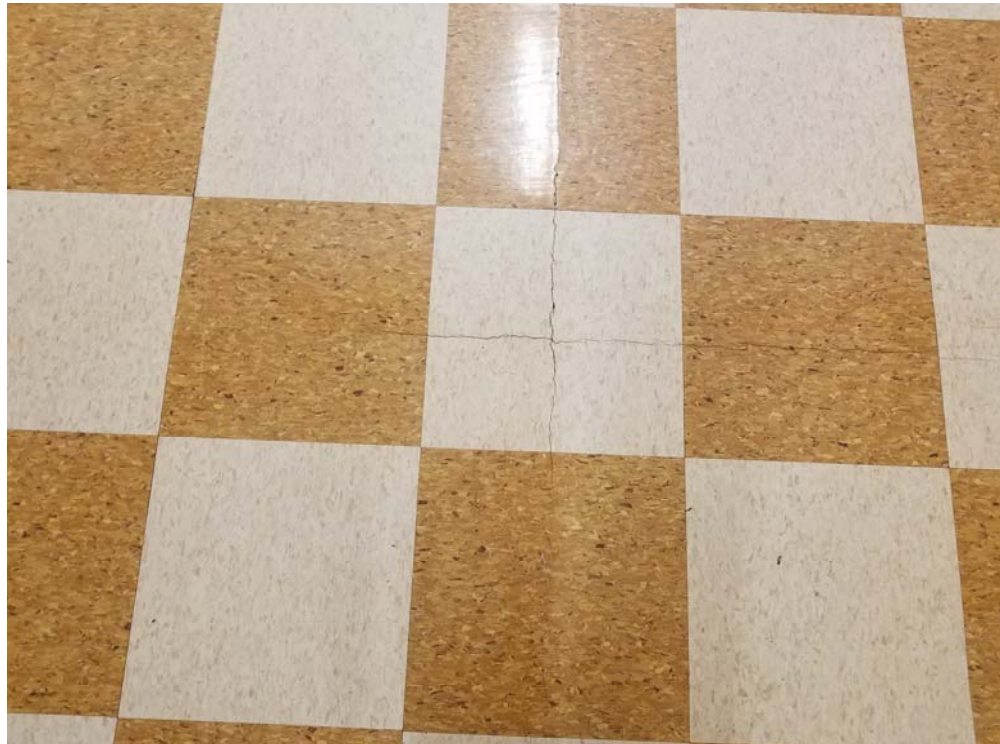
5. The longer joists are approximately 11-1/2" deep and are spaced roughly 3'-0" o.c. The precast joists in the corridor are about 7-1/2" deep with similar spacing. The concrete slab over the joists was measured at a small existing conduit penetration and is estimated as being 3-1/2" to 4" thick. Wire mesh reinforcement was also observed at the penetration. Below the upper level corridor, a few diagonal cracks and cracks between floor penetrations were observed on the underside of the slab. Recently more cracks in the VCT flooring in the corridor above have been noticed by Town Employees. The cracks in the VCT are linear and similar to the checkerboard pattern of the floor tiles, although spaced further apart than the typical tile dimension. The cracks do not follow the seams of the tiles, but occur through the tiles in each orthogonal direction. The cracks observed in the flooring and in the underside of the slab did not appear to coincide with one another; however, it is common for cracks in concrete slabs to propagate through flooring materials.

Cracks in Main Level Flooring

The cracks observed in the surface of the corridor tile flooring do not appear to coincide with the pattern and alignment of the cracks observed on the underside of the structural slab visible from the lower level. The slab cracks on the underside of the slab appear similar to typical shrinkage and temperature cracks that typical occur in concrete over time. The pattern and location of the cracking does not appear comparable to patterns of cracking that would form if the structure was overloaded. The formation of shrinkage and temperature cracking

in concrete is a common occurrence and does not indicate a structural concern at this time; however, it is common for cracks in concrete slabs to propagate through flooring materials and become an aesthetic issue.

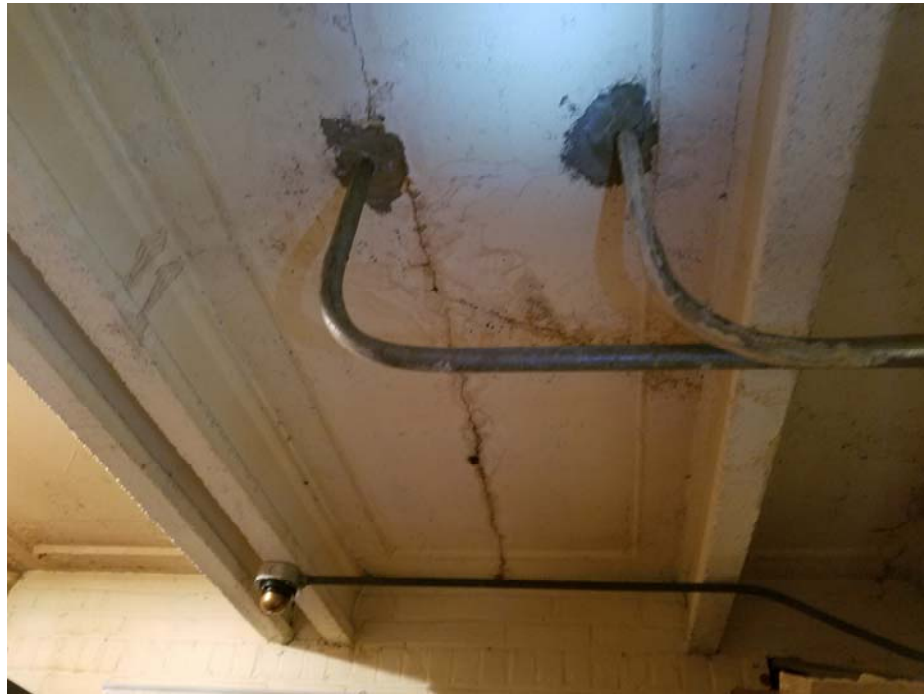
Slab Crack on Underside of Slab

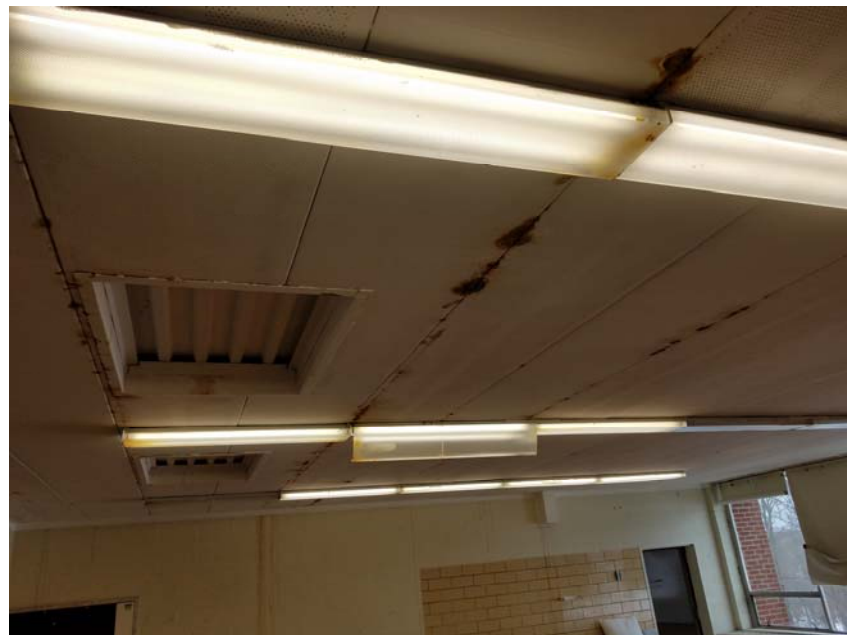
3. The steel roof deck is approximately 7" deep and spans a distance of roughly 29 ft. from bearing wall to bearing wall at its longest location. Rust stains are evident in many areas on the underside of the deck, especially between panel joints indicating roofing leakage and water infiltration. Based on the extent of the staining on the underside of the deck and previous experience, it is reasonable to expect the top surface of the deck under the roofing has considerably more damage and section loss than is visible from below.

Corosion of Metal Decking

Based on extent of rust stains on the underside of the North Building roof deck, it is expected a large majority of the existing roof deck will need to be replaced. Because the roof area is relatively small, complete replacement of the existing roof deck should occur if it is determined that renovation of the existing building is a feasible and viable option.

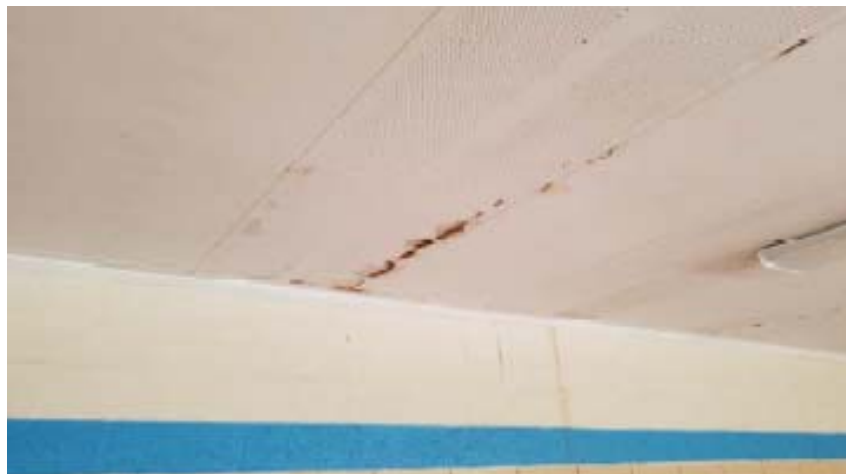
Corrosion of Metal Decking

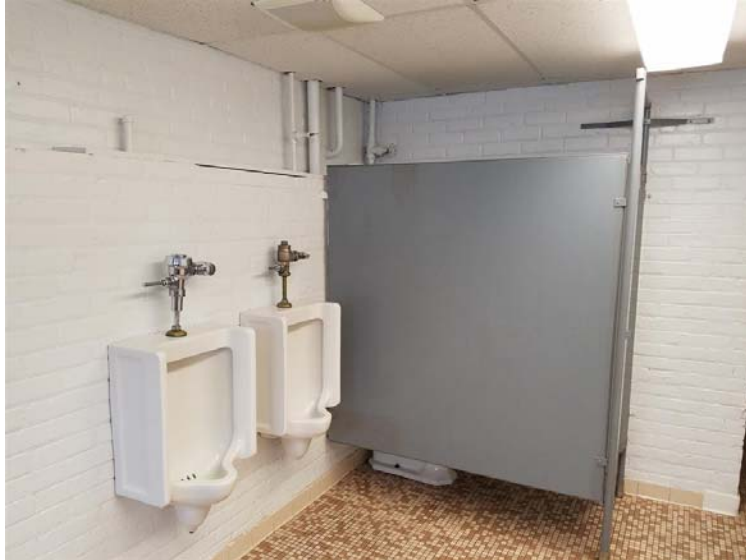
The existing toilet rooms are original construction, except for the Senior Center, and are past their useful service life and should be replaced.

Typical Toilet Room

None of the current Accessibility Codes are met within the existing toilet rooms and new expanded toilet rooms will be required as part of any renovation.

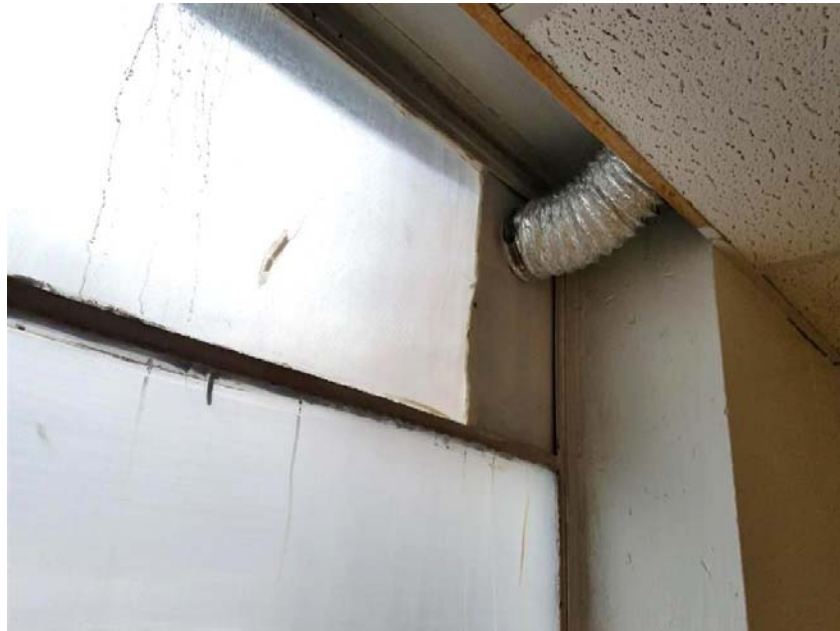
Toilet Room Exhaust Fan

Proper exhaust fans need to be installed to serve the toilet rooms.

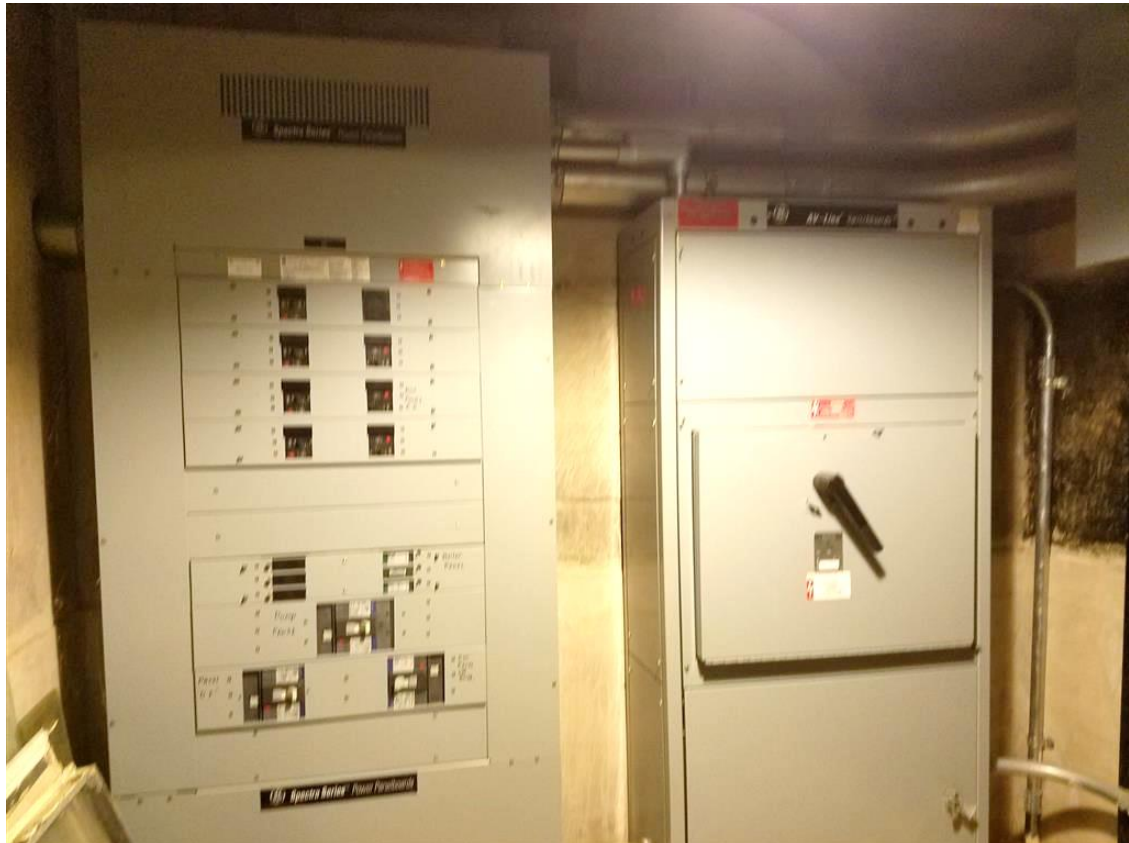
The existing building complex has a General Electric 800-Ampere, 120/208-volt, 3-phase bolted pressure switch (fused) main device which feeds an adjacent switchboard distribution section. Both BPS and switchboard distribution are rated for 65,000 AIC.

Incoming Electrical Service

The electrical service, while in good shape, is undersized to accommodate the installation of air-conditioning throughout the facility and a new elevator.
