Re: Notch Road Municipal Center Project - North Section Roof Review  
104 Notch Road  
Bolton, Connecticut

BVH visited the site on November 8, 2018 to review the exploratory openings made by Town Personnel exposing the existing metal roof deck within the North Building roof system. The existing roof system comprises of roof membrane, felt, insulation, and metal deck. As mentioned in the August 27, 2018 Facility Study Report, the existing roof deck is 7 inches deep with a maximum span of approximately 29 feet.

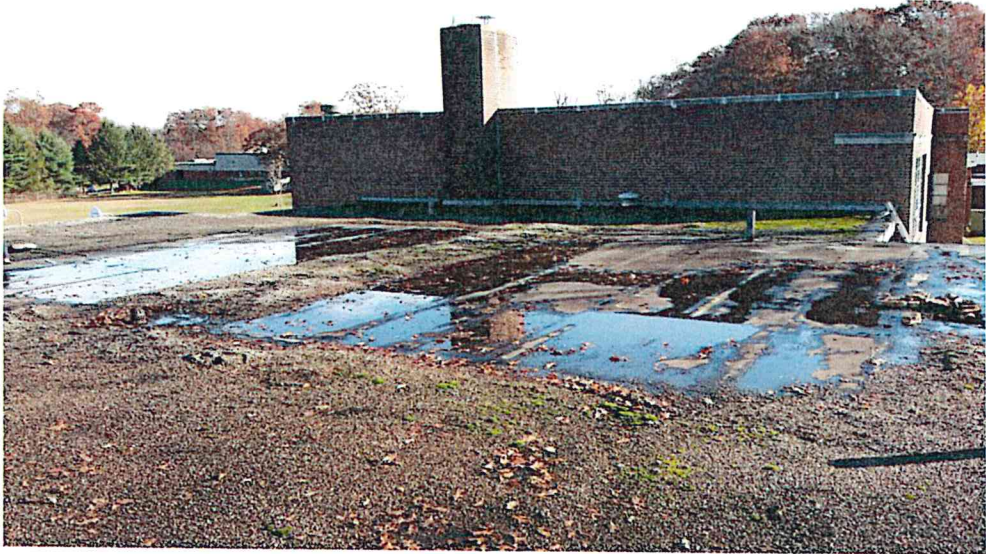
The existing roof is in very poor condition and has numerous leaks as mentioned in the Facility Study Report. In conversations with the Town, it is our understanding the roof is not currently being maintained or repaired, and no temporary means of protection or repairs are planned. At a minimum, we would recommend the roof drains be maintained and cleared of debris.

Existing Roof - North Building Roof

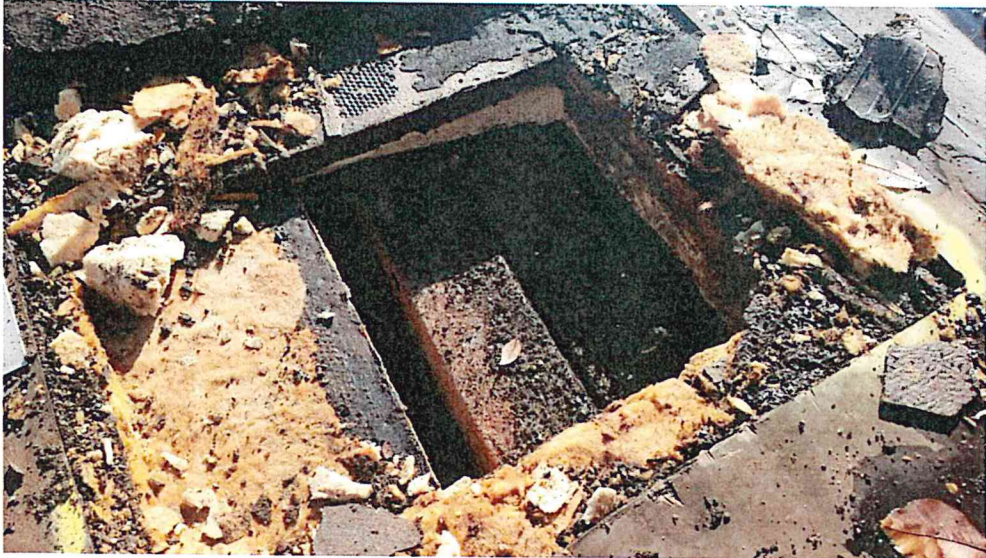
Two (2) exploratory holes were made in the roof system located at locations of consistent water ponding on the roof. The metal deck appeared to have a thin bituminous type coating over the surface of the deck that easily flaked off when scraped with a putty knife. Surface rusting of the deck was observed with some metal loss occurring. The top flute of the deck was struck with a hammer and tapped with a blunt flathead screwdriver without significant deformation or puncture of the deck.

Exposed Roof Deck

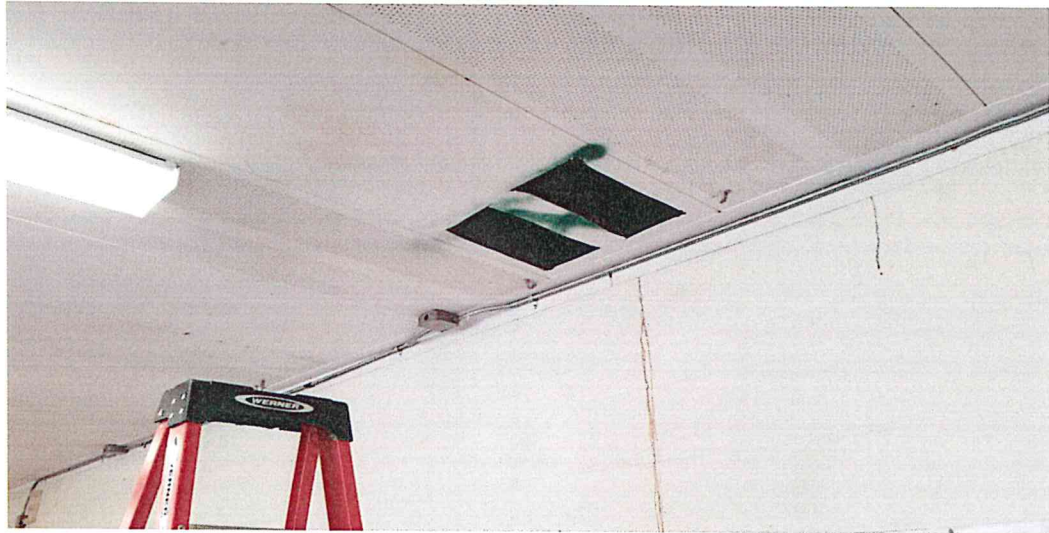
The exploratory openings were made at locations showing signs of leaks and rust staining inside the building as well as at locations showing no signs of leaks or rust. Holes were cut into the underside of the deck cover plate to expose the deck up-flute. As expected, the existing metal deck was in good condition at locations showing no signs of leaks or rusting. At locations showing signs of leaking and rust, surface rusting of the overall up-flute was observed to varying degrees but no significant loss of metal or holes in the deck were observed. We struck the underside of the deck with a hammer and tapped a blunt flathead screwdriver without significant deformation or puncture of the deck.

**Interior Deck Access Openings**

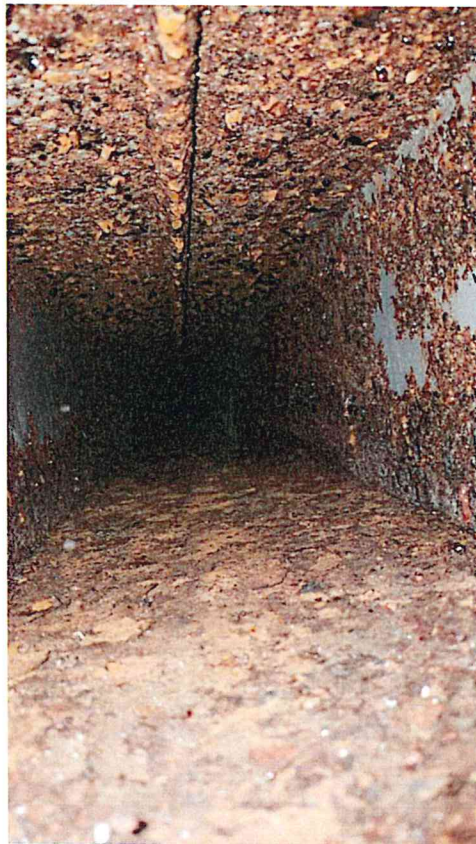
**Inside Existing Roof Deck in  
Areas of Water Infiltration**

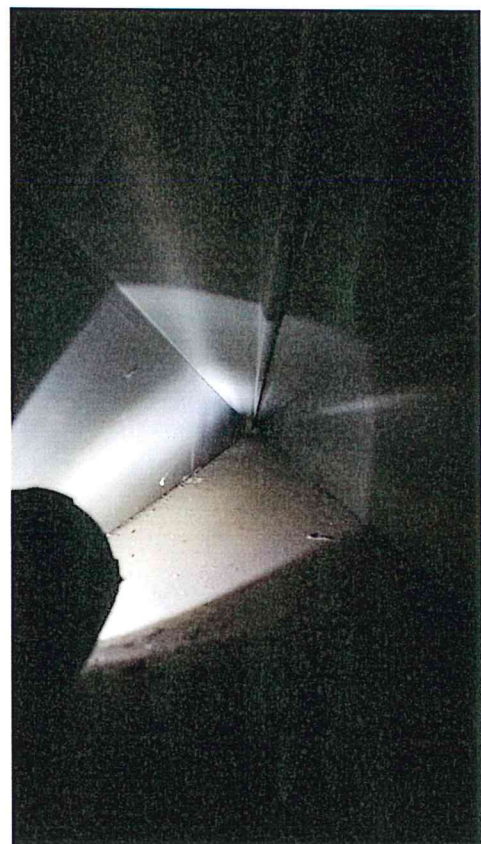
**Inside Existing Roof Deck  
No Water Infiltration Observed**
