**RE: Water Quality Certification Transmittal No. X254090
MassDEP Wetlands File No. 61-0633**

On behalf of KHB Venture, LLC and in accordance with Conditions 15 and 17 of the Water Quality Certification dated June 4, 2013, attached is the second vegetation monitoring report for 2014 for the Oak Island RAM Mitigation Project.

Subject:
Summer 2014 Vegetation Monitoring Report
Oak Island RAM Area Salt Marsh Restoration
KHB Venture, LLC
Revere, Massachusetts

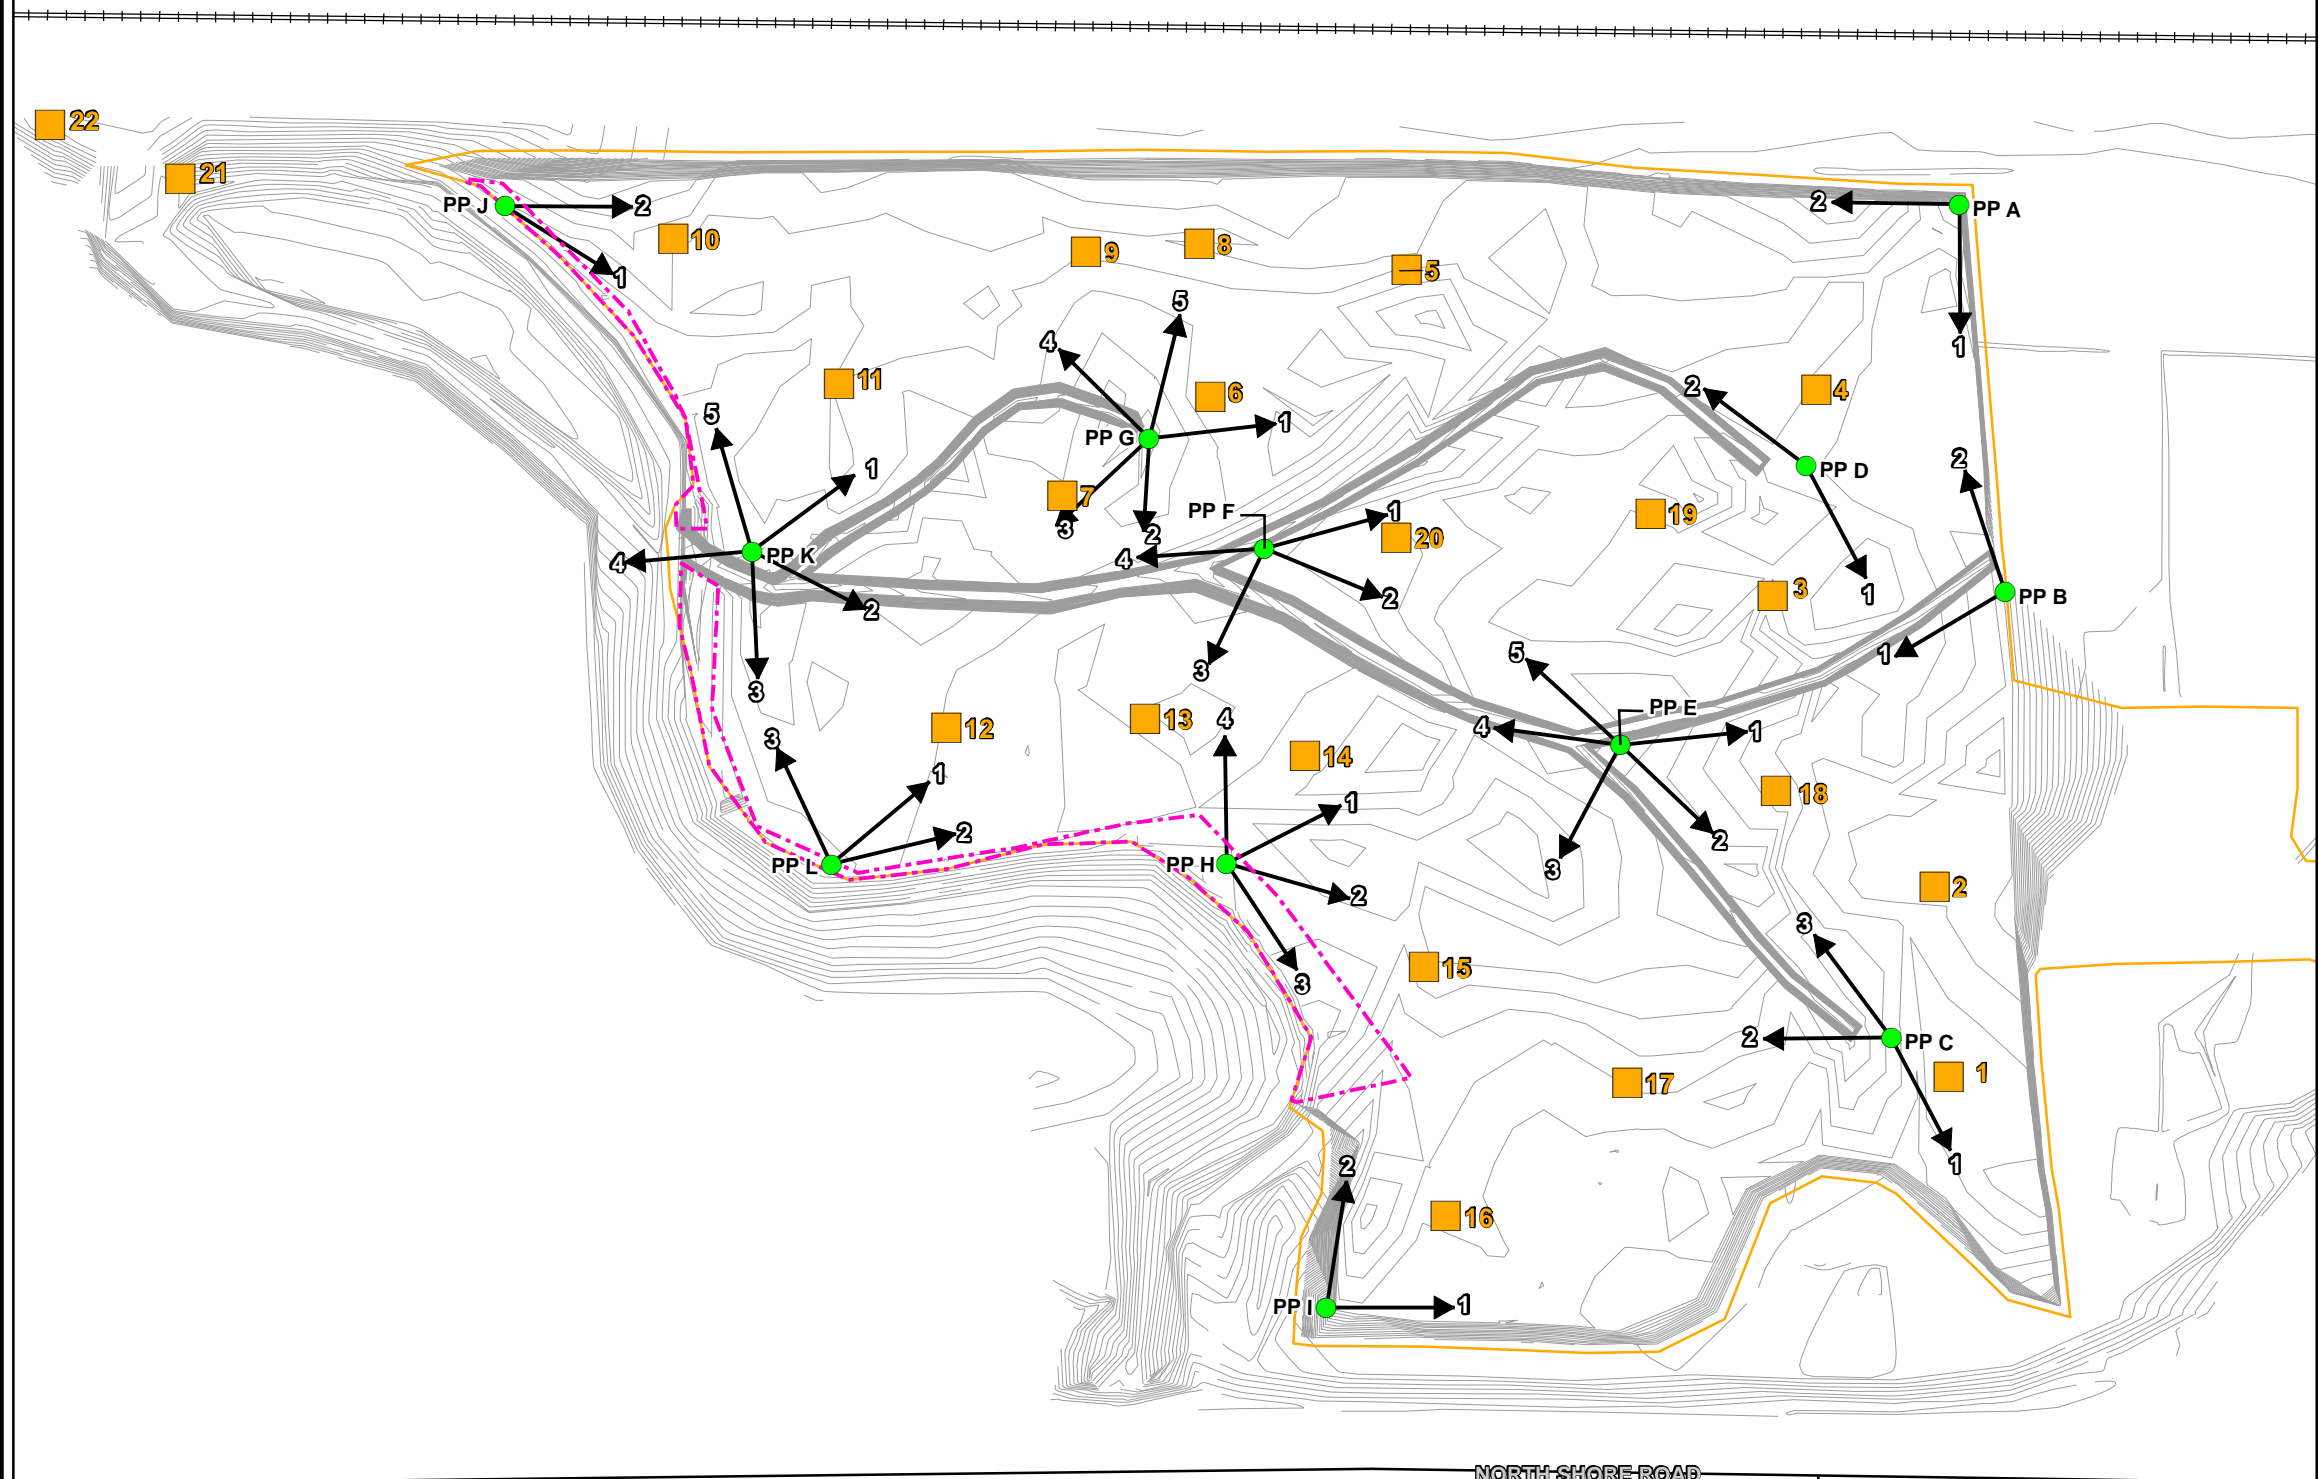
FIGURE
1

The third quarter photo-documentation event was performed at low tide on August 26, 2014. The fixed photo locations and directions of the photographs are indicated on Figure 1 and the photographs are presented in Attachment A. No signs of bank erosion or bank instability were observed in the feeder streams constructed in the RAM Mitigation Area. The photographs indicate the sparse ground cover during the summer inspection, and also indicate a reduction in the density and extent of *Phragmites* present on the Site. The RAM Mitigation Area is dominated by algae covered mud that contains the remnants of *Phragmites* shoots and roots in many areas. Although the majority of the Site was not vegetated, a few pockets of the desirable tidal wetland plant species Smooth Cordgrass (*Spartina alterniflora*) and Virginia Glasswort (*Salicornia depressa*) were observed in the northeast and central portions of the restoration area (See photos 5 and 32-36 in Attachment A). A few individual *Phragmites* plants were observed along the western bank of Diamond Creek in the southern portion of the Site where a larger and denser stand of *Phragmites* was observed during the spring monitoring event (See Figure 1 and photos 25 and 26 in Attachment A). A comparison of the spring and summer photographs indicates a significant reduction in size and density of the *Phragmites* at this location.

The 20 randomly located vegetation monitoring plot locations on the Site and 6 monitoring locations in reference wetlands are shown on Figure 1 and the vegetation monitoring results are summarized in Table 1. The quantitative vegetation plot monitoring effort on the Site provided no useful data due to the absence of emergent vegetation in any of the plot locations. The presence of algae was noted in all 20
