**RE: DEP Transmittal No. X254090  
DEP Wetlands File No. 61-0633**

Subject:  
Spring 2014 Vegetation Monitoring Report  
Oak Island RAM Area Salt Marsh Restoration  
KHB Venture, LLC  
Revere, Massachusetts

FCTPF OAK ISLAND SALT MARSH RESTORATION  
 REVERE, MASSACHUSETTS  
**SPRING 2014 VEGETATION MONITORING REPORT**  
**SITE PLAN WITH PHOTO LOCATIONS  
 AND IDENTIFIED WEED AREAS**

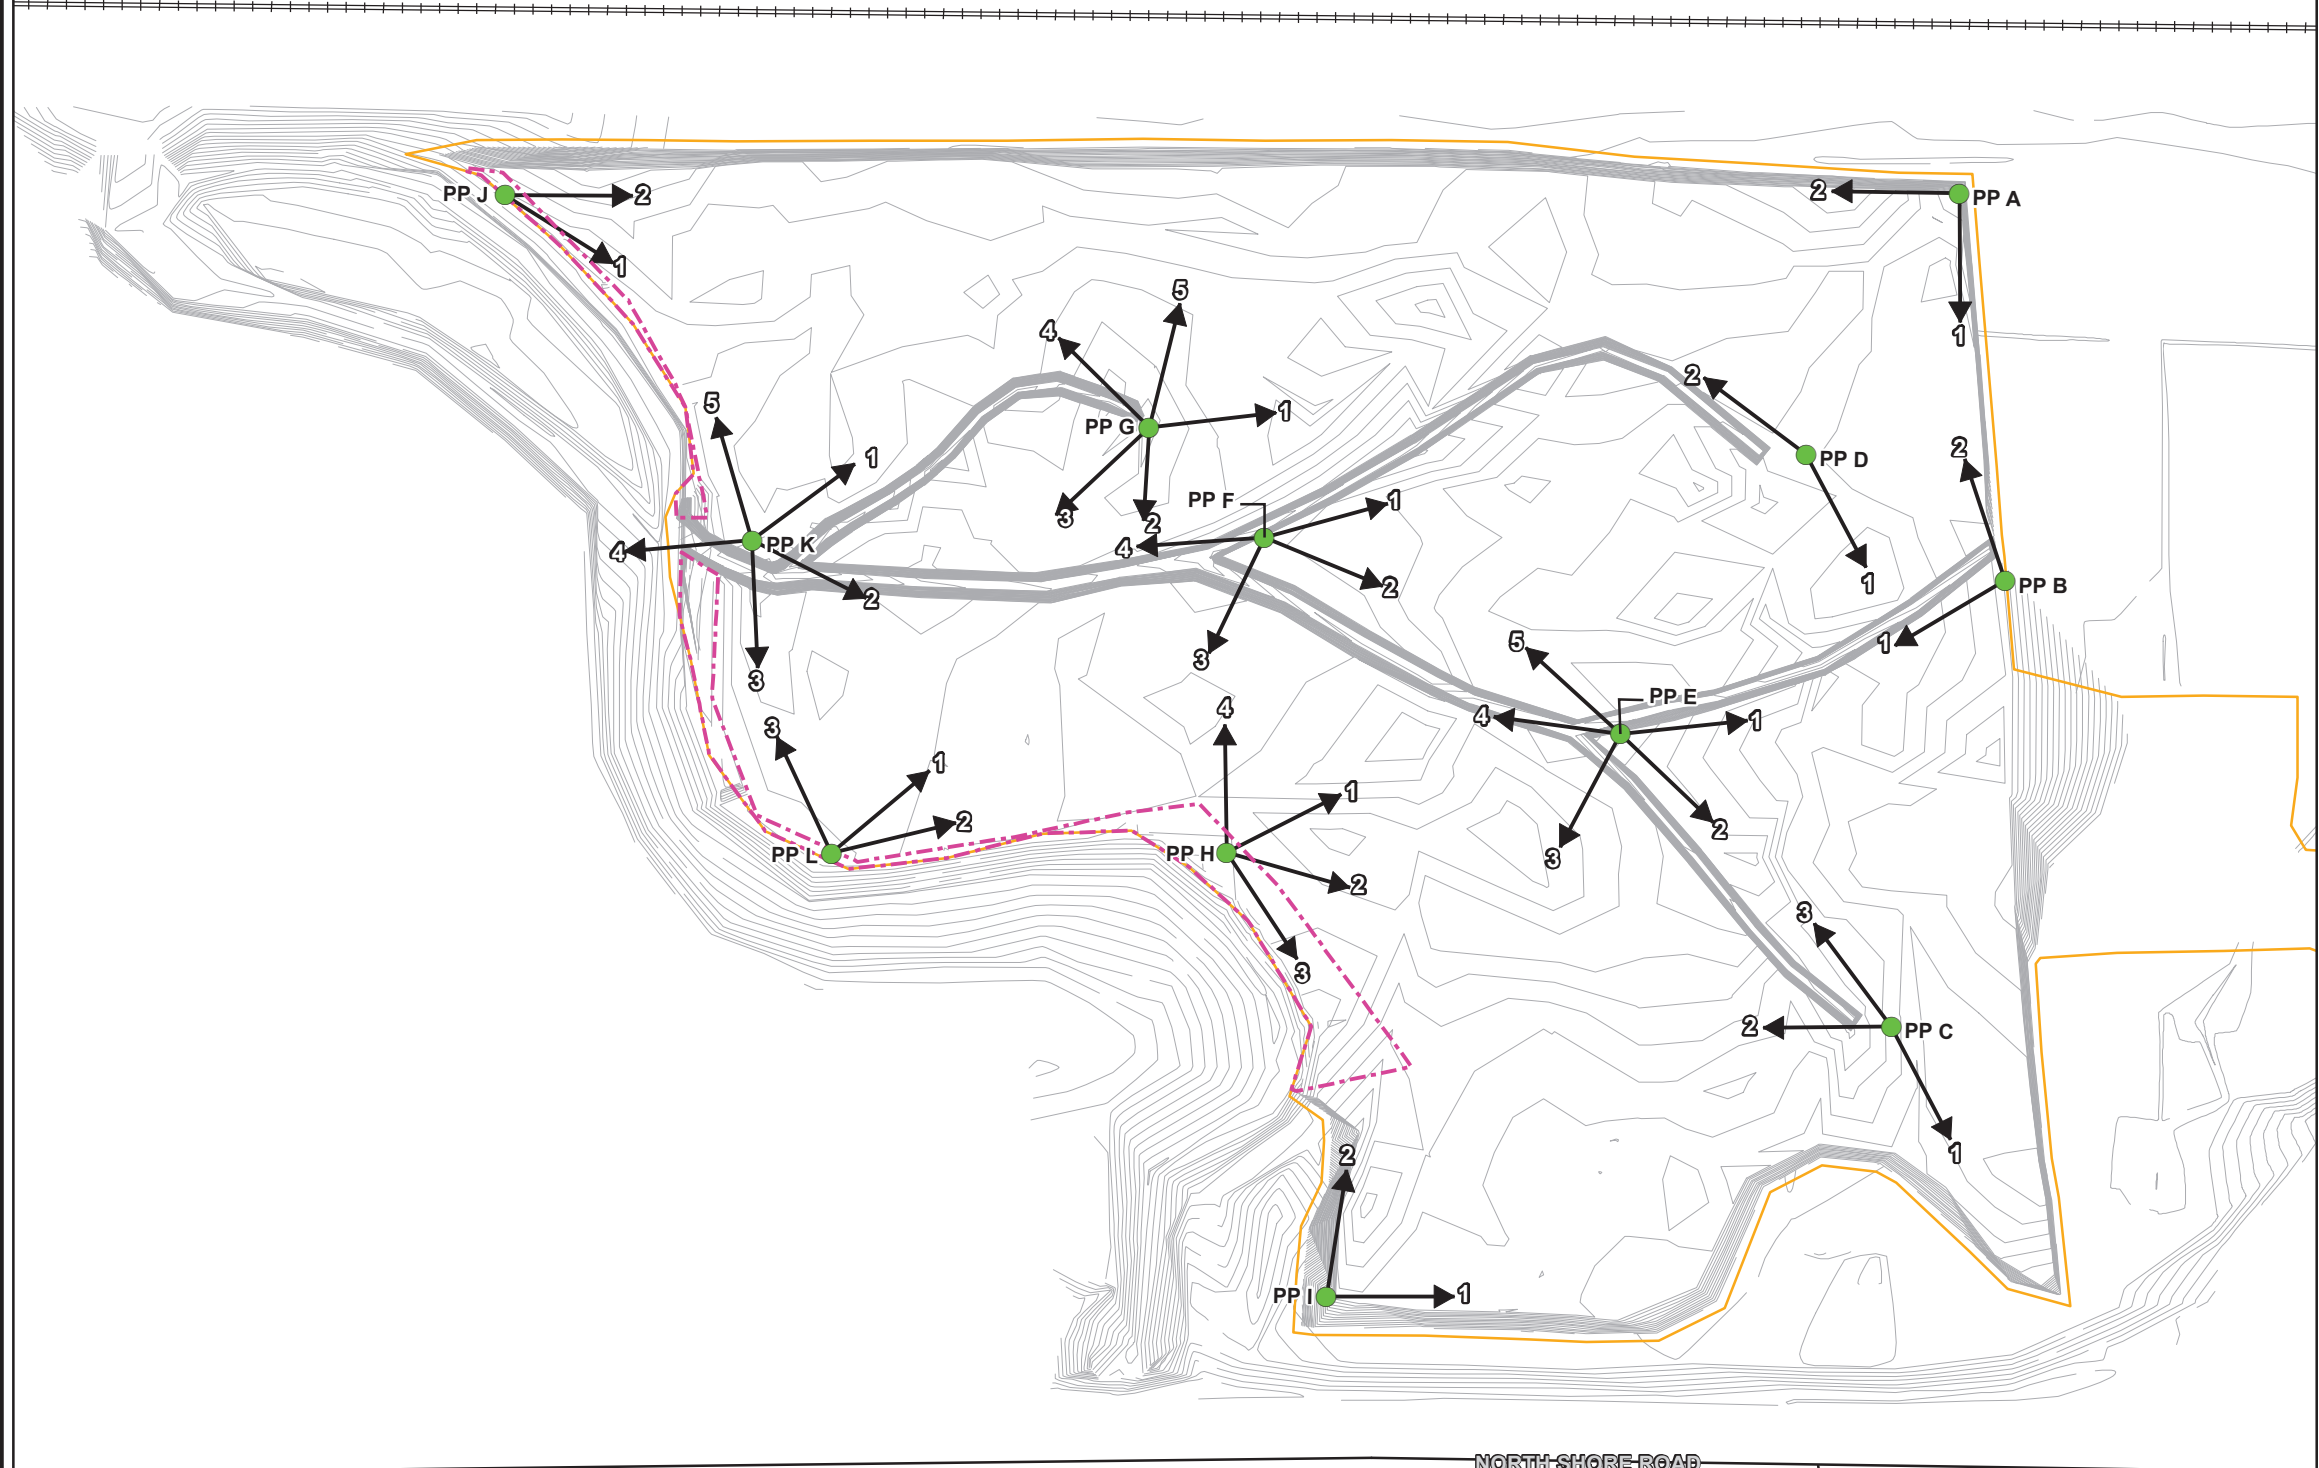
A few live individual *Phragmites* plants were observed scattered throughout the restoration area. Live *Phragmites* were also observed up to and above the top of the north bank of Diamond Creek at the south end of the RAM Mitigation Area. The lower creek banks also supported *Spartina* sp. closest to the low water elevation. The new *Spartina* growth of approximately 6-inches in height had not developed adequately to enable identification to species, but was estimated to be providing approximately 20% cover on the lower banks. *Phragmites* observed on the upper banks of Diamond Creek provided a visually-estimated cover of approximately 40% and similar cover was observed in two narrow bands along and beyond the top of the bank (See June photos in Attachment B on Figures B-31, B-34, B-35, B-36, B-38, and B-39). The limits of the *Phragmites* in these two areas were defined using GPS and are presented on Figure 2. The total area of *Phragmites* cover in these two delineated *Phragmites* areas was approximately 6,000 square feet, which represents approximately 2% of the RAM Mitigation Area.
