**HYDROLOGIC AND HYDRAULIC ANALYSIS
WETLANDS RESTORATION INVESTIGATION
BALLARD STREET SALT MARSH
SAUGUS, MASSACHUSETTS**

**Prepared for
Town of Saugus**

**United States Department of Agriculture
Natural Resources Conservation Service
Amherst, Massachusetts**

August 1999

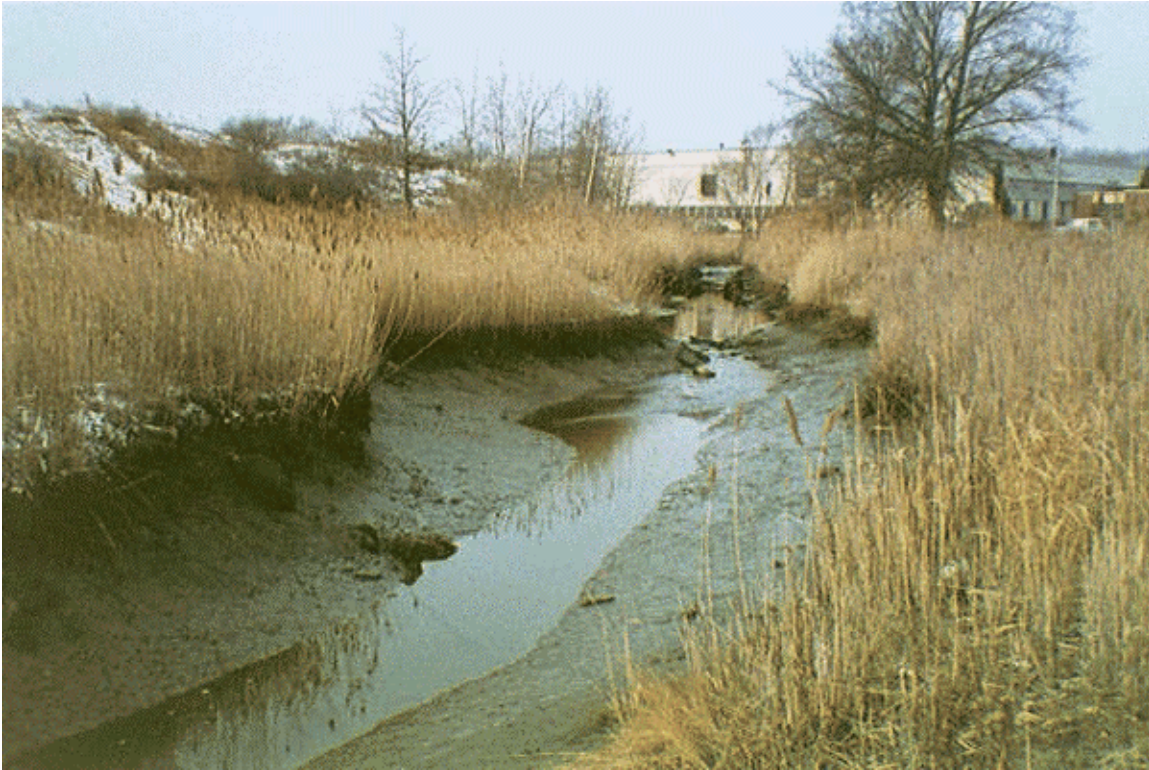
Cover Photo- Tidal channel looking west toward Eastern Stamping and Tool Company. This is the site of the proposed tide gate location.

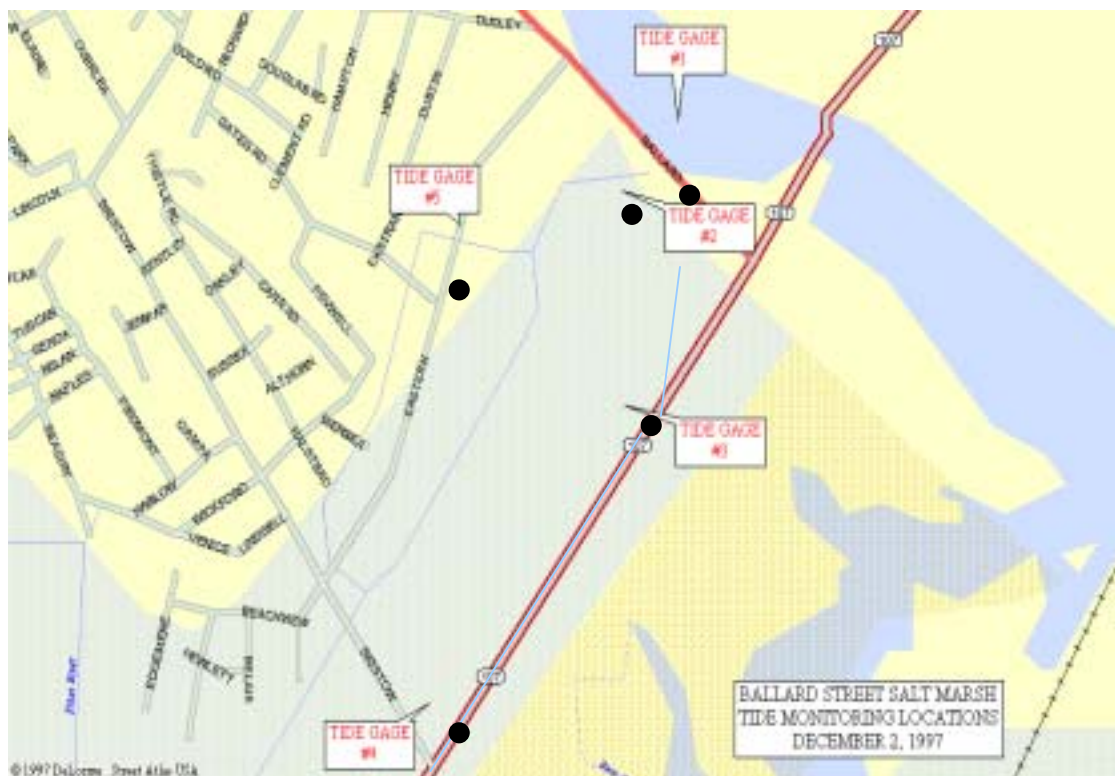
Figure 4 – Tide Monitoring Locations

The tidal monitoring was conducted on December 2, 1997, between the hours of 8:00AM and 3:00PM (see Appendix B). The existing steel plate gate on the outlet of Ballard Street culvert was removed for the duration of the incoming flood tide. The culvert was free flowing in both directions for the duration of monitoring. A high tide occurred at 12:15PM on the Saugus River at the outlet of the salt marsh.

The water surface elevations recorded at the five gage locations on December 2, 1997 were used to calibrate the model. Following the monitoring of the gages, it was necessary to re-survey approximately one-half mile of channel and overbank areas within the marsh. During the late fall, the "channel" had been excavated by the Northeast Massachusetts Mosquito Control and Wetland Management District (NEMMC&WMD). While this greatly increased the storage volume within the marsh area, it was the existing condition when the water level (monitoring) measurements were obtained. Therefore it was necessary to survey the changes.

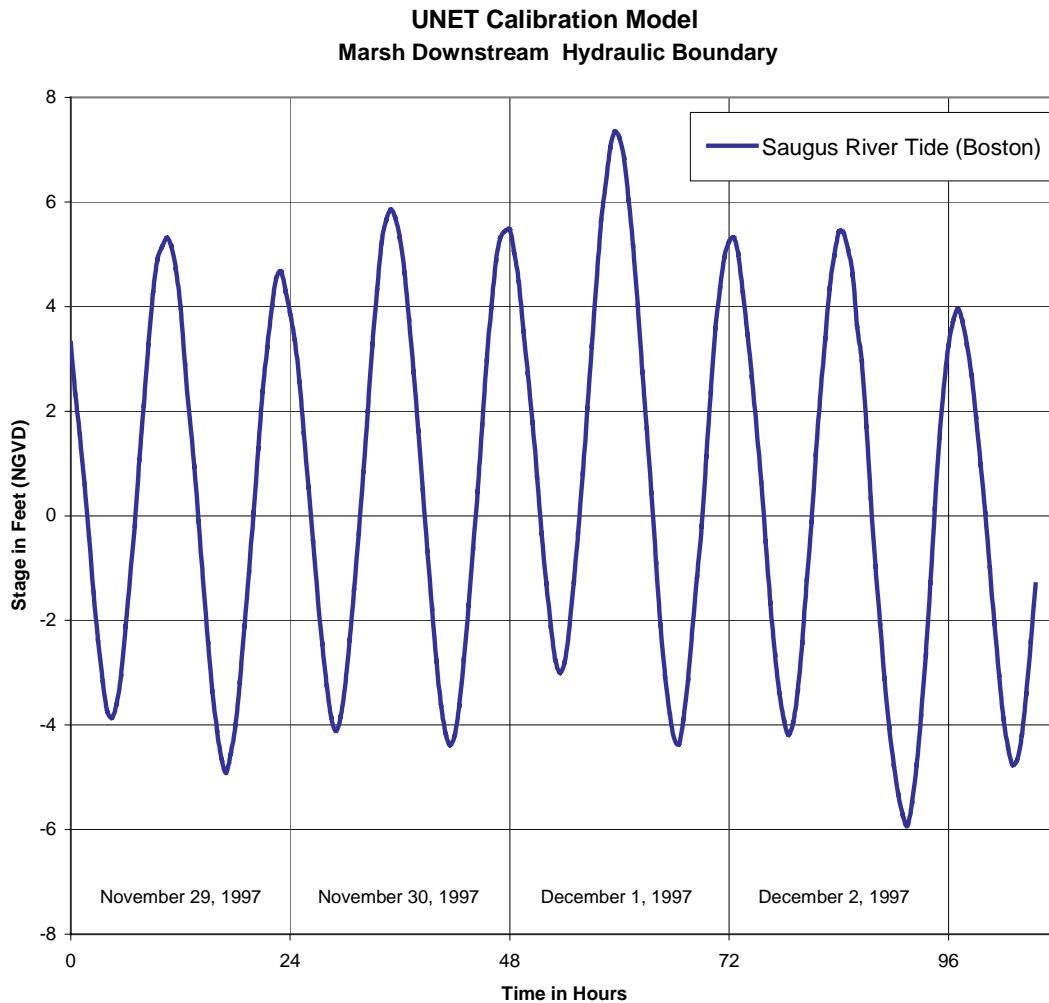
Figure 5

Measured tidal levels from the Boston Harbor gage (Location Map, Figure 1) were used to simulate the flood and ebb tides in the Saugus River. They were used to run the UNET model dataset for three days (see Figure 5) prior to the monitored period of December 2. This was recommended so the model is not reacting to startup conditions during the important simulation period.

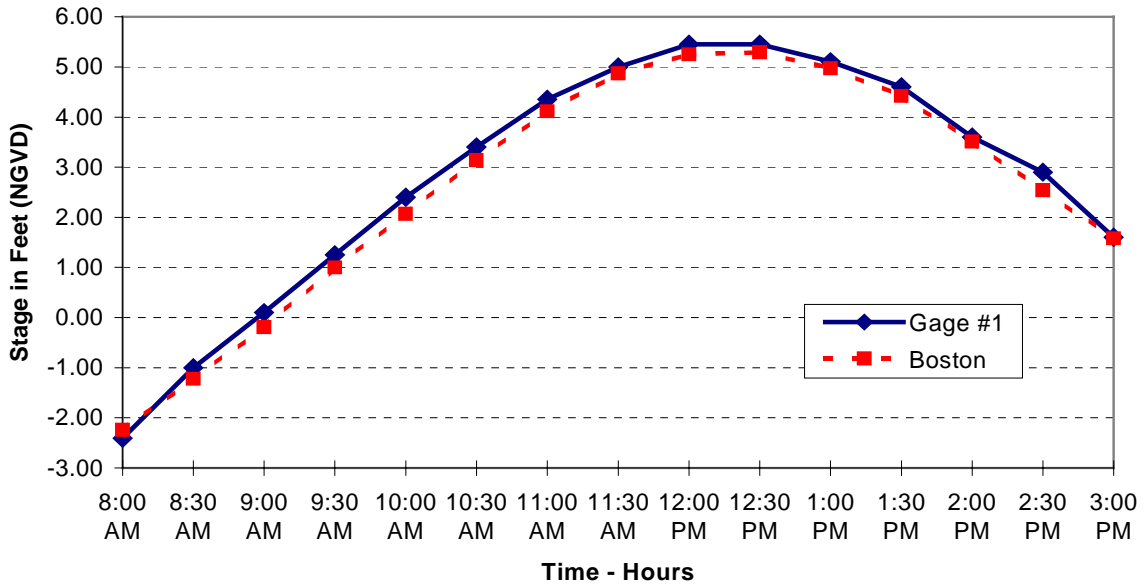
Figure 7

Observed vs. Preliminary Tide Data
Saugus River vs. Boston Harbor
December 2, 1997

Tide Stage Adjusted to Observed Data
December 2, 1997

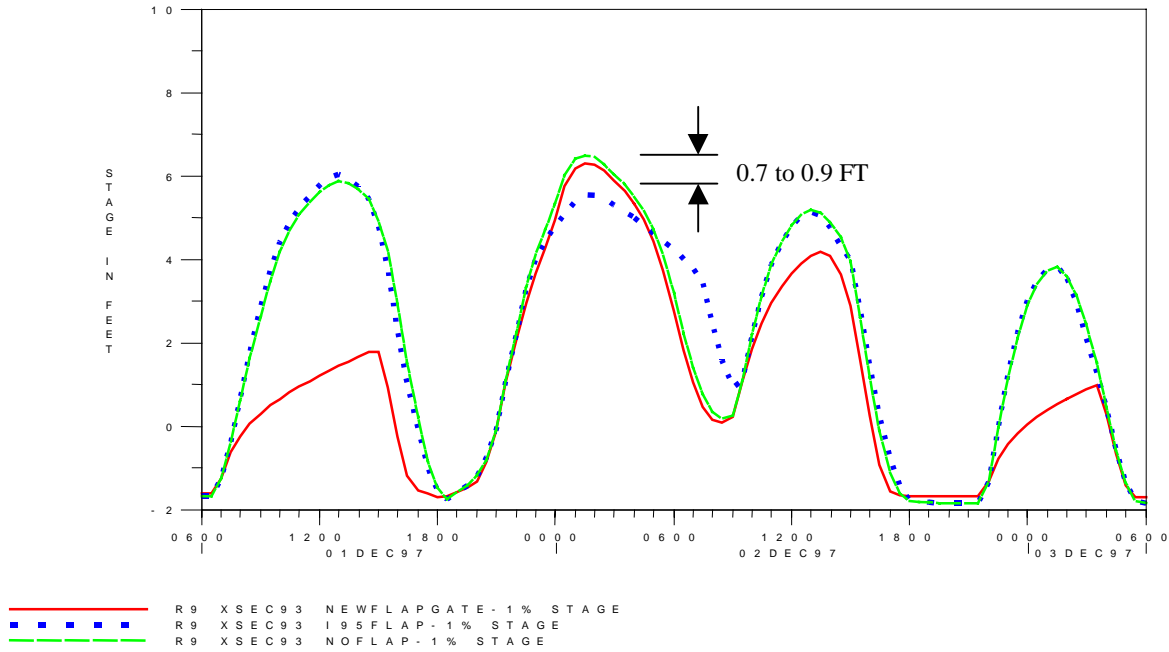
Figure 15

**Ballard Street (xsec93) Elevation Comparison –
One-Percent Chance Flood Scenario
Relocated I-95 Tide Gate vs.
New Ballard Street Tide Gate and No Tide Gate**

This graph shows that immediately following the peak inflow to the marsh, during a one-percent chance flood, Alternative 3 (the relocated I-95 tide gate alternative-dotted line) results in a lower peak flood level in the marsh area at Ballard Street. The primary reason for this is the associated excavated storage capacity between the I-95 fill and Eastern Avenue that is an integral part of this alternative. Alternative 2 (new Ballard Street tide gate alternative-solid line) and Alternative 1 (no tide gate alternative-dashed line) must store storm water runoff in the salt marsh at higher elevations for two different reasons. In the case of the no tide gate alternative, the storm water arrives at the marsh when it is already partially full of sea water at high tide. For the new Ballard Street tide gate alternative, the existing storage of the empty salt marsh is simply not adequate to lower the final flood elevation significantly.

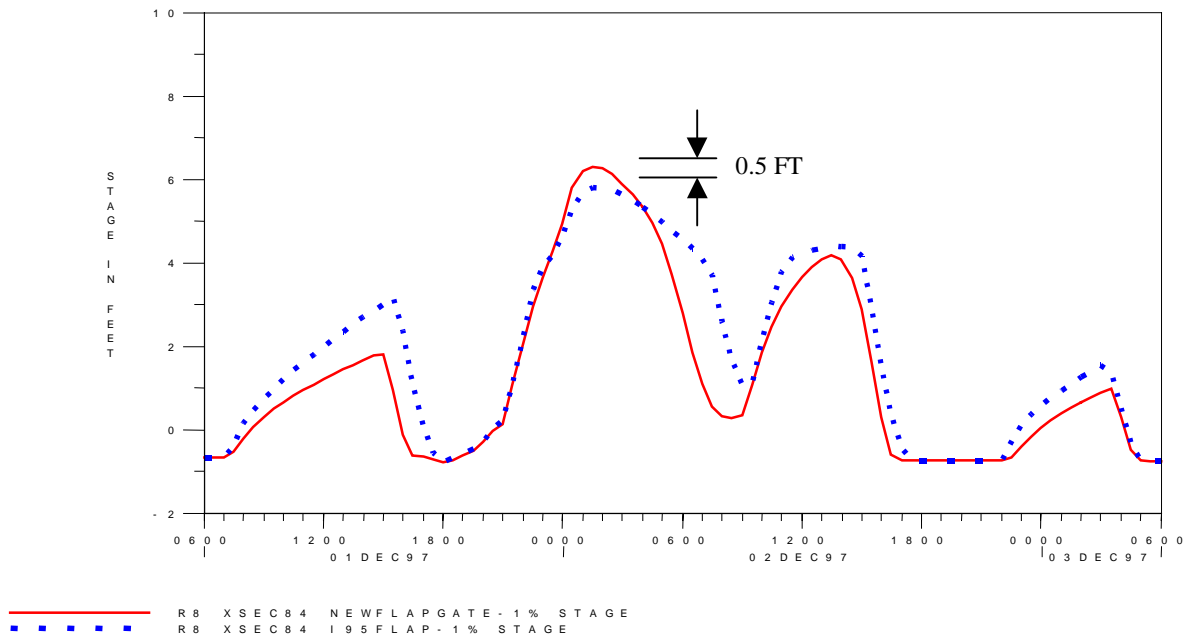
Figure 16

Reach 8 (xsec84) Elevation Comparison – One Percent Chance Flood Scenario
Relocated I-95 Tide Gate vs. New Ballard Street Tide Gate

This graph shows that the relocated I-95 tide gate alternative (dotted line) with its associated excavated storage between the I-95 fill and Eastern Avenue provides for a lower peak flood elevation in the area of Eastern Tool and Stamping than does a 100% effective new tide gate at Ballard Street (solid line).

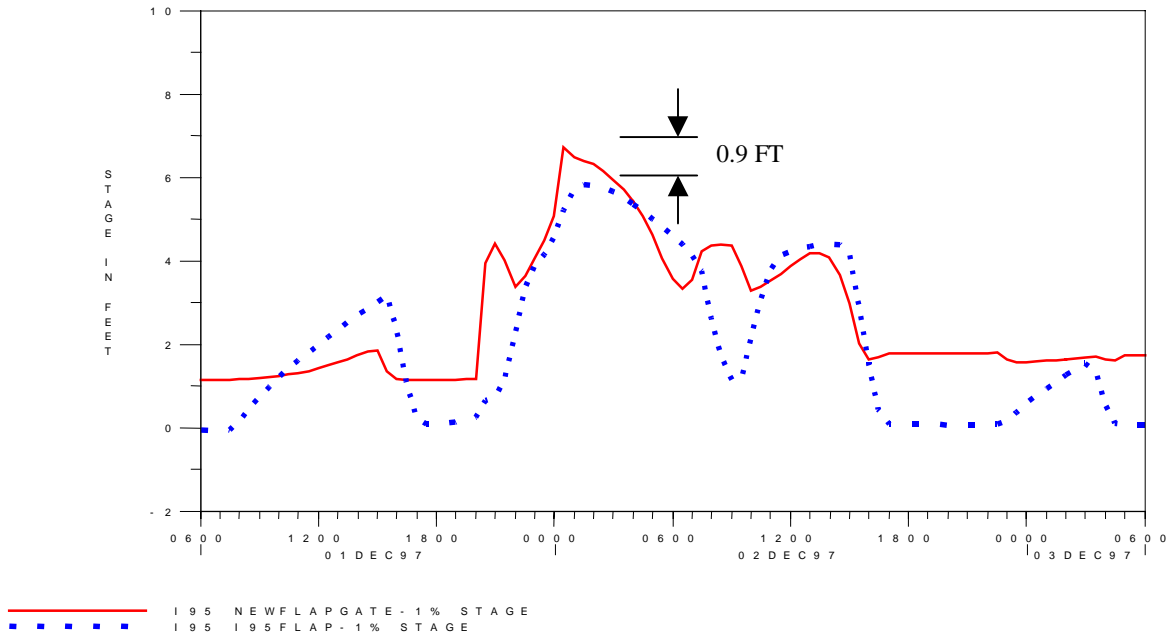
Figure 17

**Storage Area 3 Elevation Comparison – One Percent Chance Flood Scenario
Relocated I-95 Tide Gate vs. New Ballard Street Tide Gate**

This graph shows that the relocated I-95 tide gate alternative (dotted line), with its associated excavated storage between the I-95 fill and Eastern Avenue, provides for a lower peak flood elevation in the area of the I-95 storage area than does a 100% effective new tide gate at Ballard Street (solid line).

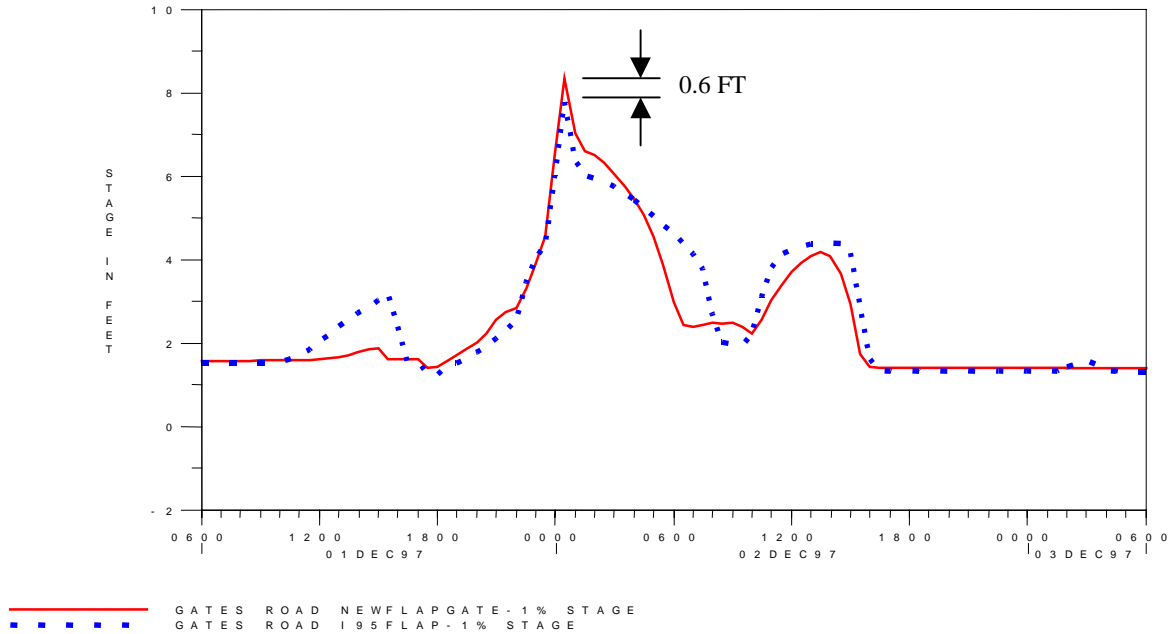
Figure 18

Storage Area 1 (Gates Road) Elevation Comparison –
One Percent Chance Flood Scenario
Relocated I-95 Tide Gate vs. New Ballard Street Tide Gate

This graph shows that the relocated I-95 tide gate alternative (dotted line) with its associated excavated storage between the I-95 fill and Eastern Avenue provides for a lower peak flood elevation in the area of Gates Road than does a 100% effective new tide gate at Ballard Street (solid line).

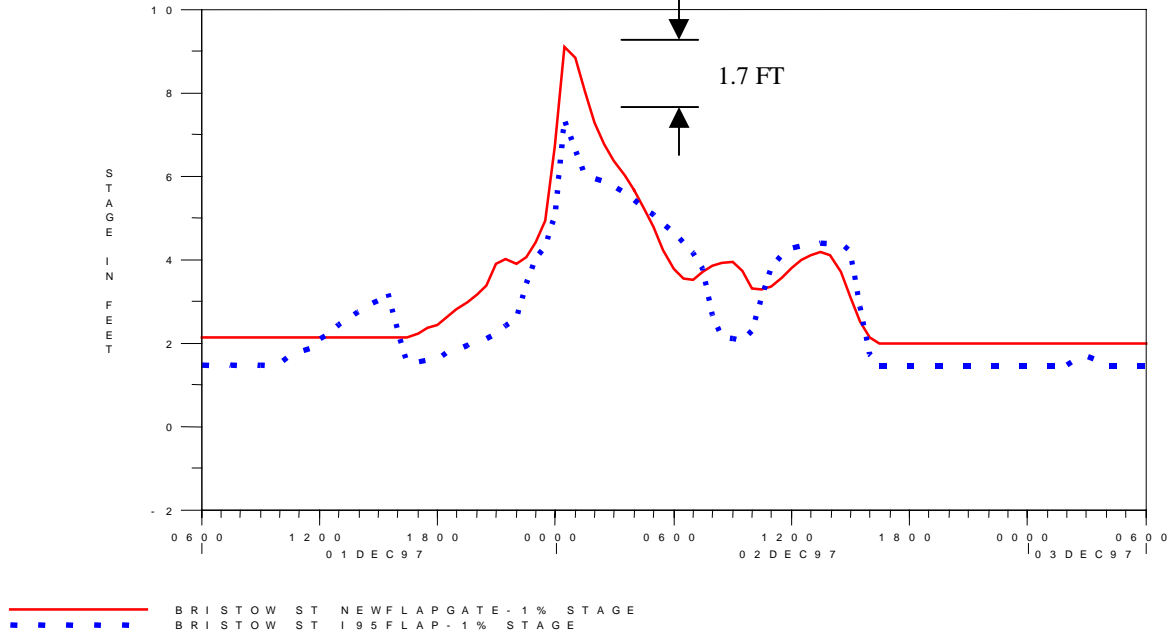
Figure 19

Storage Area 2 (Bristow Street) Elevation Comparison –
One Percent Chance Flood Scenario
Relocated I-95 Tide Gate vs. New Ballard Street Tide Gate

This graph shows that the relocated I-95 tide gate alternative (dotted line) with its associated excavated storage between the I-95 fill and Eastern Avenue provides for a lower peak flood elevation in the area of Bristow Street than does a 100% effective new tide gate at Ballard Street (solid line).

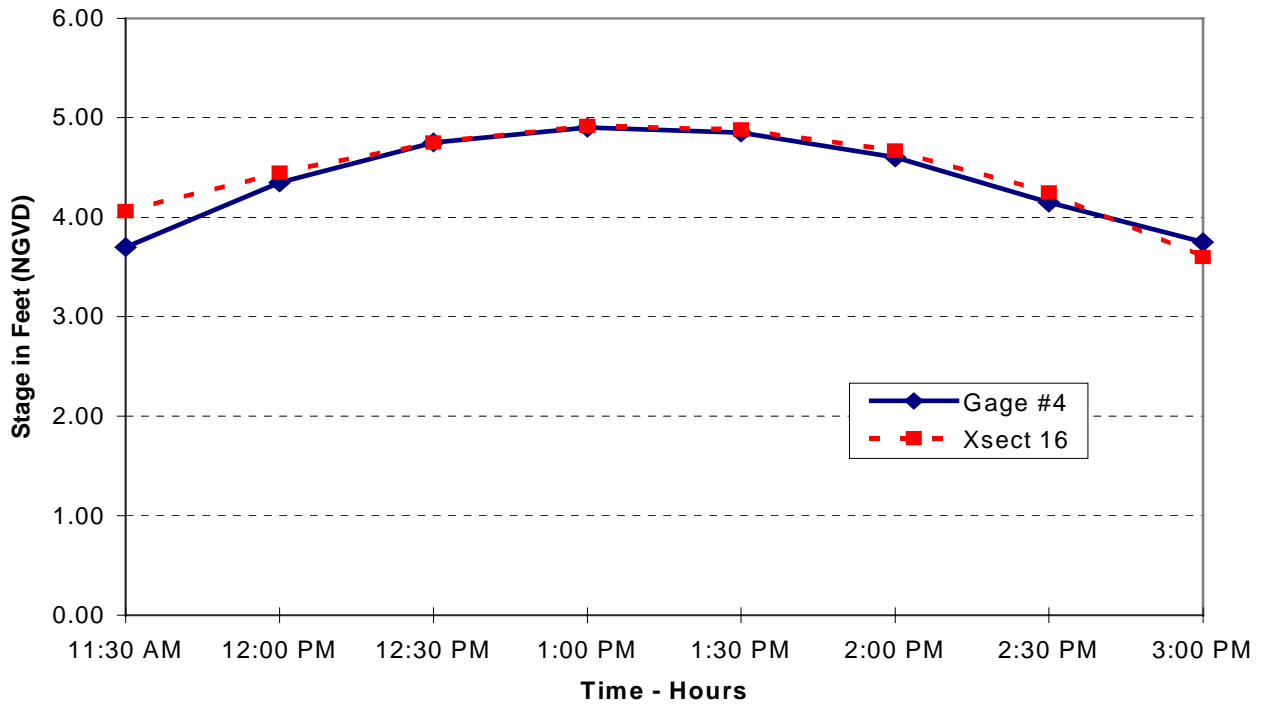
Figure C-2

UNET Calibration Model December 2, 1997
