Opportunities and Constraints for Mitigating the Environmental Effects of an Abandoned Highway Embankment Fill at Rumney Marsh in Revere and Saugus, Massachusetts

Edward Reiner - EPA New England

New England Association of Environmental
Biologists
March 16-18, 2011
Sturbridge, MA

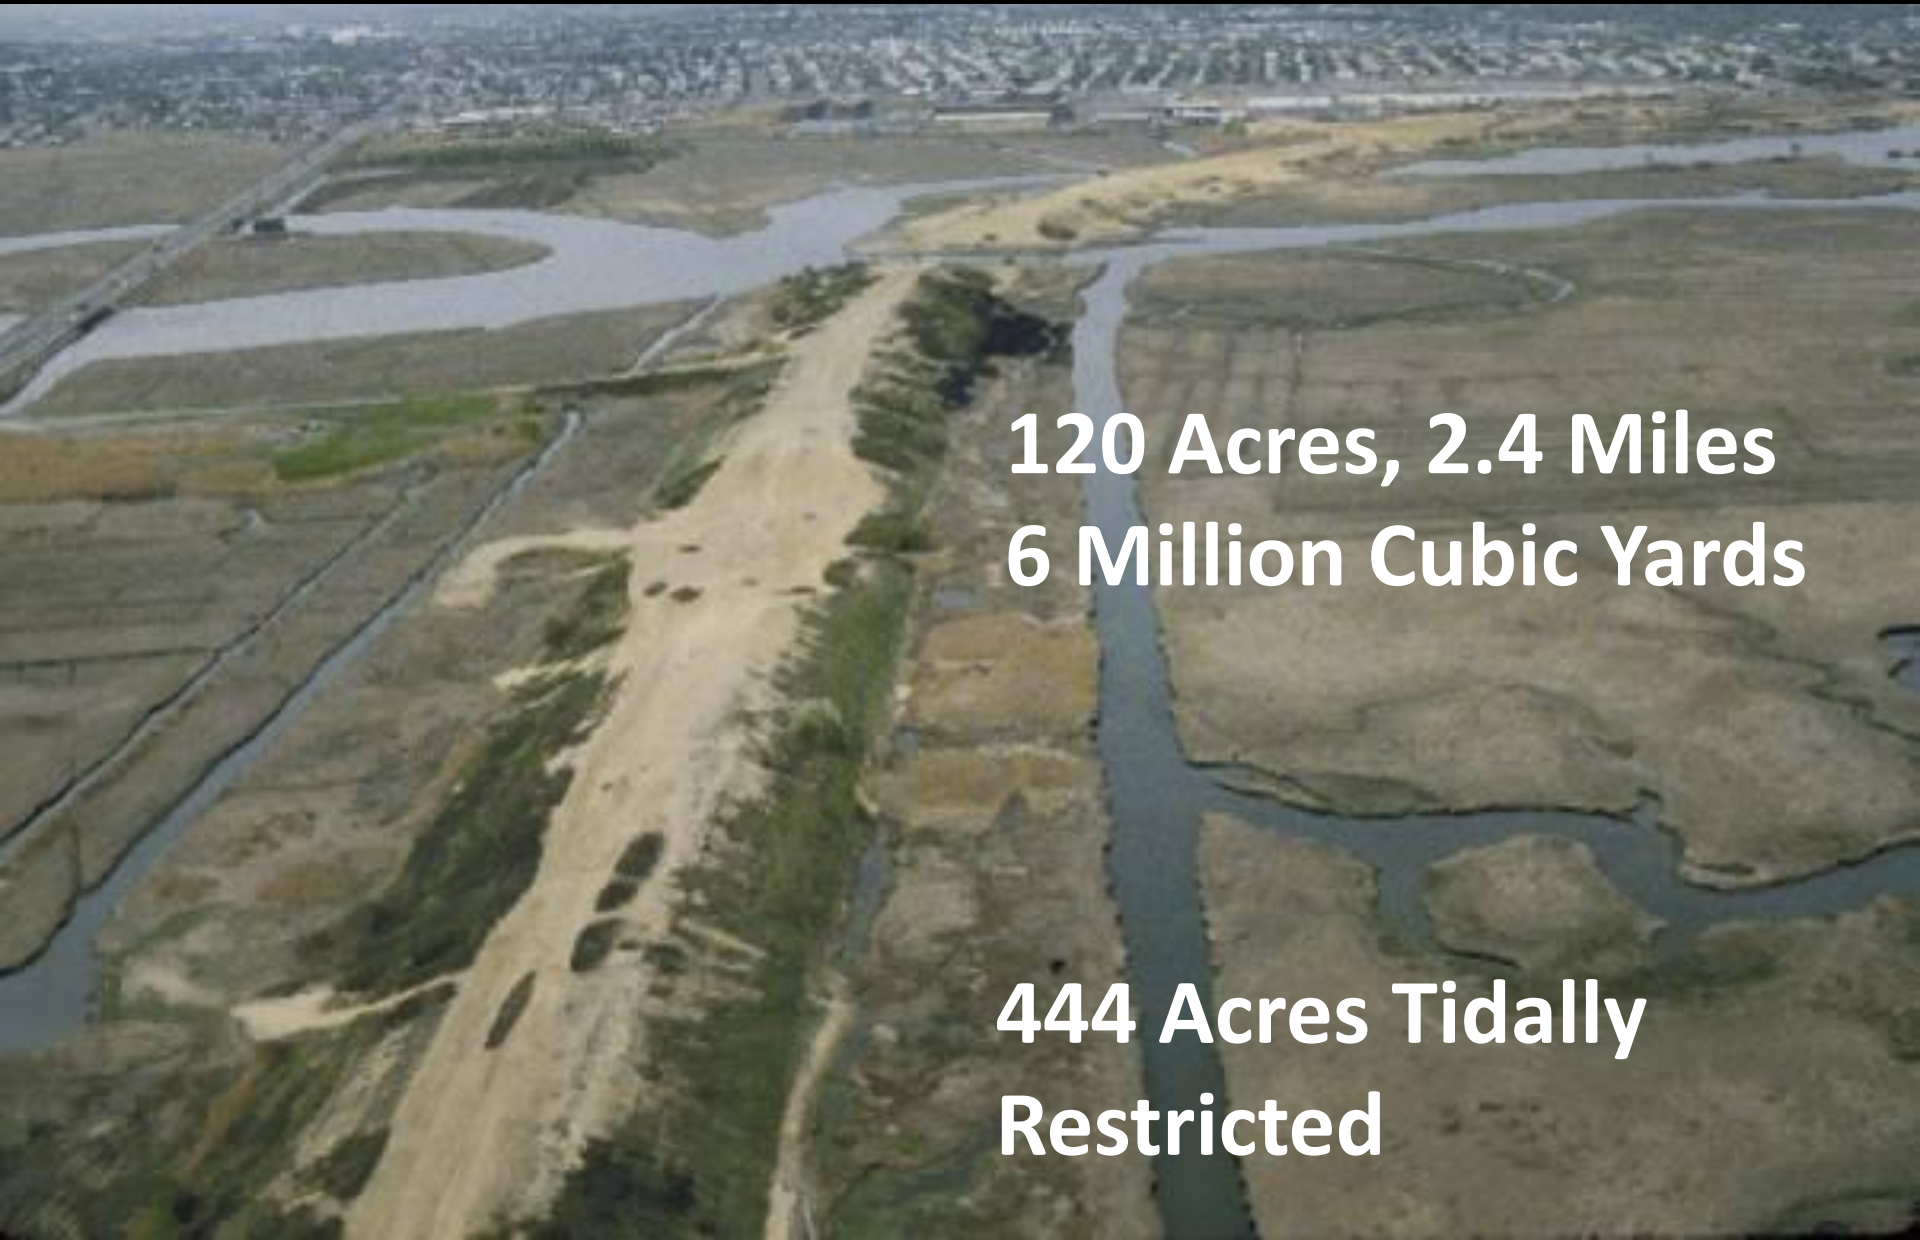
I-95 Abandoned Embankment

**120 Acres, 2.4 Miles
6 Million Cubic Yards**

**444 Acres Tidally
Restricted**

- Loss of 120 acres of marsh
- 444 acres hydrologically altered
- 25 acres restored
- 25 additional acres can be restored while maintaining a flood barrier

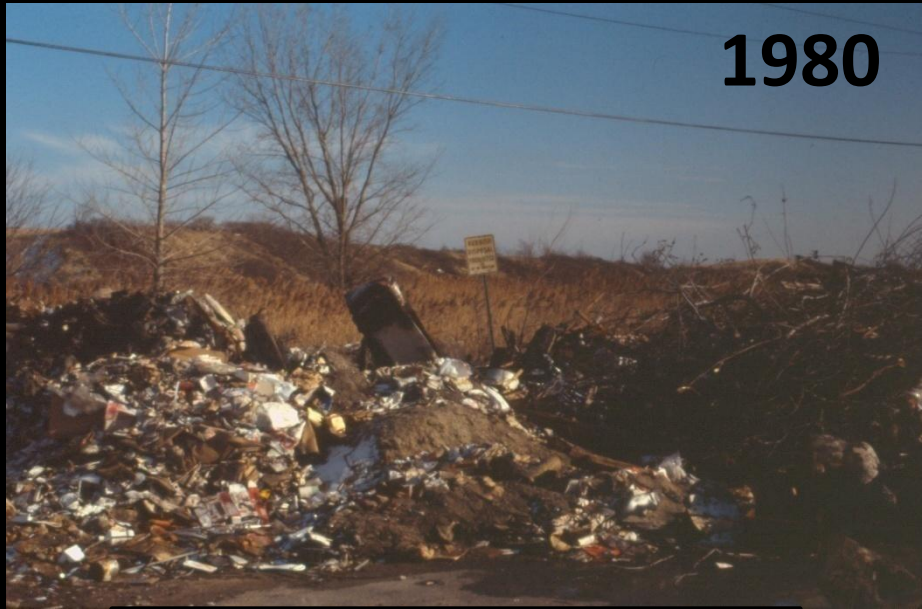
1980

Dumping

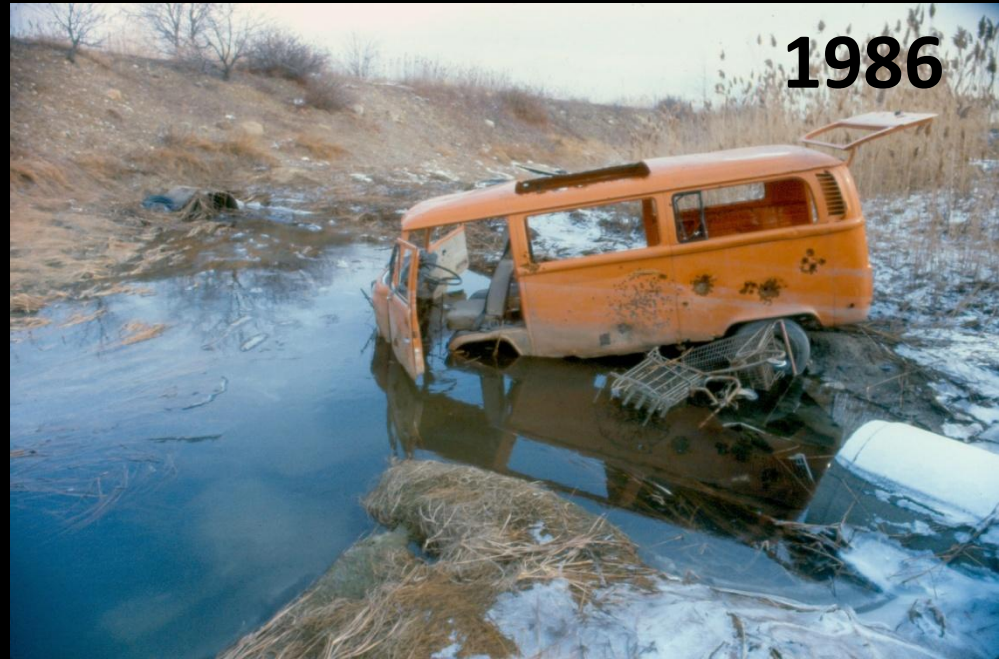
1986

Refuse Dump

Abandoned Vehicle

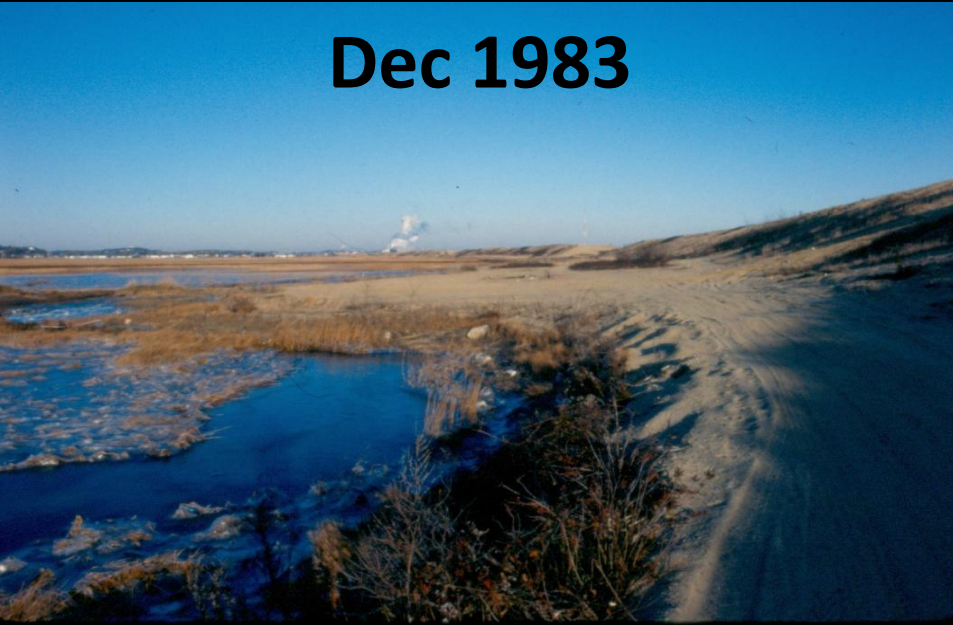
Dec 1983

Erosion Effects

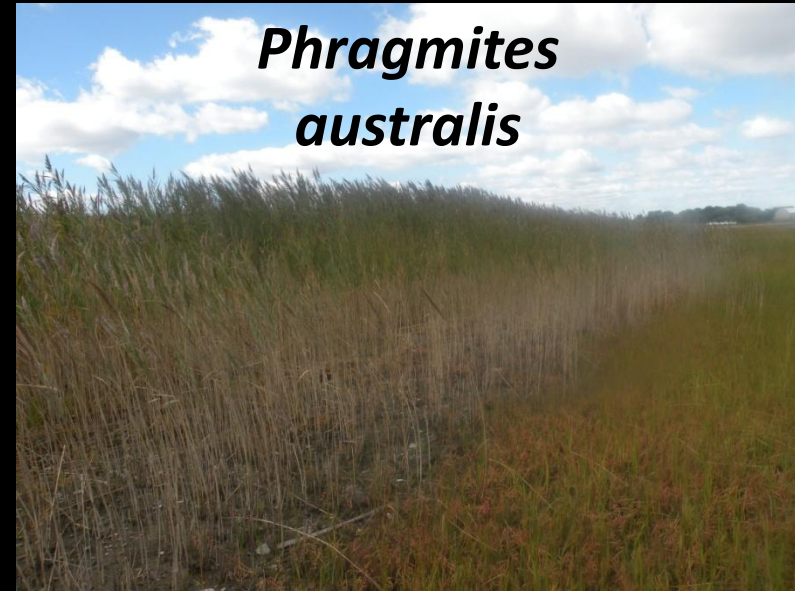
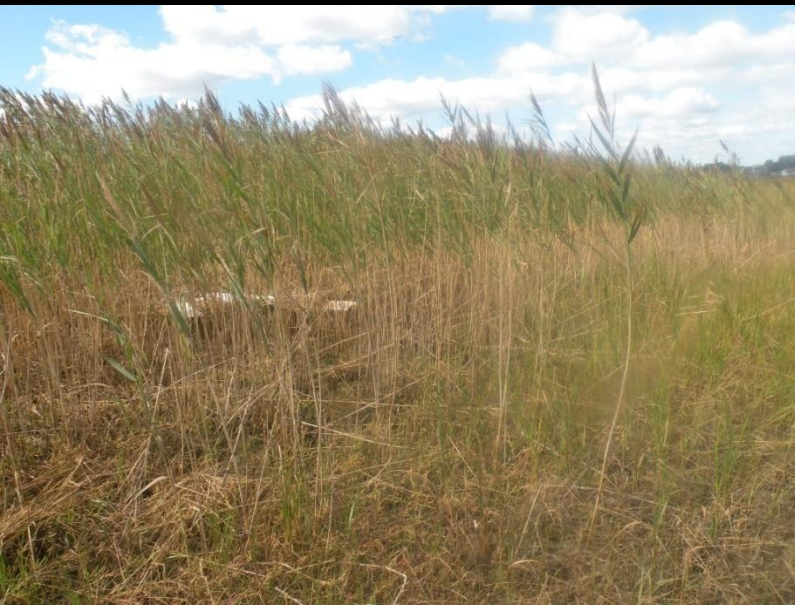
Invasive Species

Phragmites australis

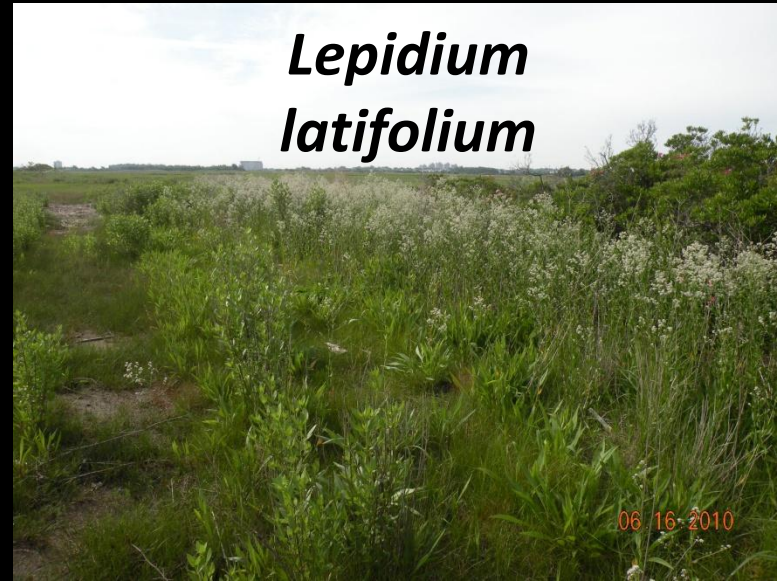
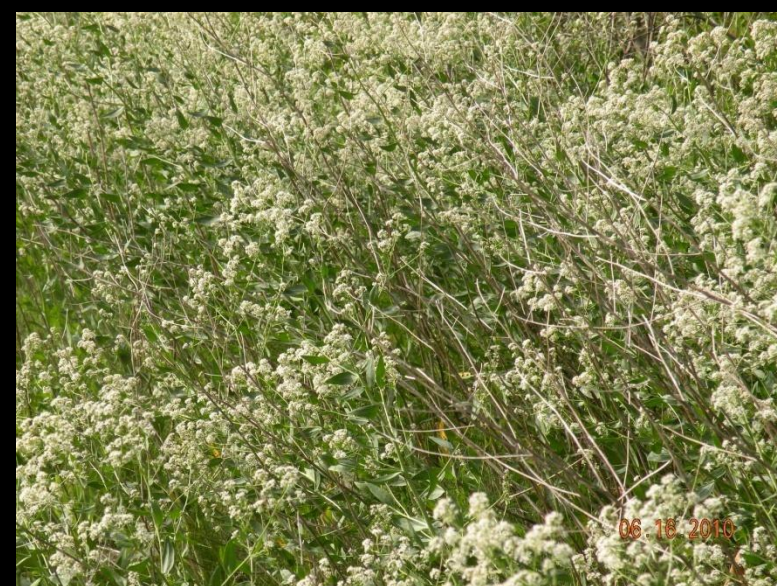
Lepidium latifolium

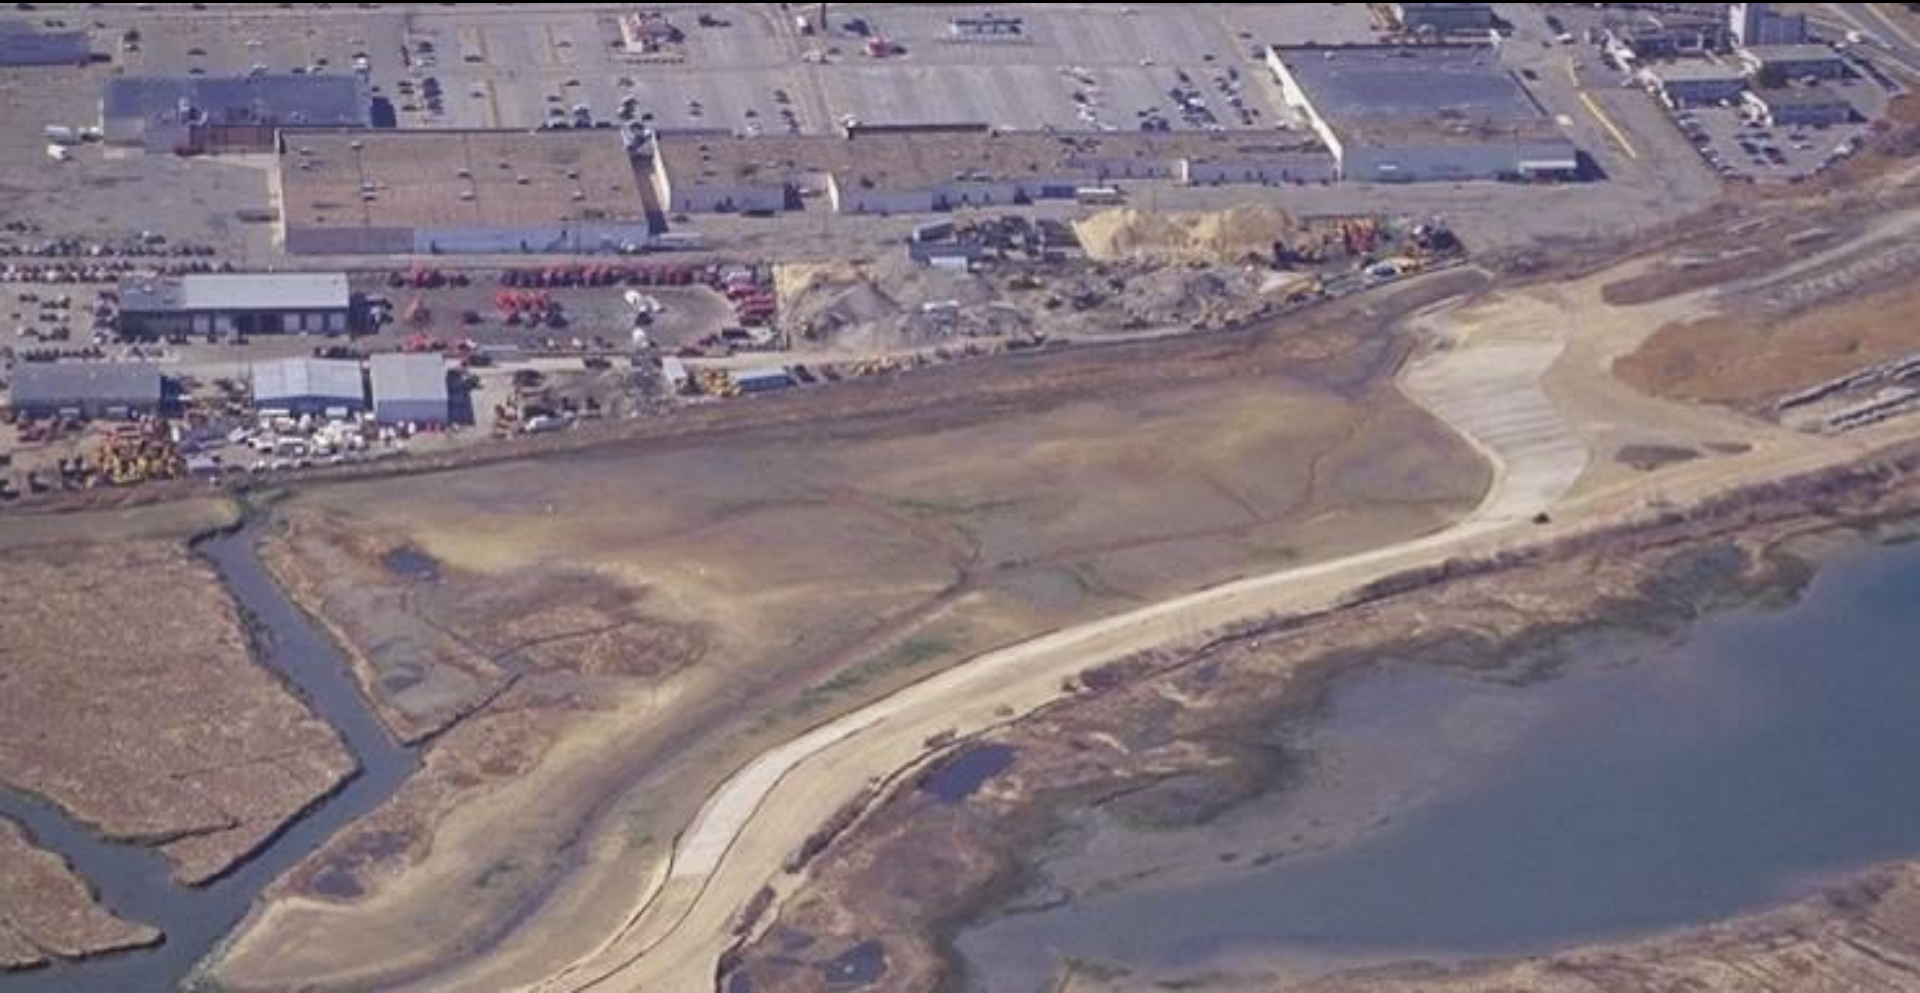
Grading Below MHW Helps Control *Phragmites*

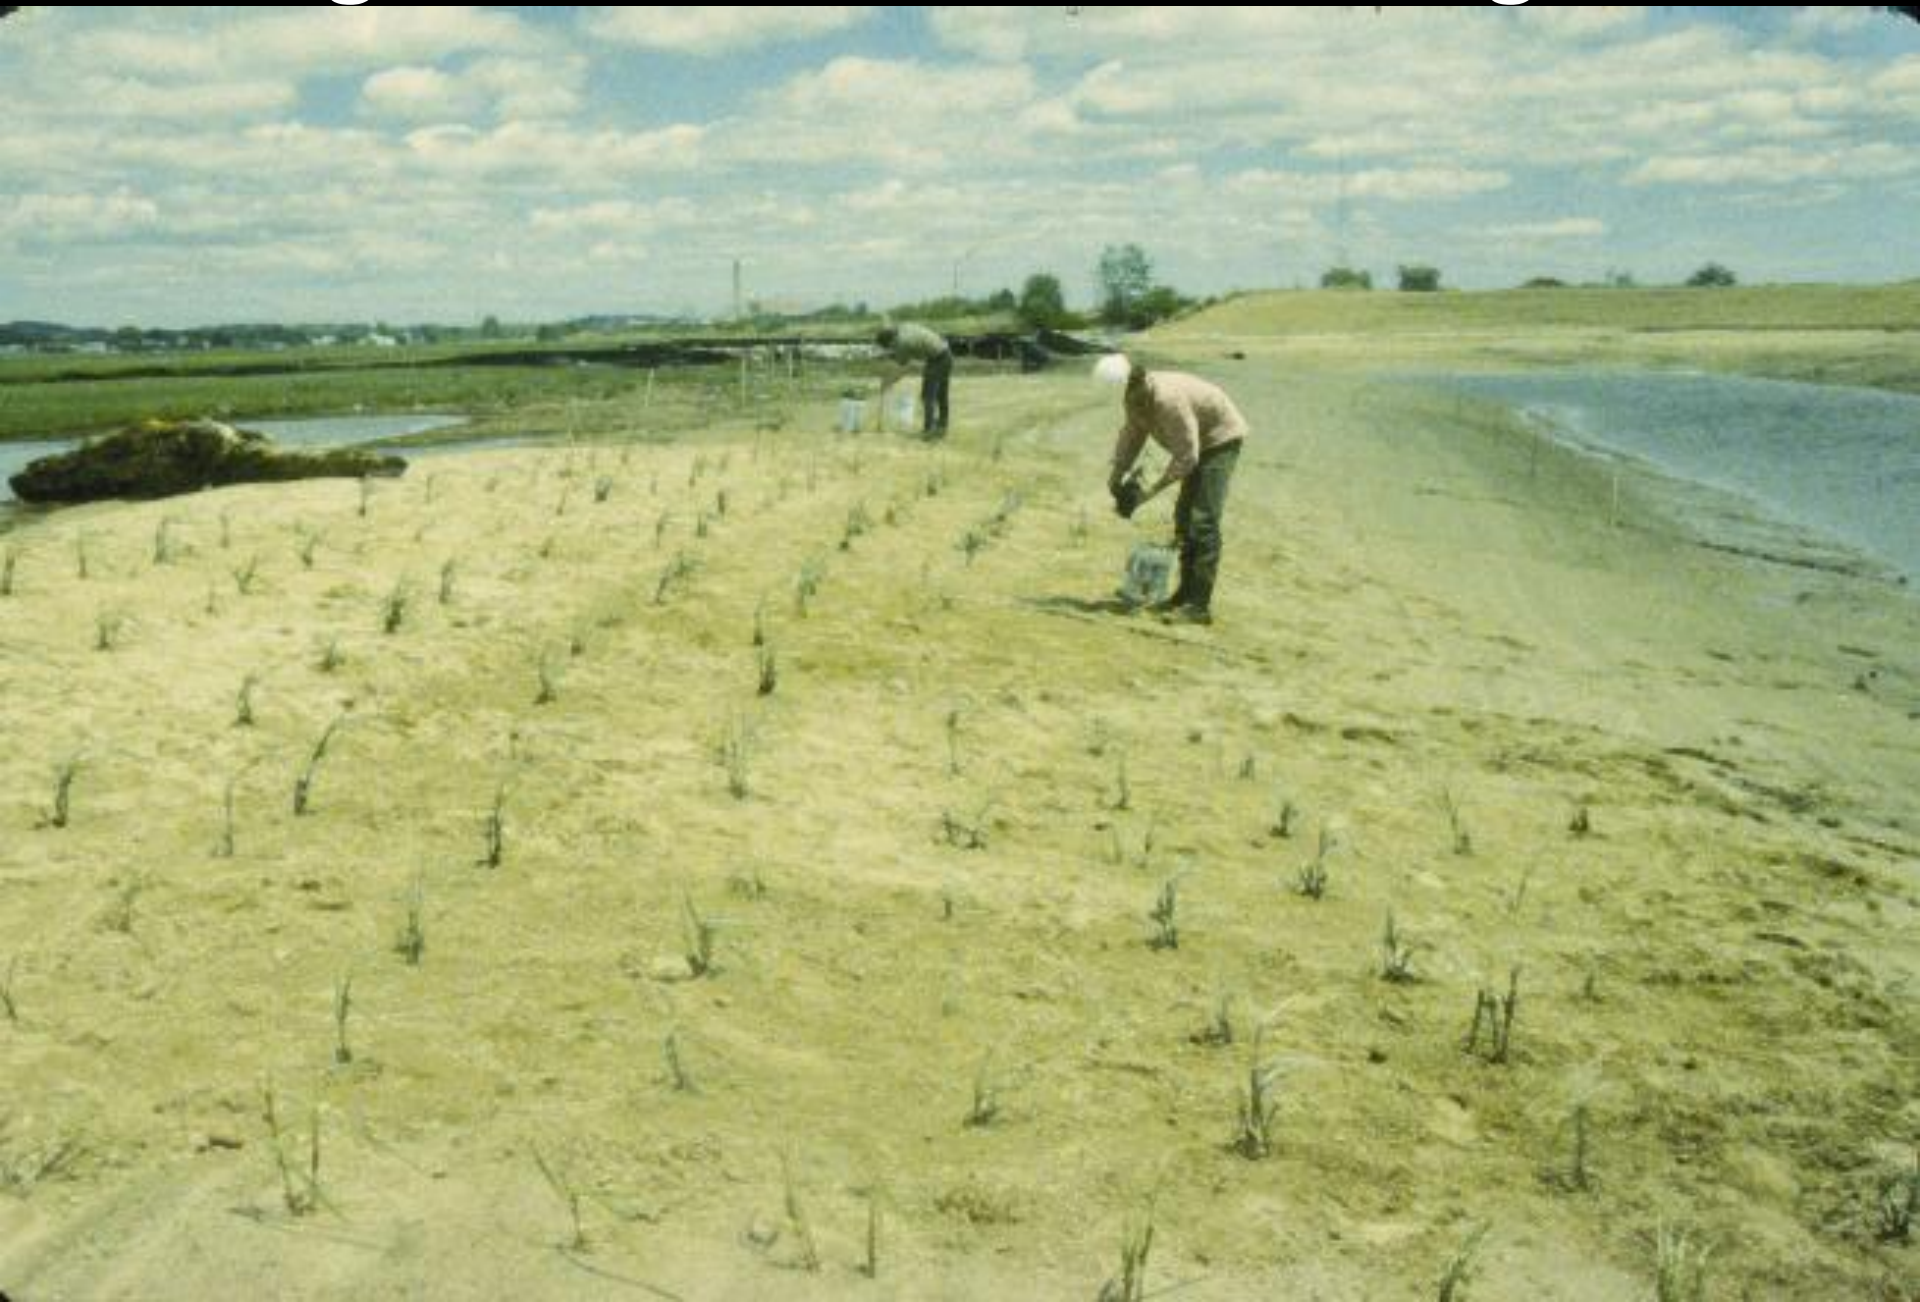
Roughans Point Clam Flat Mitigation

Natural Colonization Usually Works

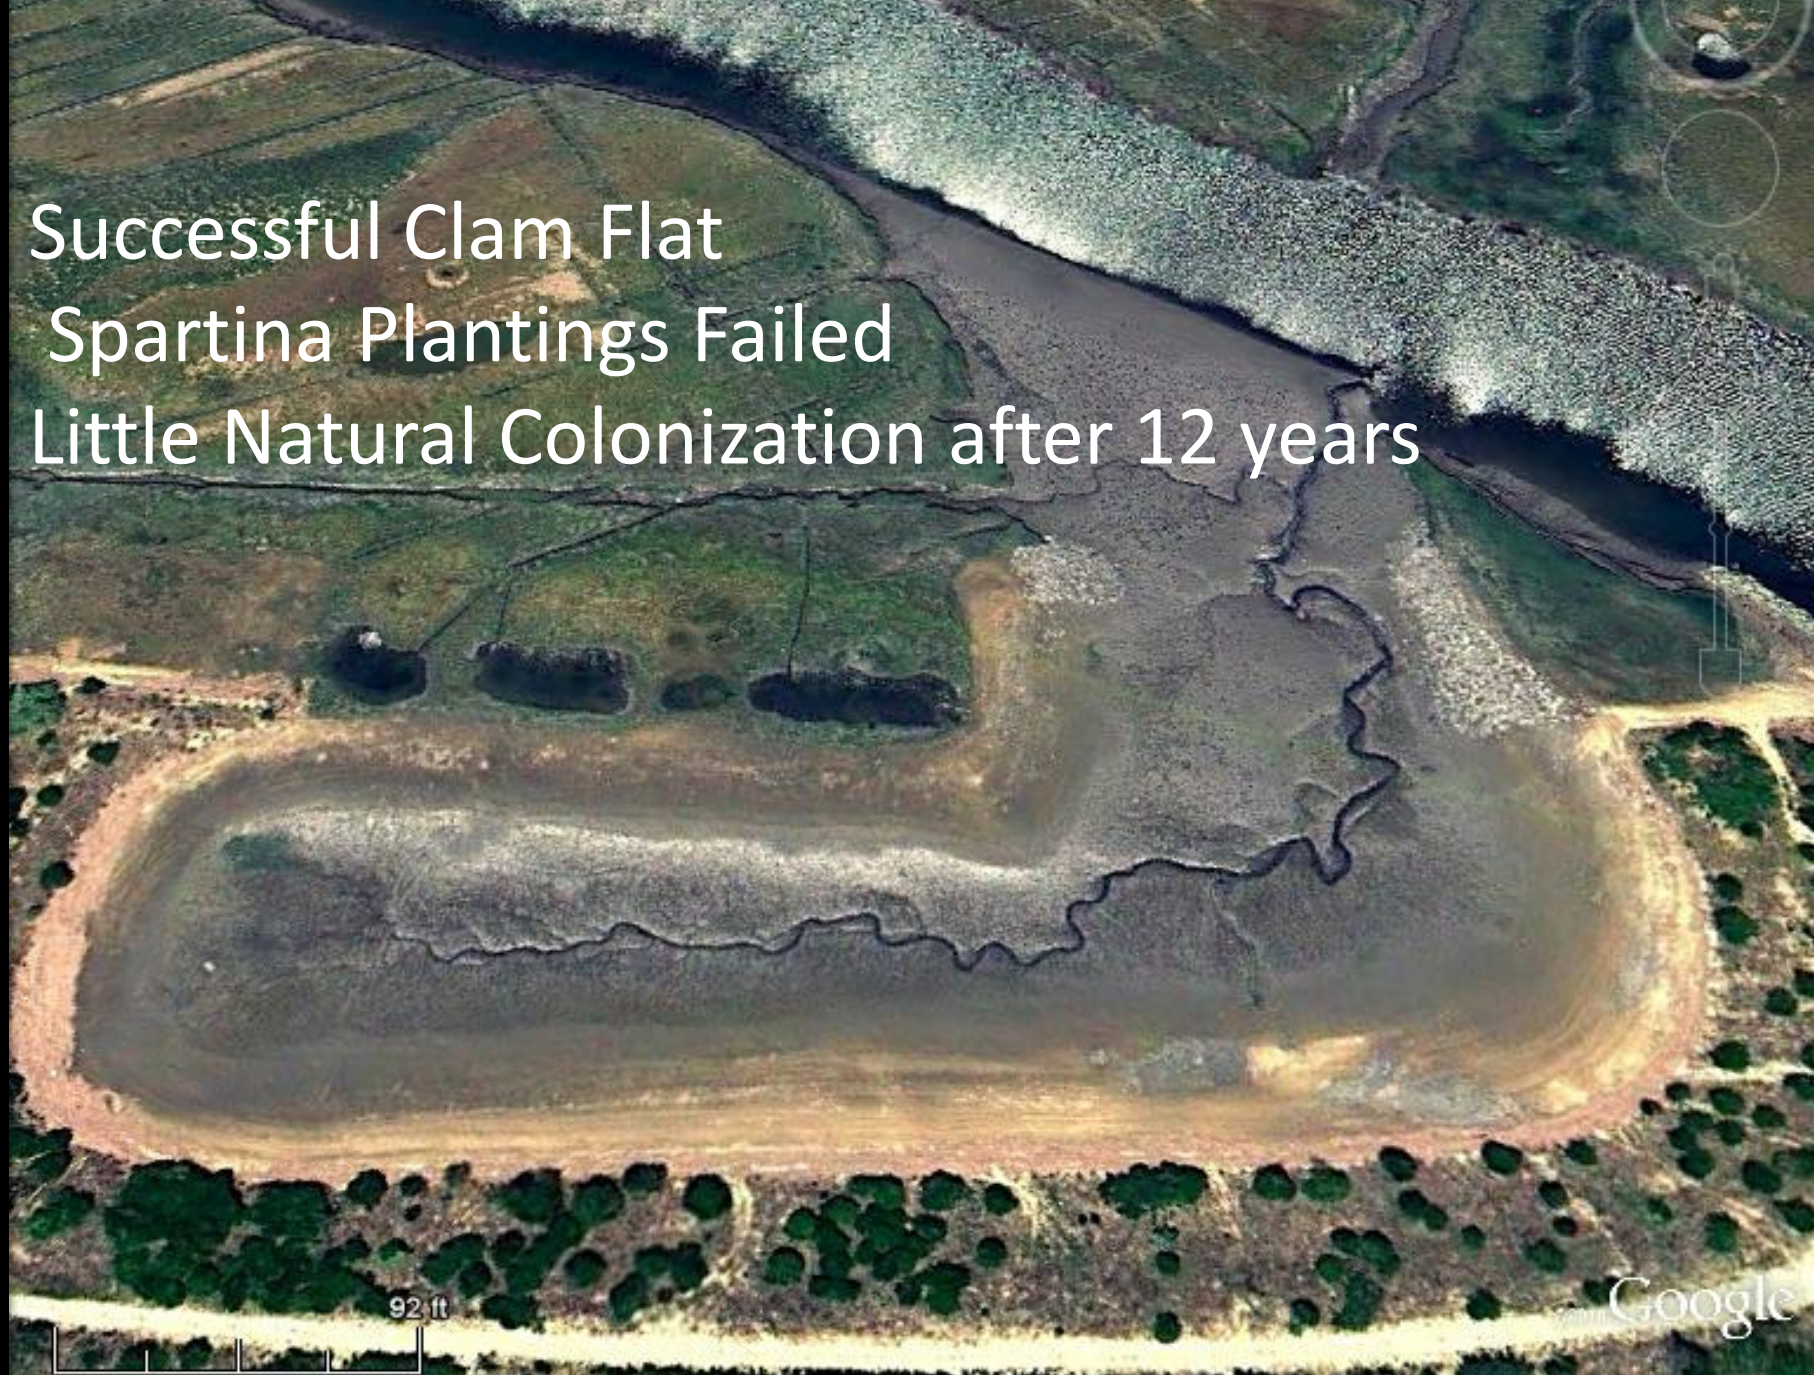
Successful Clam Flat
Spartina Plantings Failed
Little Natural Colonization after 12 years

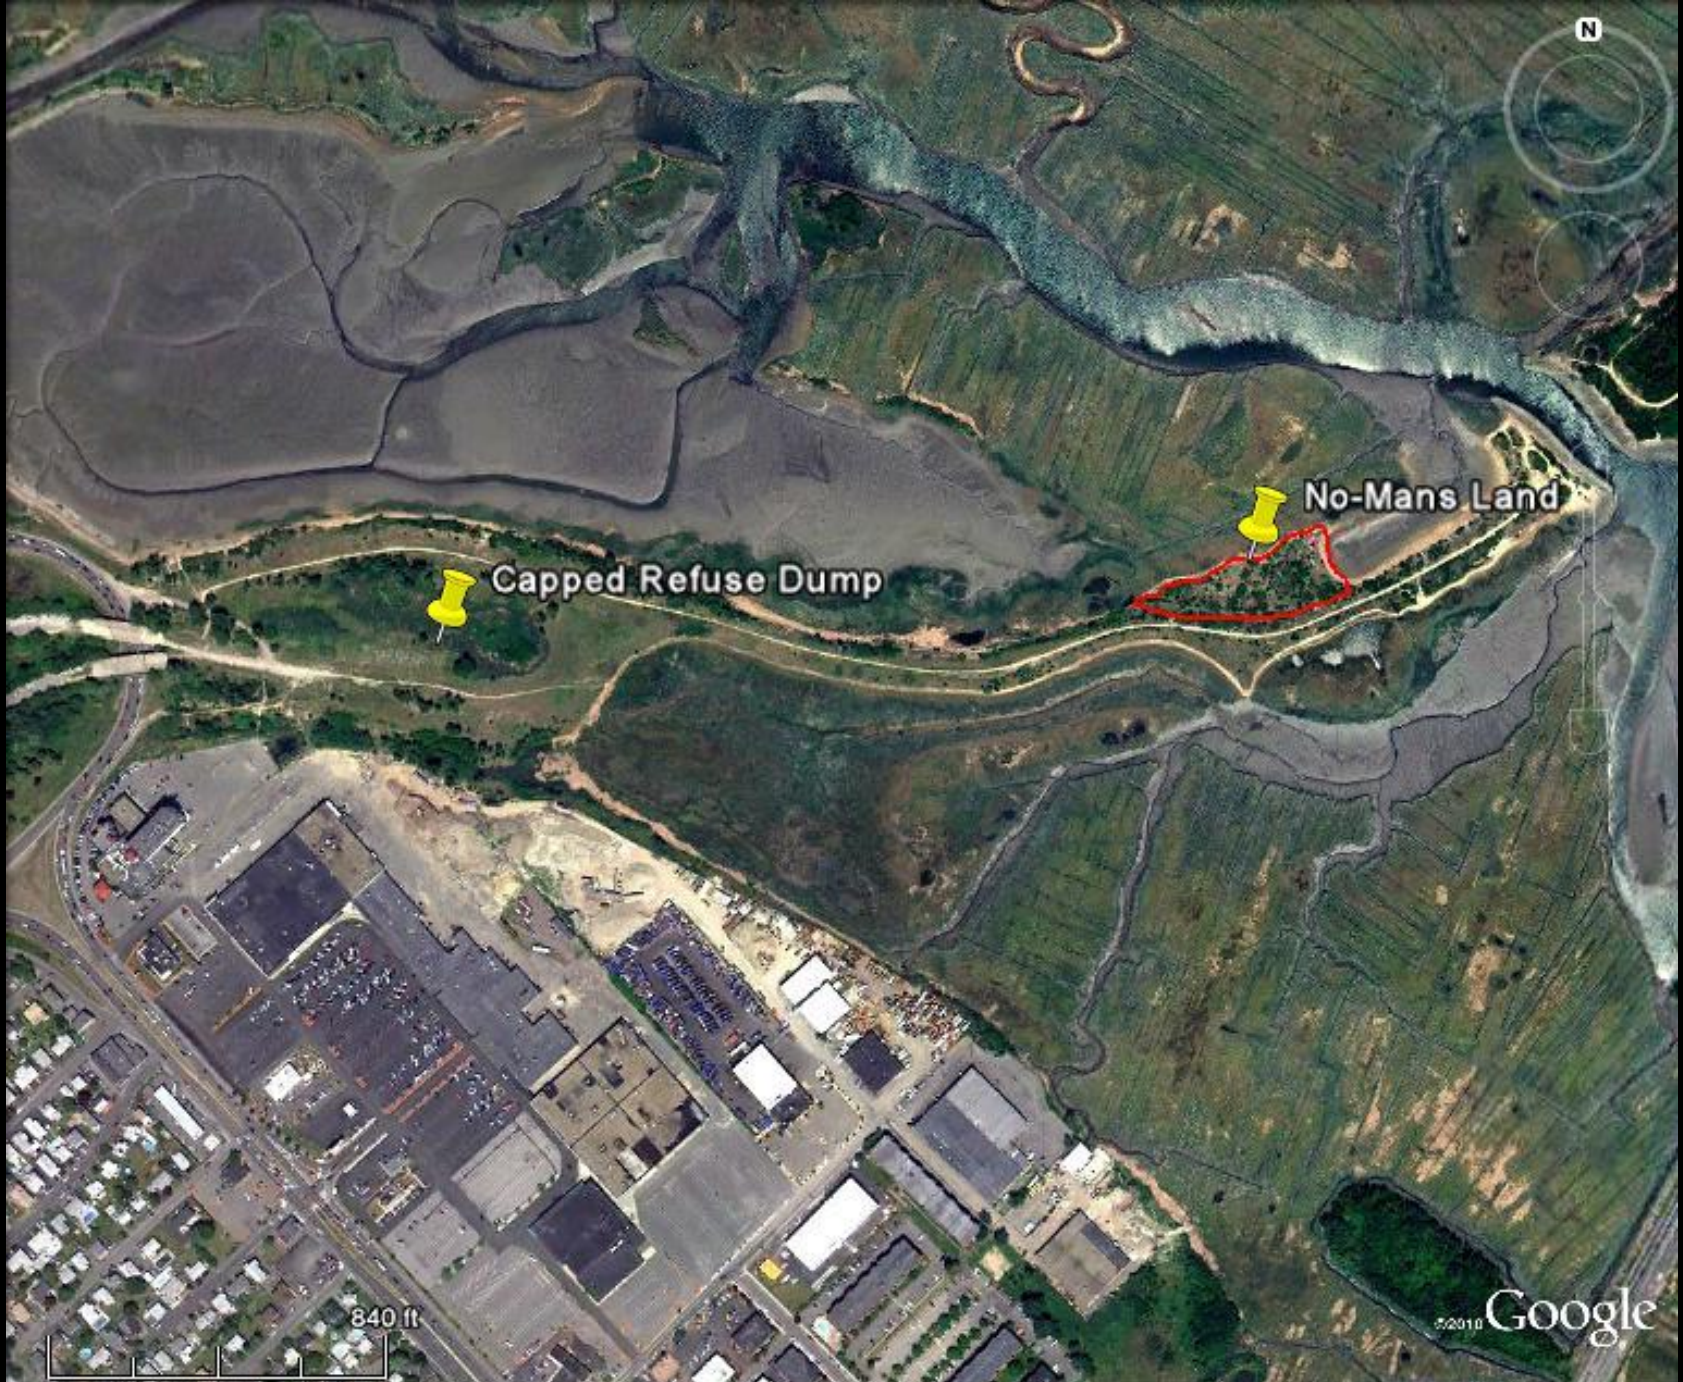
Capped Refuse Dump

No-Mans Land

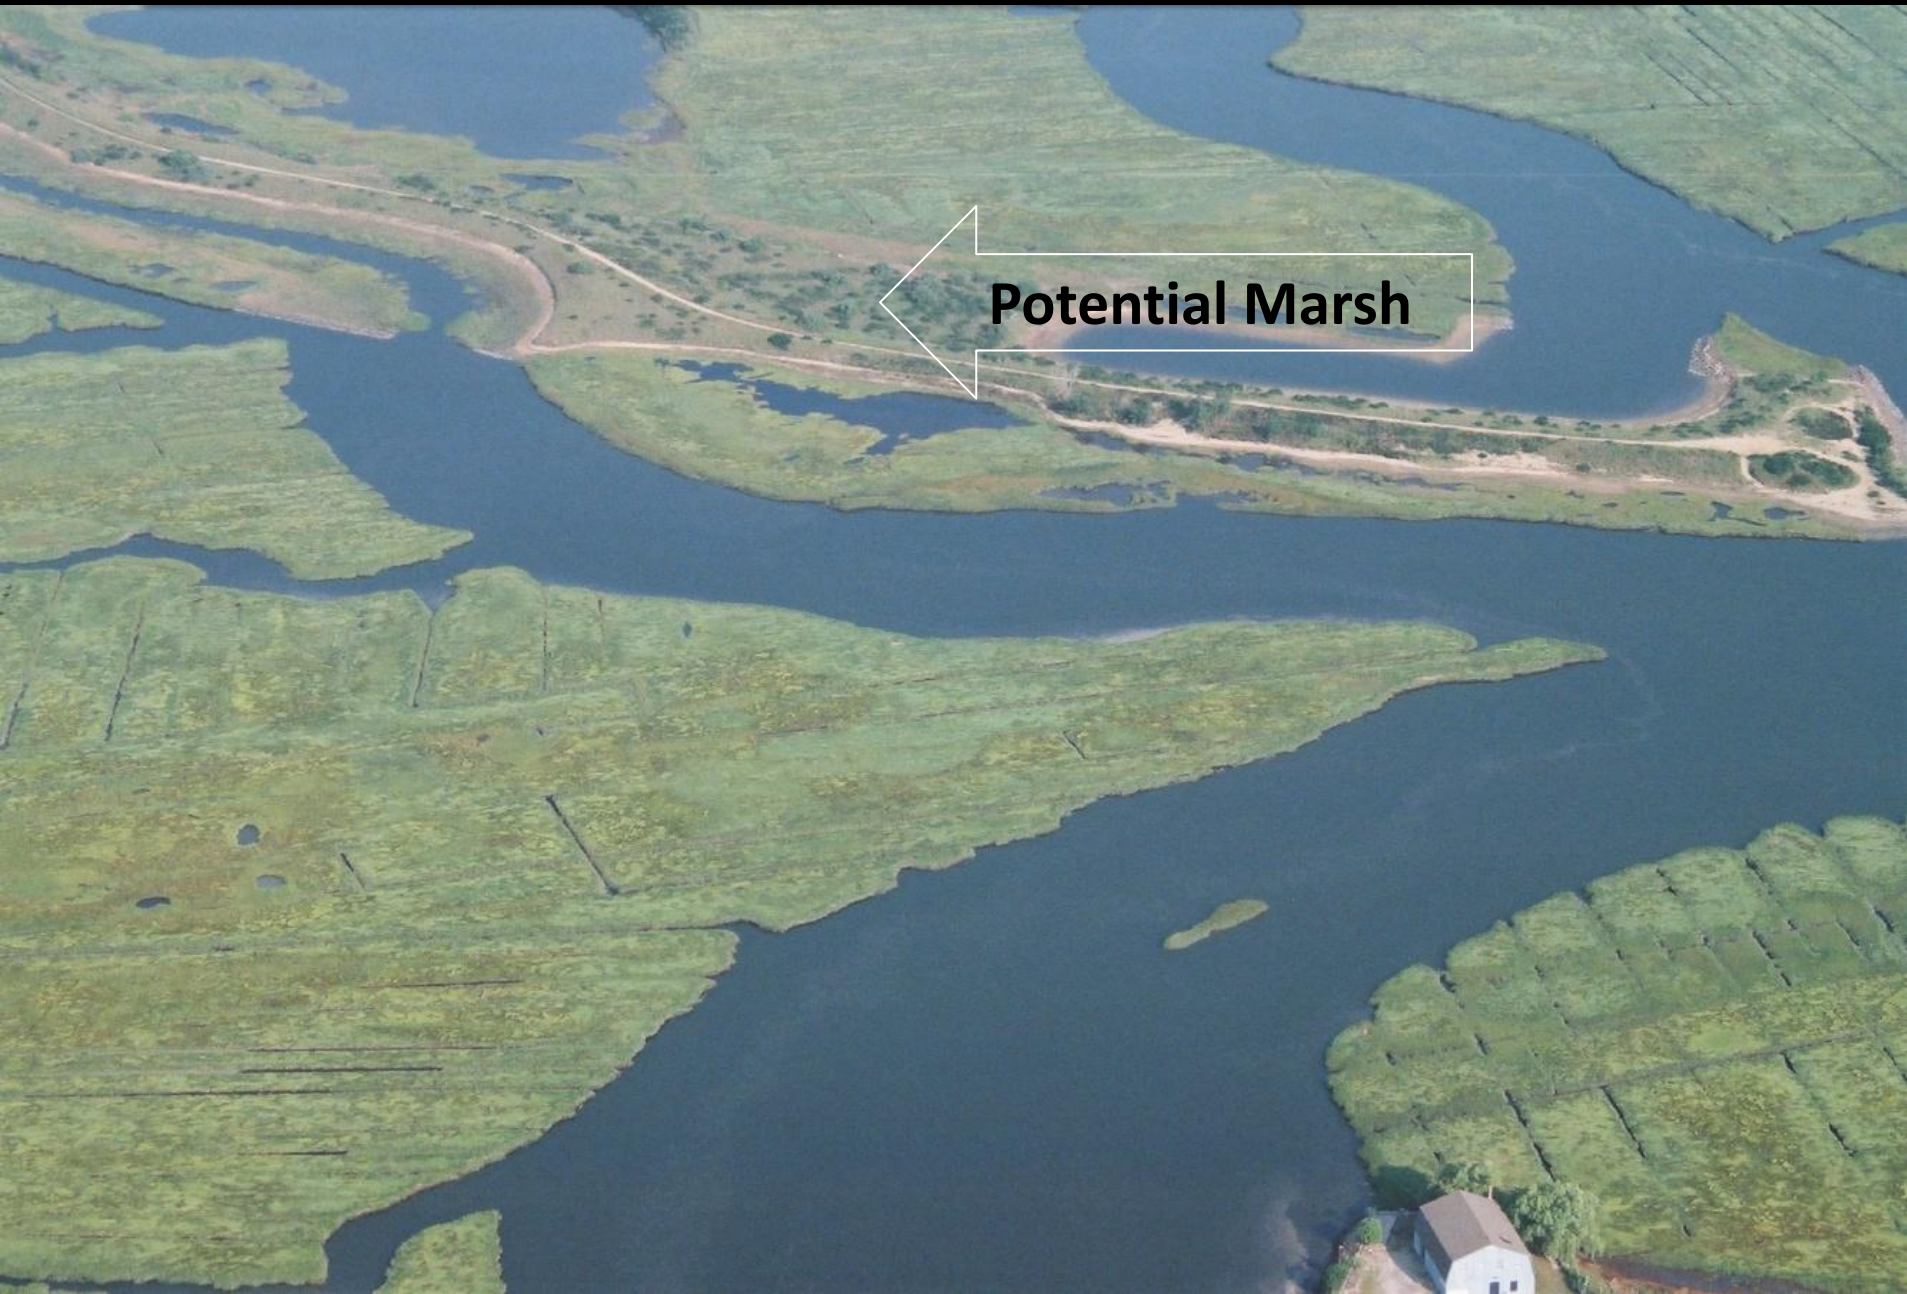
Additional Restoration Possible

Potential Marsh

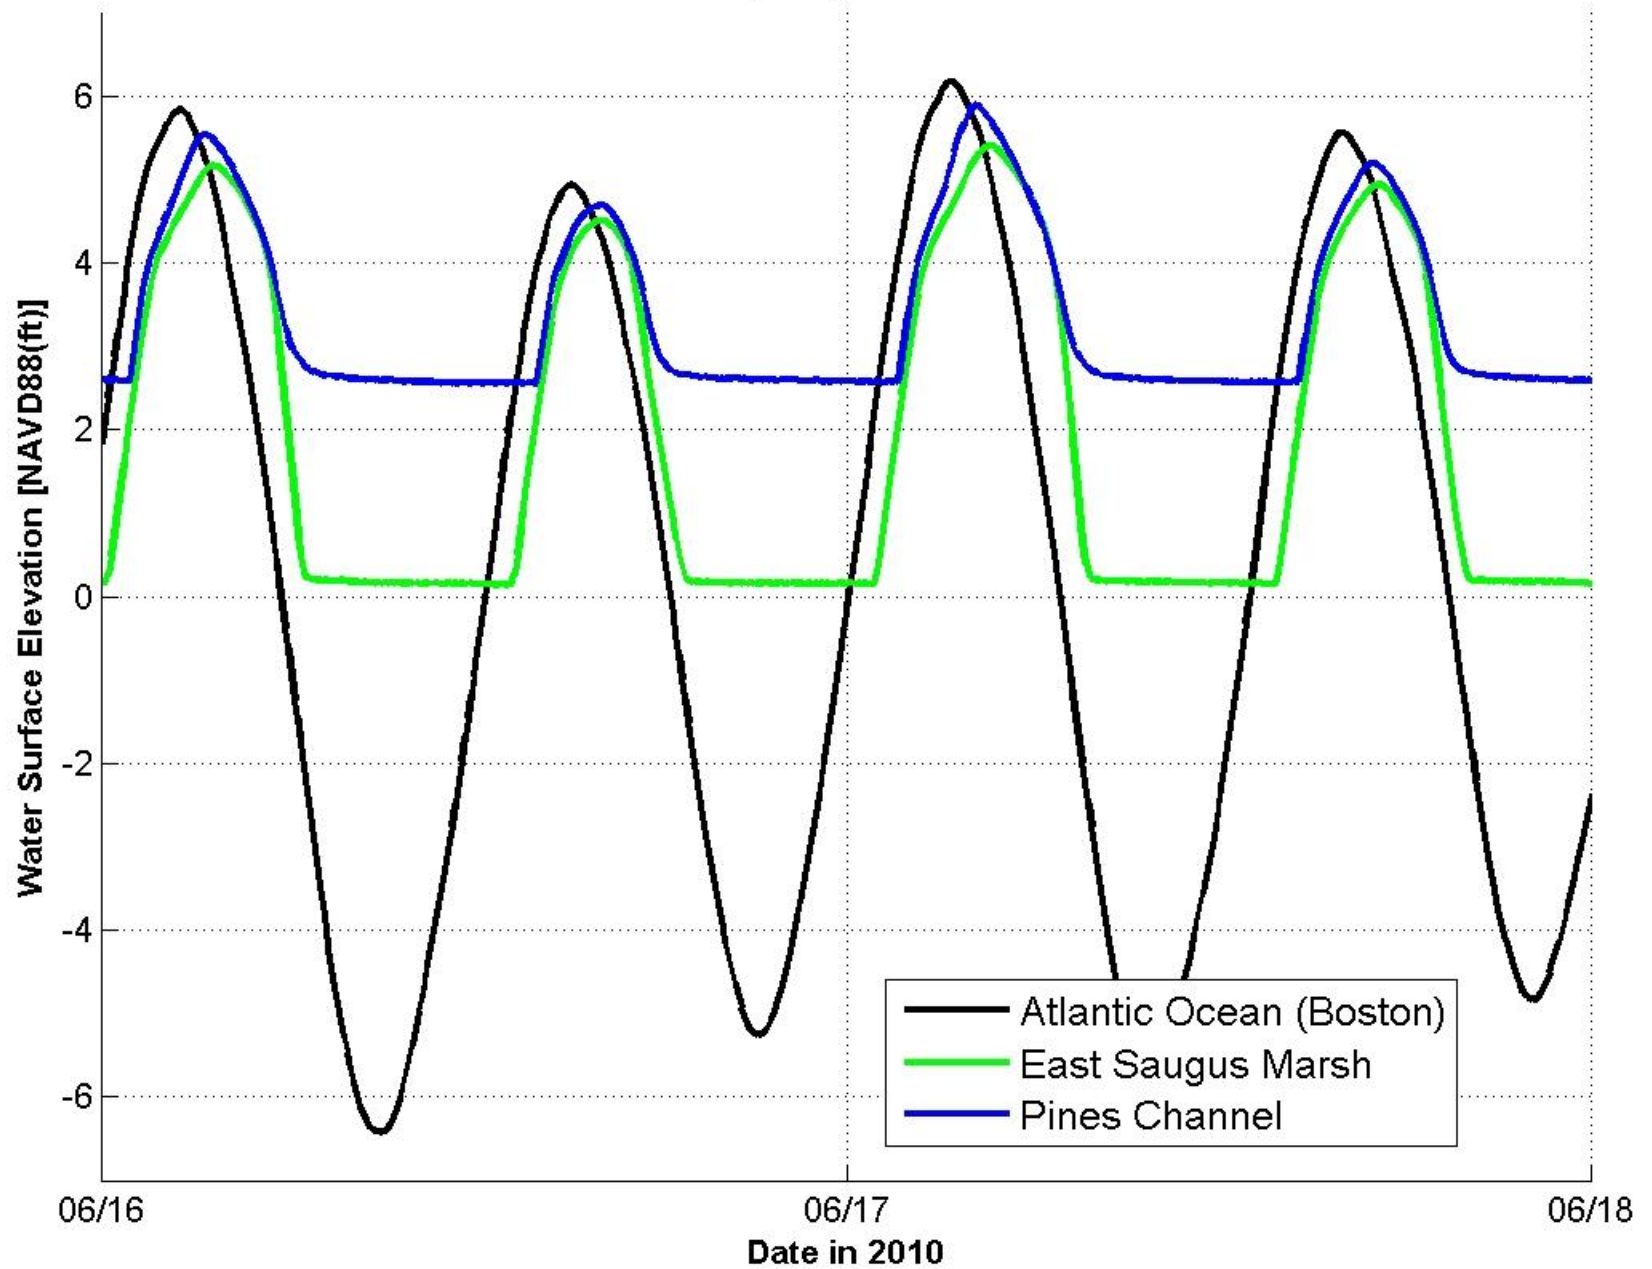
Tidal Observations in Rumney Marsh Spring Tides

Spring Tide Water Surface Elevation

Tide Gauge Station	Maximum (NAVD88-ft)	Mean High Water (NAVD88-ft)
Pines Channel	6.52	4.66
East Saugus Marsh	5.65	4.4

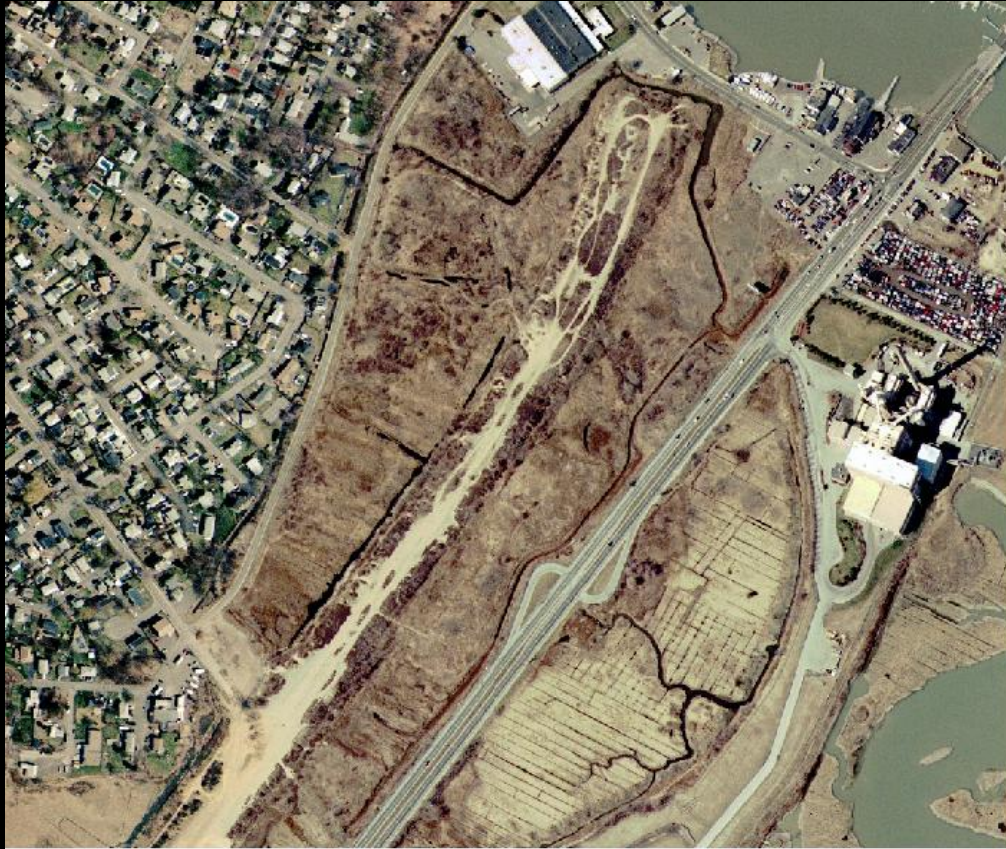
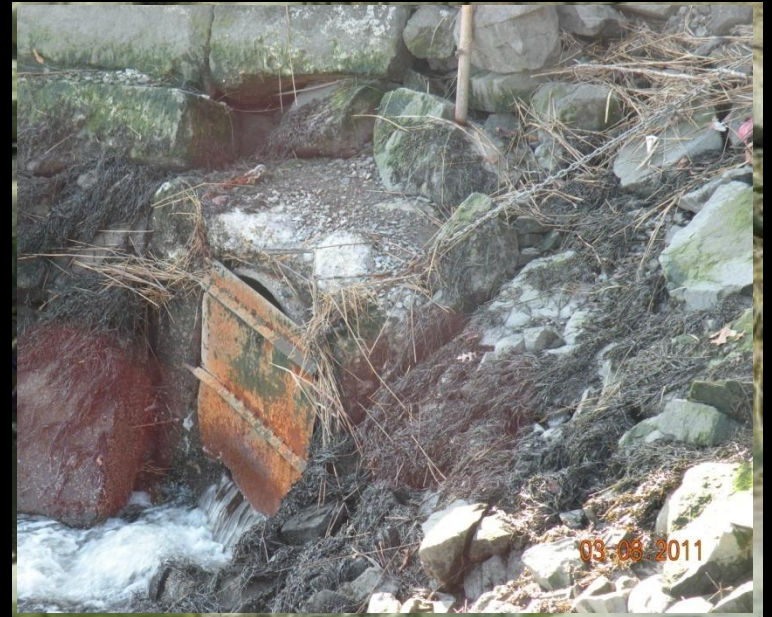
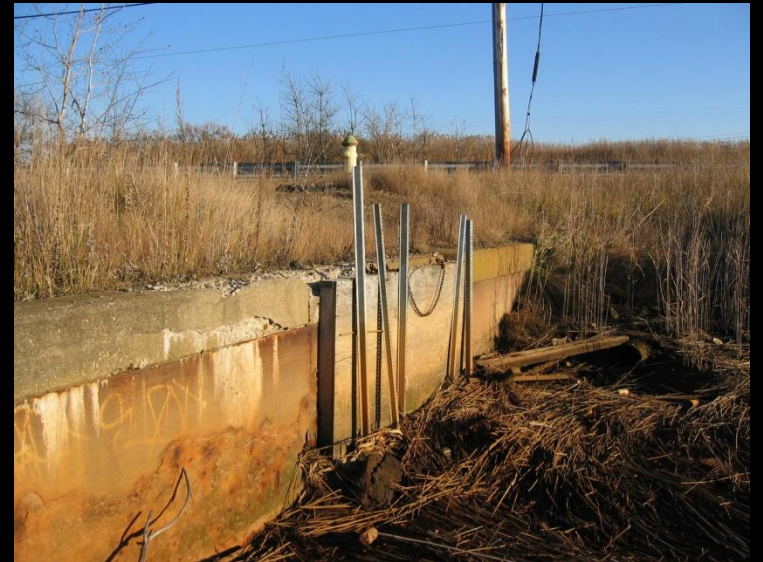
Ballard Street Salt Marsh

Ballard Street Marsh

82,800 c.y.

Excavation,

51-acre feet

SRT

An aerial photograph of a large, brown, marshy area. A white outline on the right side of the image encloses a specific section, with text indicating an excavation of 82,800 cubic yards and 51-acre feet. A green arrow points downwards from the center of the marsh area towards the bottom of the frame, with the letters 'SRT' written inside it. The surrounding area includes a road, some buildings, and a parking lot.
