# Gymnasium Wall Study

**BOLTON CENTER SCHOOL  
TOWN OF BOLTON, CT**

**Prepared: May 8, 2014  
Revised: May 21, 2014**

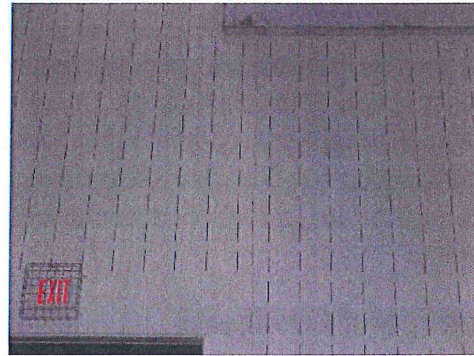
Fig. 3

The wall type sections in Figures 1 and 2 do not include a moisture barrier in the wall system. Photos taken of the destructive wall tests done for the previously mentioned exterior study revealed that the face of the rigid insulation had an adhered moisture barrier material. It is unknown whether this material is an air barrier, vapor retarder, weather-resistive barrier or a combination thereof.
