Town of Bolton
Notch Road Municipal Center
104 Notch Road, Bolton, Connecticut

BVH Project No. 21-18-009

Existing Facility Study
Building Systems Review

August 27, 2018

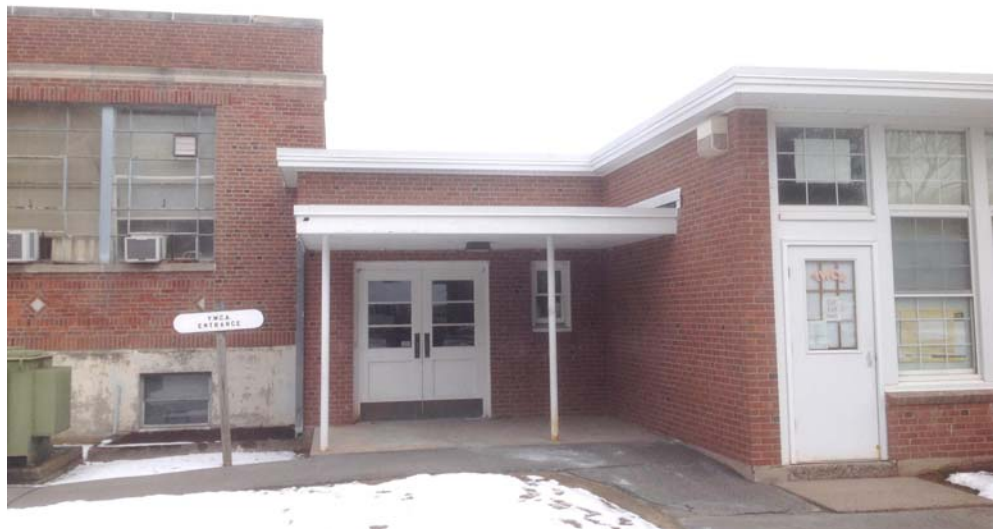
Entrance at South Stair Used for YMCA Daycare

1. The main stairs could be repaired, but addressing accessibility issues with exterior ramps would require the stairs to be moved and rebuilt. Overall

the entrances are in fair condition, but the door and hardware would need to be replaced to meet accessibility requirements.

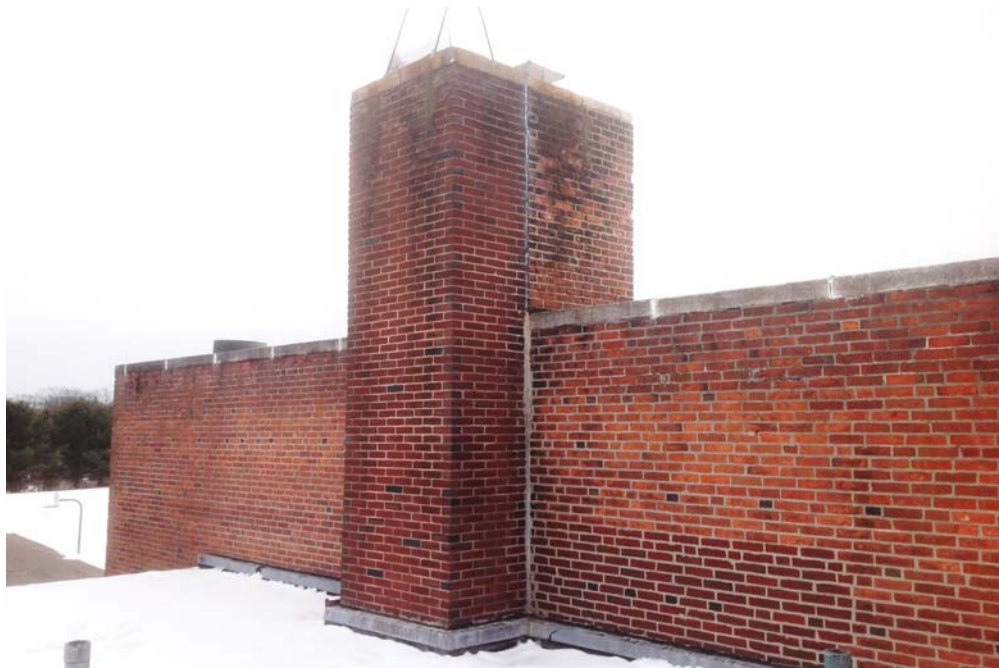
Chimney Stack Looking at Center Section from North Wing Roof

1. Similar to the Center Section, the built up roofing system is well beyond its useful life and would require complete replacement. Our understanding is the roof was replaced around 1990 and has been patched in various locations since that time. Numerous leaks are clearly evident and significant in numerous rooms below. Water damage and mold are anticipated to be extensive in multiple areas.

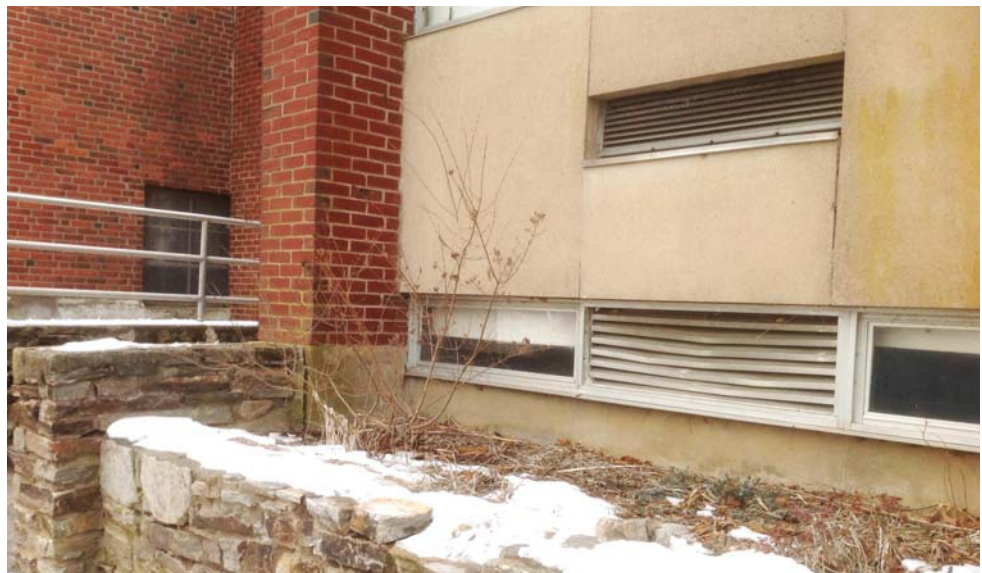
North Wing at East Side - Precast Panels and Louvers

1. The brick and CMU masonry in the North Wing, as well as the limestone infill panels and sills, are generally in better condition than those of the Center Section, with less spalling or signs of efflorescence.

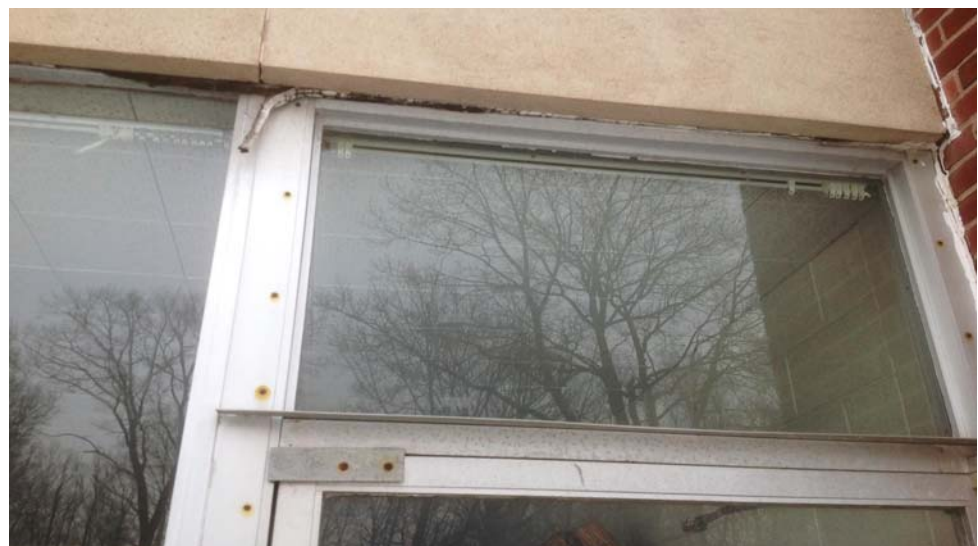
North Wing Curtainwall at Precast Panels

1. The curtainwall on the north side consists of a two-story, single glazed aluminum system with operable units and transoms panels. Other areas have smaller units from the same system. The exterior sealants have failed and are falling out in many areas, with mold and deterioration anticipated.

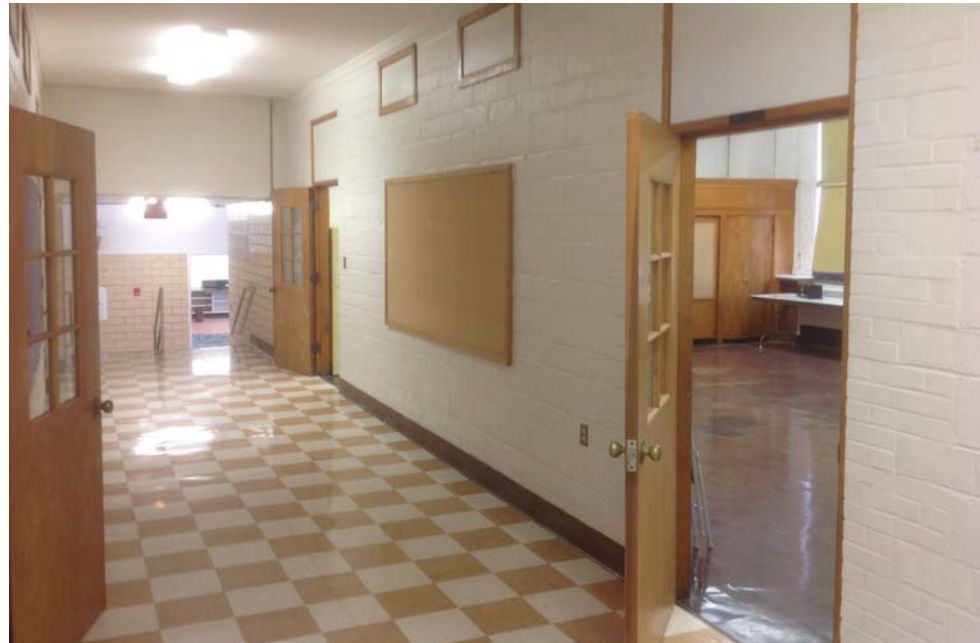
Upper Level Corridor Flooring with View of Classroom Flooring

1. Many of the floor finishes are original and composed of vinyl asbestos tiles (VAT) and also vinyl composition tiles (VCT). Some rooms have carpet installed over the VAT. Most of the flooring is beyond its useful life and should be replaced.

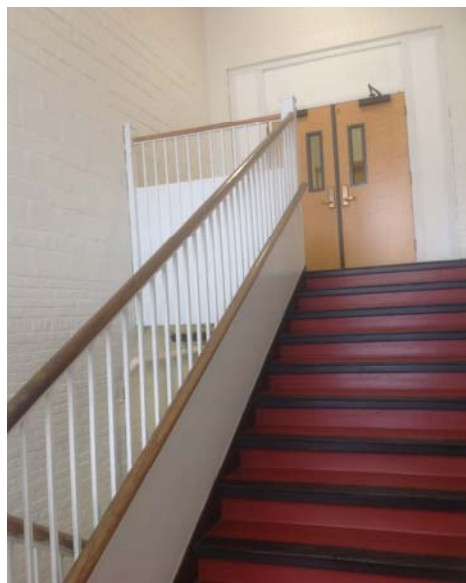
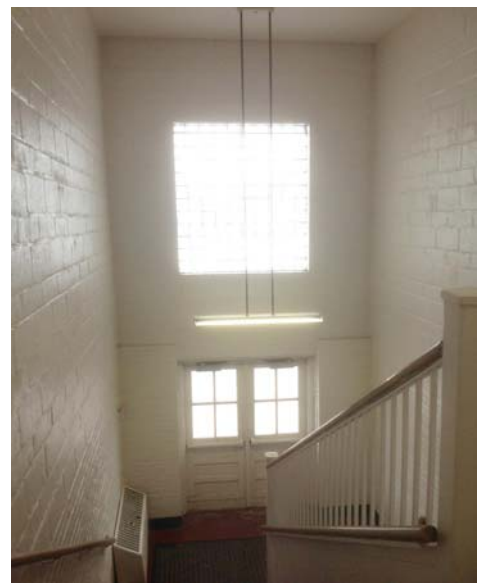
Center Section Stairs

1. The stairs are of concrete construction with metal tread nosings and center metal guardrails with wood caps and separate handrails. There are also separate handrails on the wall sides of the stairs, but none of the handrails meet the code required top and bottom extensions and returns.

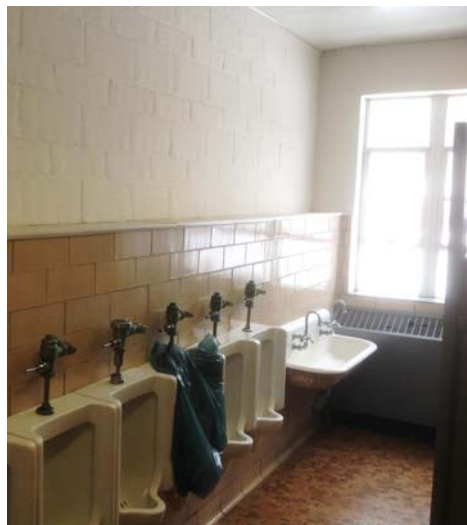
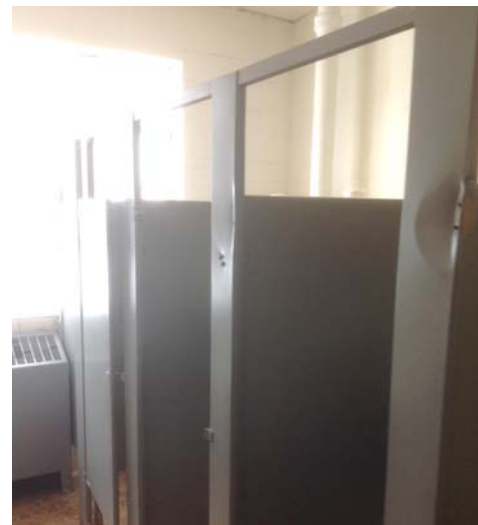
Men's Toilet Room on Upper Level

1. The main toilet rooms have ceramic tile floors, structural glazed tile wainscot on the perimeter, painted CMU on the upper walls, fiber-cane ceiling tiles, and metal partitions. The stall sizes, handrails, and accessories do not meet current accessibility standards and are past their useful life. There are also a number of small toilet rooms that have been added in various places throughout the building, none of which are accessible.

The existing toilet rooms are original construction, except for the Senior Center, and are past their useful service life and should be replaced.

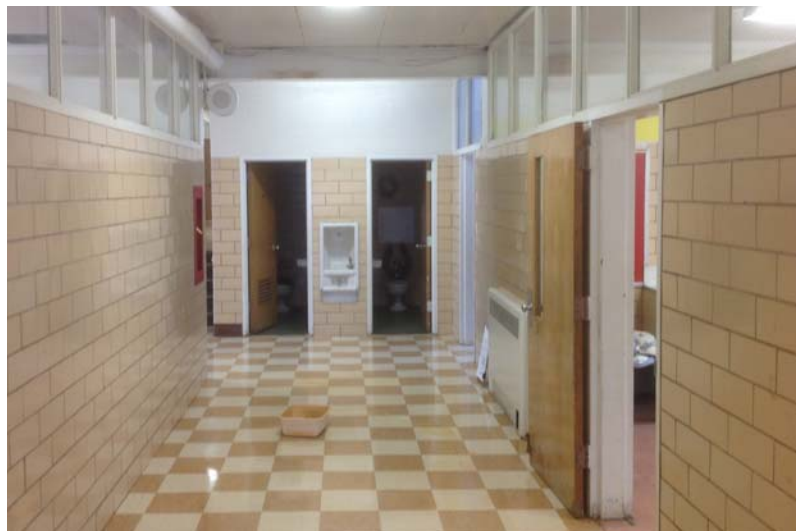
Typical Corridor Flooring

1. Many of the floor finishes are original and composed of VAT and also VCT. Some rooms have carpet installed over the VAT. Most of the flooring is beyond its useful life and should be replaced.

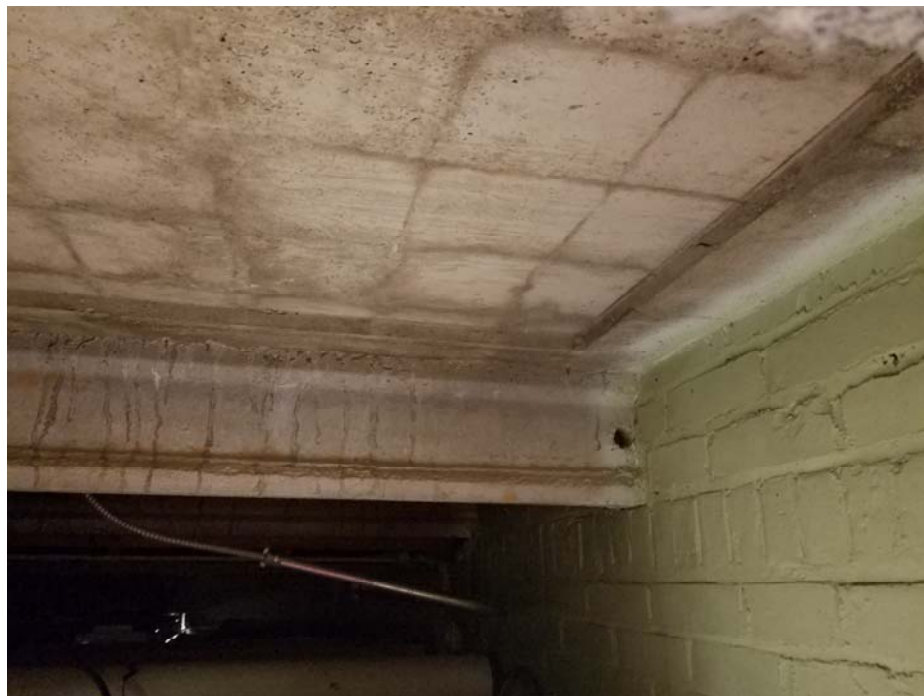
Mesh Pattern on Underside of Slab

The cracks observed in the surface of the corridor tile flooring do not appear to coincide with the pattern and alignment of the cracks observed on the underside of the structural slab visible from the lower level. The slab cracks on the underside of the slab appear similar to typical shrinkage and temperature cracks that typical occur in concrete over time. The pattern and location of the cracking does not appear comparable to patterns of cracking that would form if the structure was overloaded. The formation of shrinkage and temperature cracking

in concrete is a common occurrence and does not indicate a structural concern at this time; however, it is common for cracks in concrete slabs to propagate through flooring materials and become an aesthetic issue.

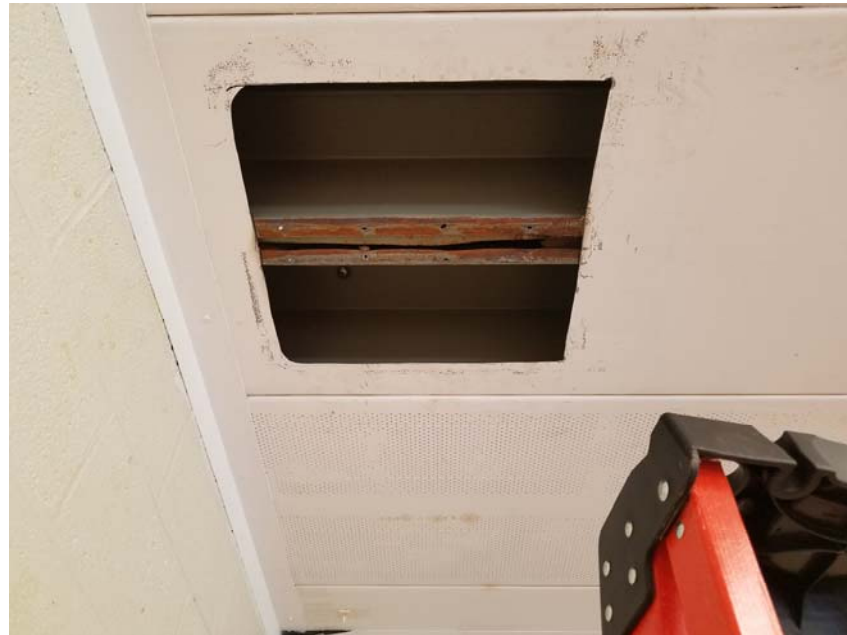
Metal Decking

3. The steel roof deck is approximately 7" deep and spans a distance of roughly 29 ft. from bearing wall to bearing wall at its longest location. Rust stains are evident in many areas on the underside of the deck, especially between panel joints indicating roofing leakage and water infiltration. Based on the extent of the staining on the underside of the deck and previous experience, it is reasonable to expect the top surface of the deck under the roofing has considerably more damage and section loss than is visible from below.

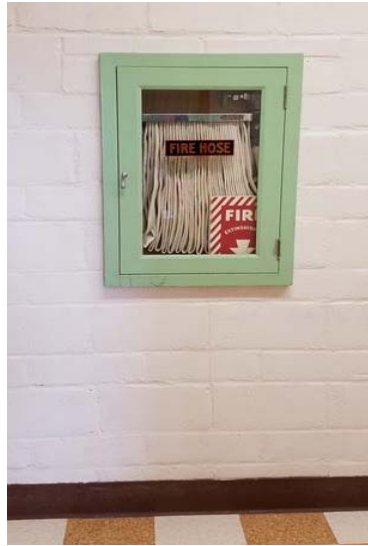
The building does not have a sprinkler system, so fire protection is limited to hose valve cabinets and smoke and fire alarm heat detectors in the corridors.

Typical Hose Valve Cabinet

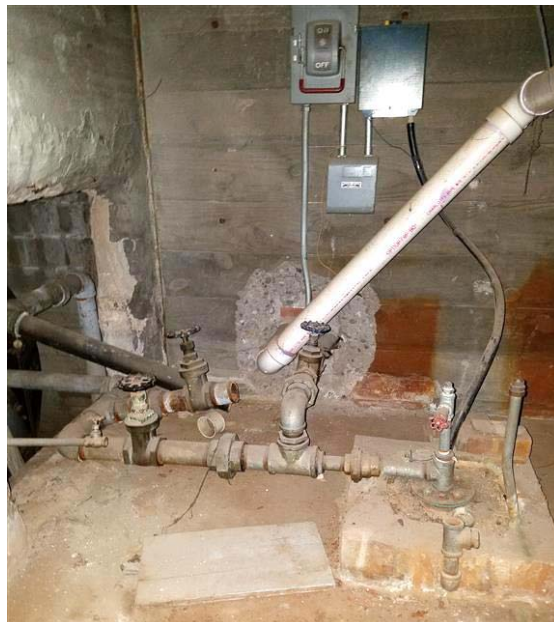
The facility now gets its water from the adjacent Bolton Center School which was completed in the mid 1990s. The water service is 2".

Incoming Water Service

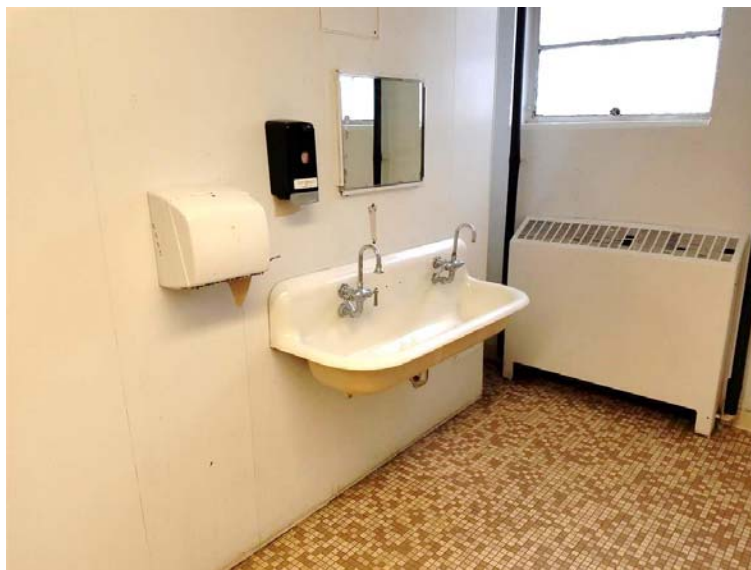
Typical Lavatory

None of the current Accessibility Codes are met within the existing toilet rooms and new expanded toilet rooms will be required as part of any renovation.

The bathrooms would all need to be demolished, expanded, and designed to current standards.

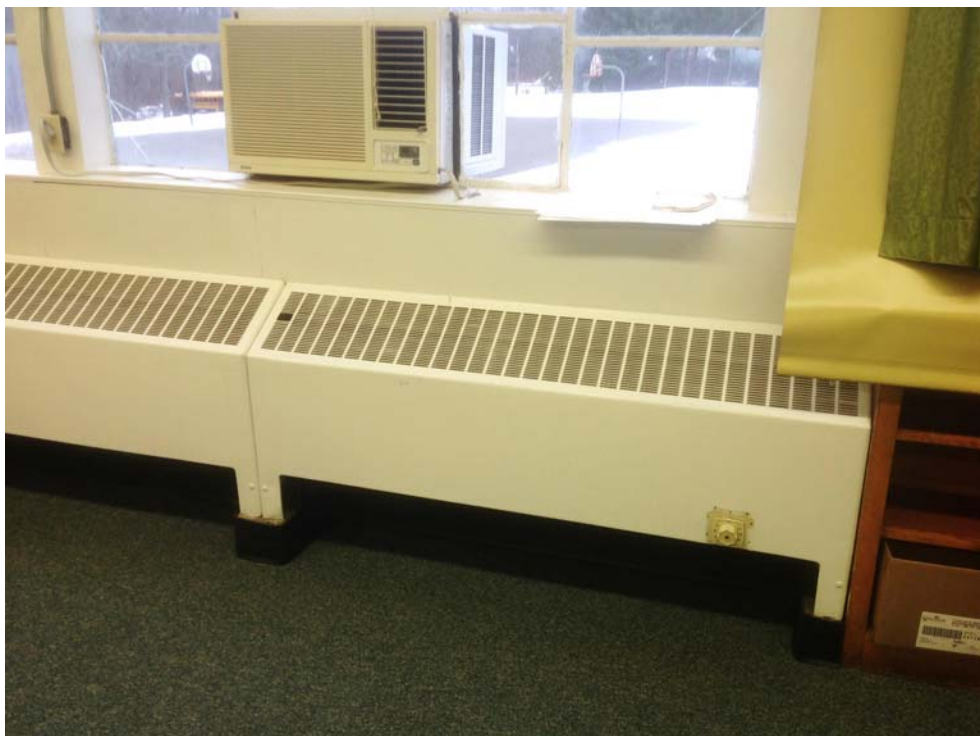
Most of the building has either radiation or hot water AAF/Herman Nelson unit ventilators for the classroom portions of the facility to provide heating and outside air.

Typical Classroom Radiation

Except for the existing boiler, all of the mechanical systems in the Central and North Sections need to be replaced including replacement of existing pumps.

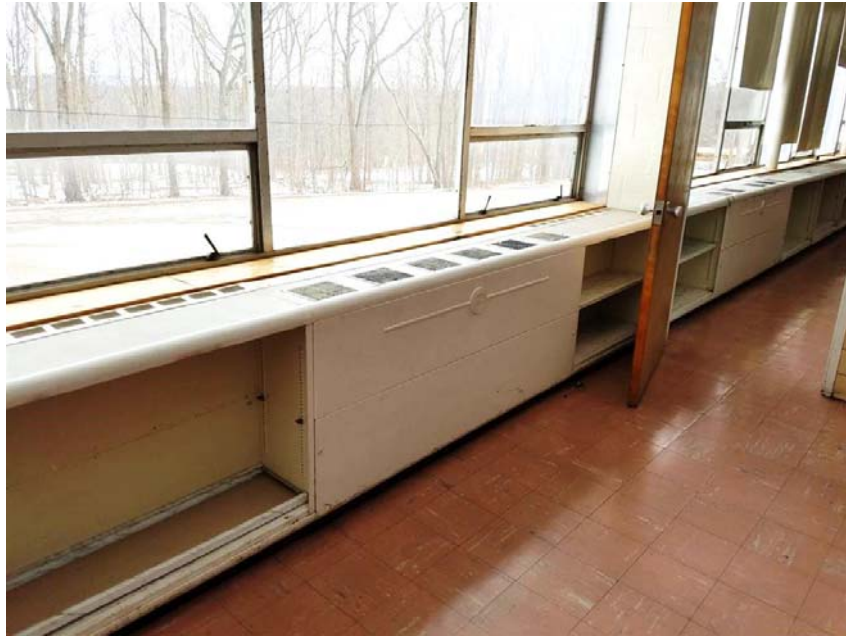
Typical Classroom Unit Ventilator

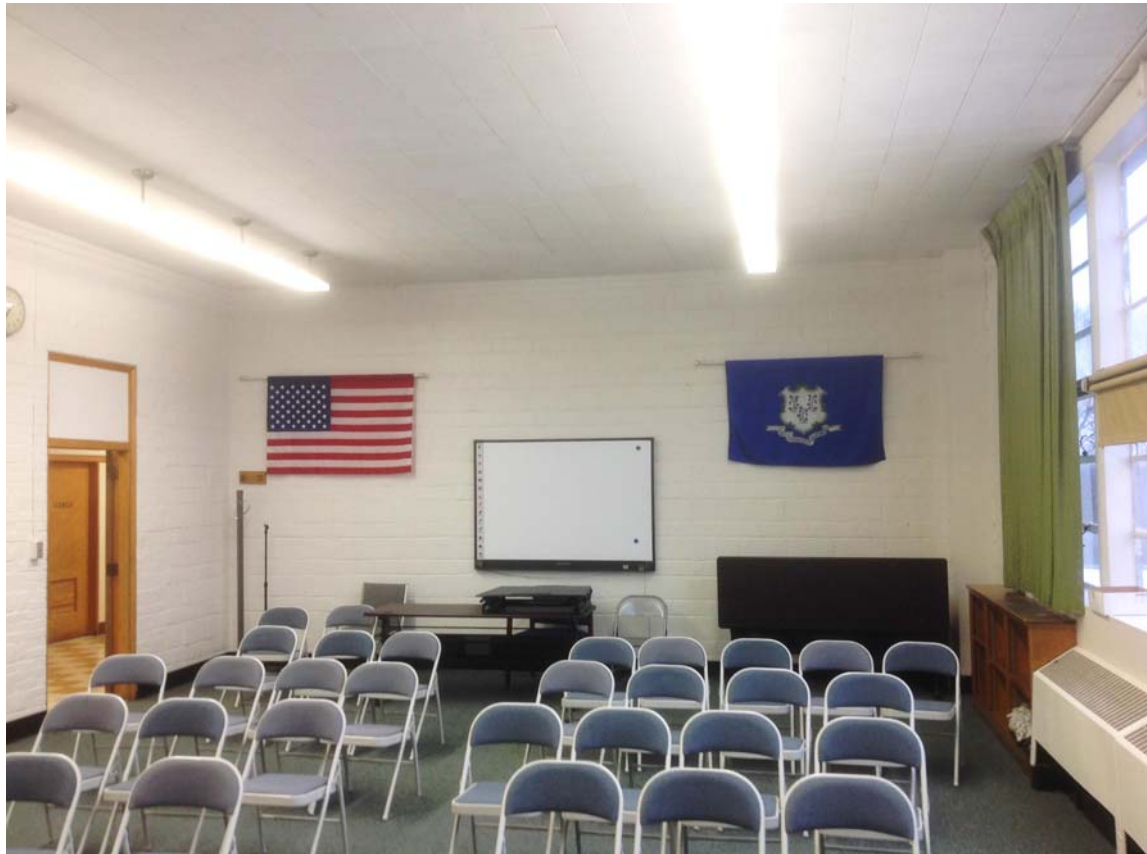
The lighting in the facility is fluorescent lamps. Most of the light fixtures are surface- or pendant-mounted wraparound fixtures. The church has open single lamp energy efficient reflector style fixtures.

Typical Room Lighting

The lighting and controls are anticipated to be replaced with new LED fixtures, which will provide dimming capabilities. The existing lighting is approximately 1 watt/SF; new LED lighting would be approximately half this amount. The use of LED lighting would allow the emergency lighting to utilize one or two small inverters, or an overall building complex generator.
