**RE: DEP Transmittal No. X254090  
DEP Wetlands File No. 61-0633**

Subject:  
Spring 2014 Vegetation Monitoring Report  
Oak Island RAM Area Salt Marsh Restoration  
KHB Venture, LLC  
Revere, Massachusetts

FCTPF OAK ISLAND SALT MARSH RESTORATION  
 REVERE, MASSACHUSETTS  
**SPRING 2014 VEGETATION MONITORING REPORT**  
**SITE PLAN WITH PHOTO LOCATIONS  
 AND IDENTIFIED WEED AREAS**

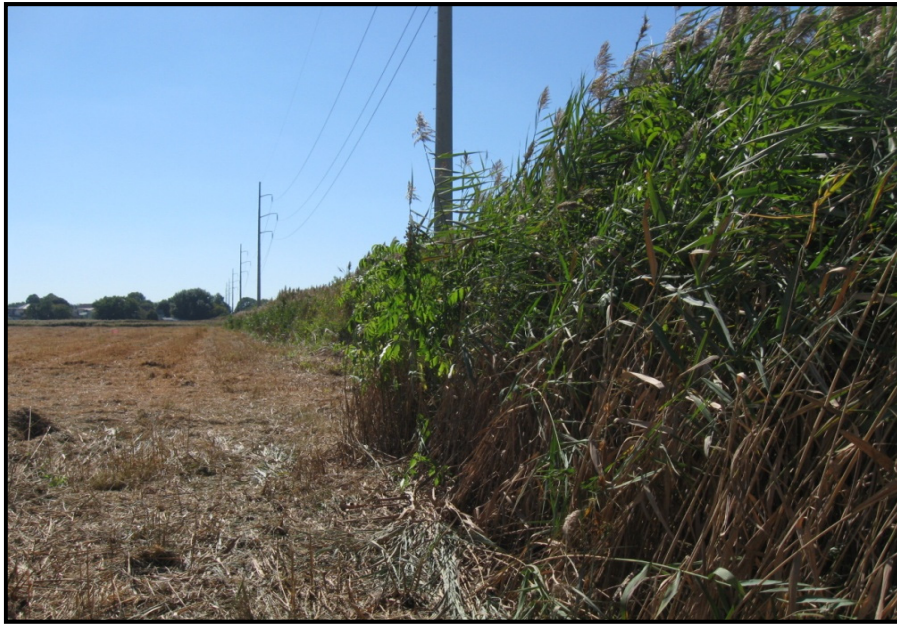
1

Photo #1: West fenceline of RAM Mitigation Area looking south from near northwest corner.

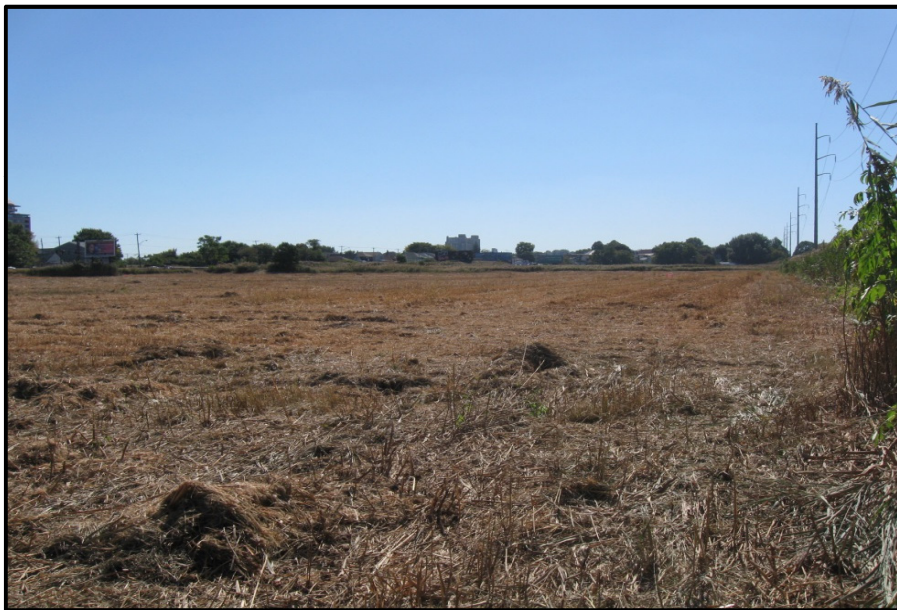
2

Photo #2: RAM Mitigation Area looking southwest from northeast corner.

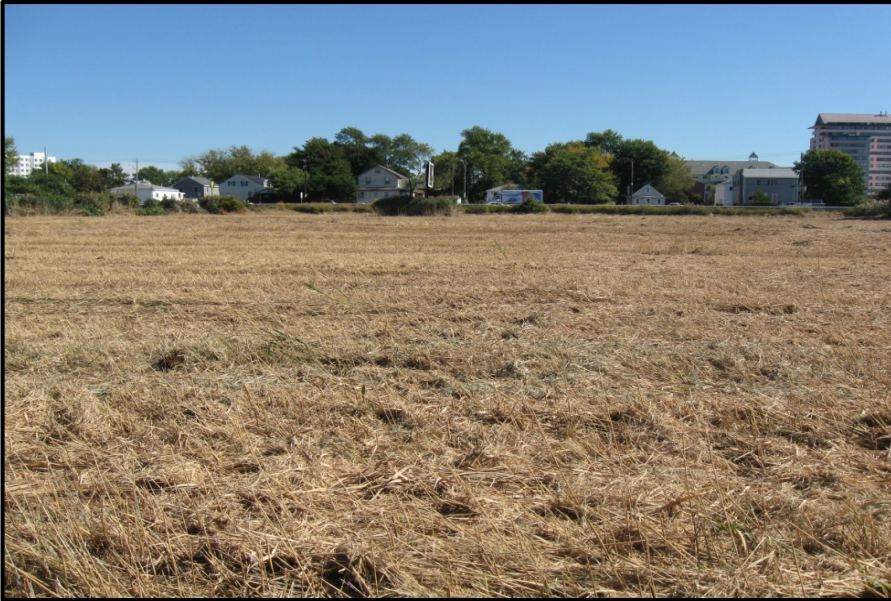
3

Photo #3: RAM Mitigation Area looking east from western boundary.

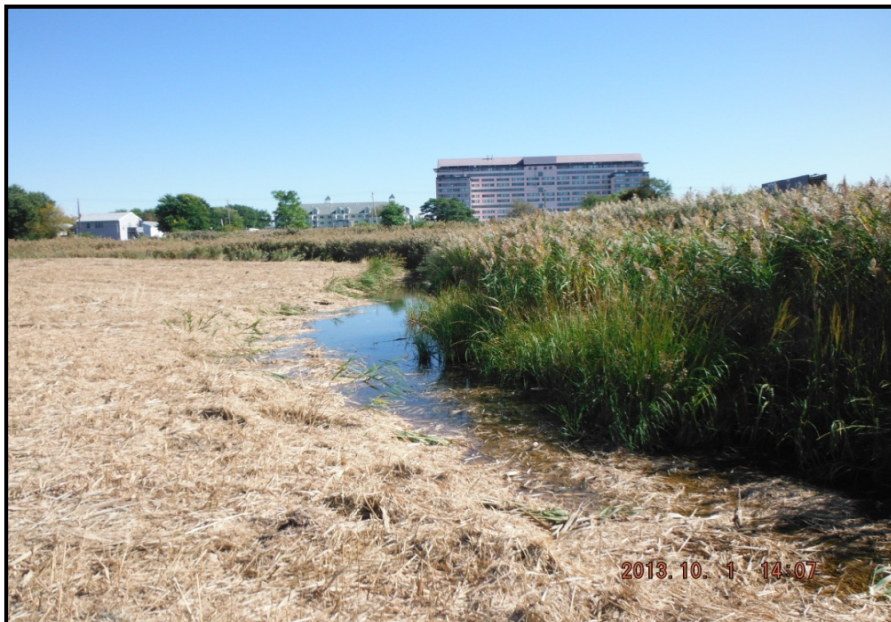
4

Photo #4: South end of RAM Mitigation Area along Diamond Creek, looking east.

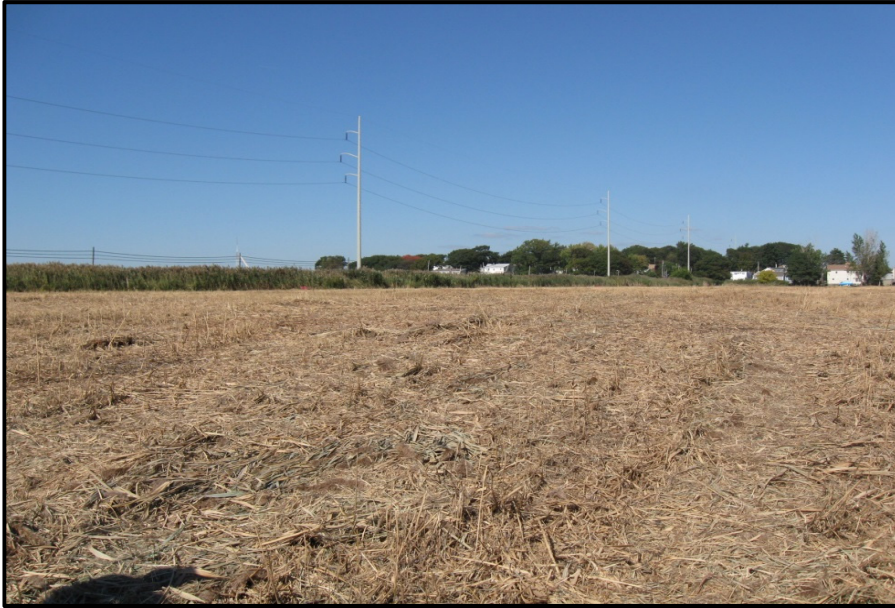
5

Photo #5: RAM Mitigation Area looking north from southern boundary.

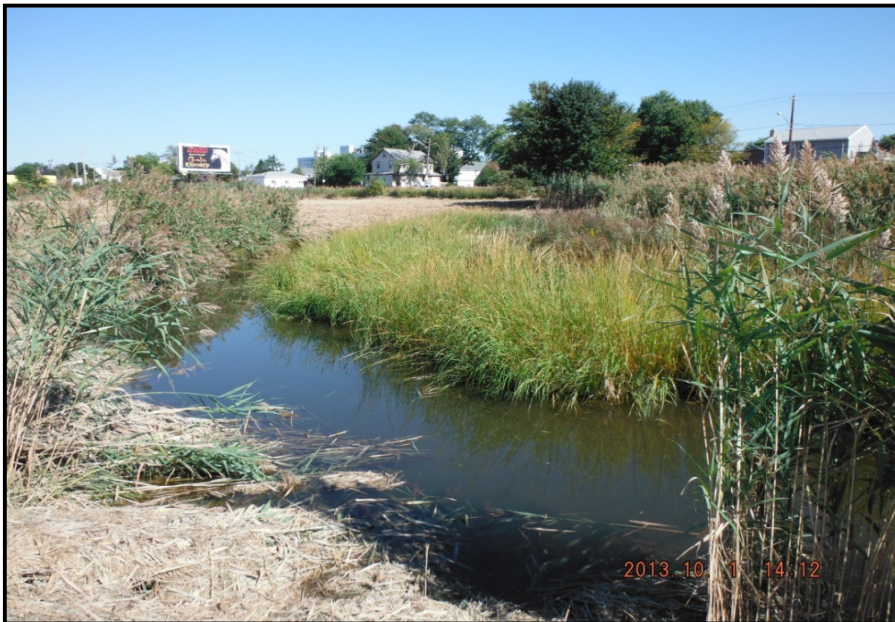
6

Photo #6: Diamond Creek at south end of RAM Mitigation Area, looking northeast.

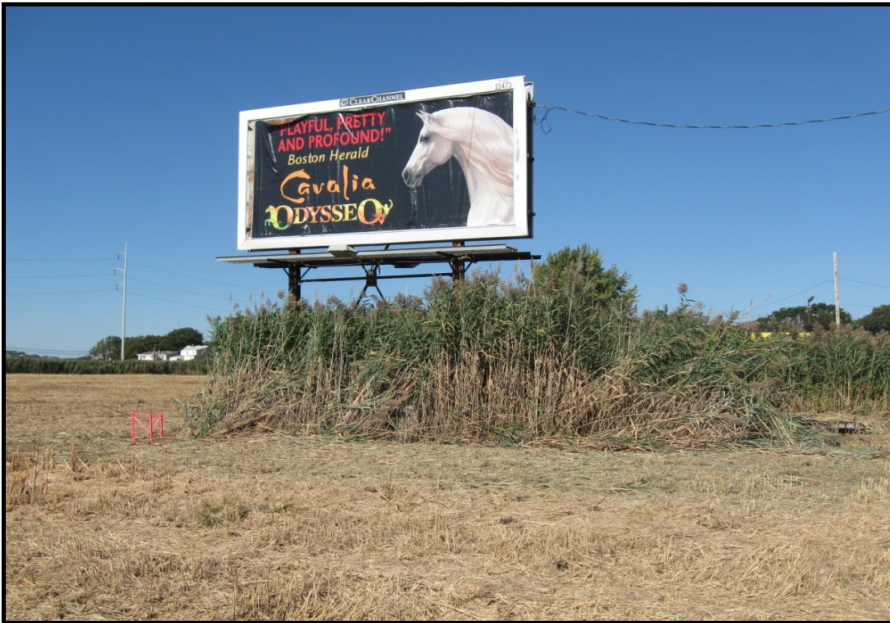
7

Photo #7: Unmowed billboard area on east side of RAM Mitigation Area, looking northeast.

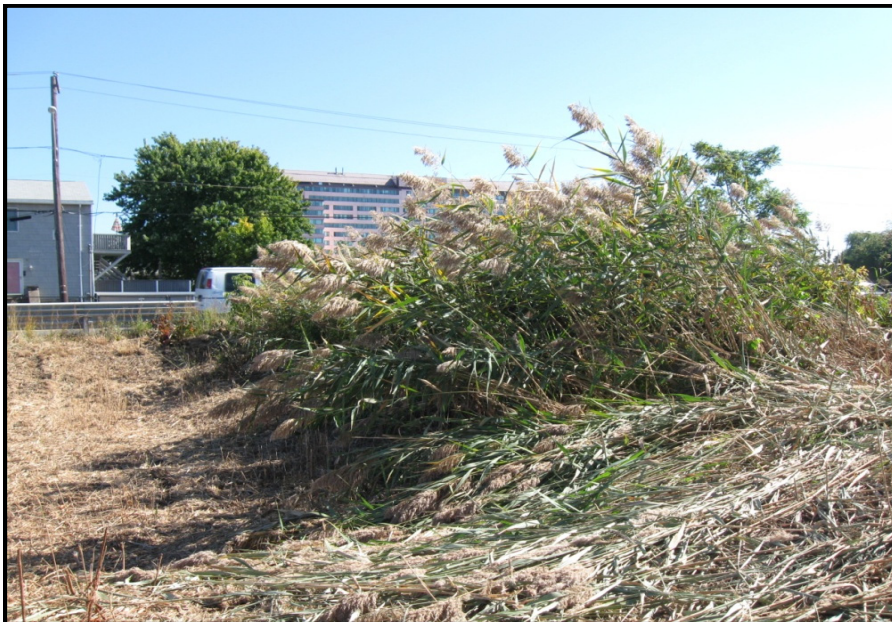
8

Photo #8: Unmowed area on east side of RAM Mitigation Area, looking east.

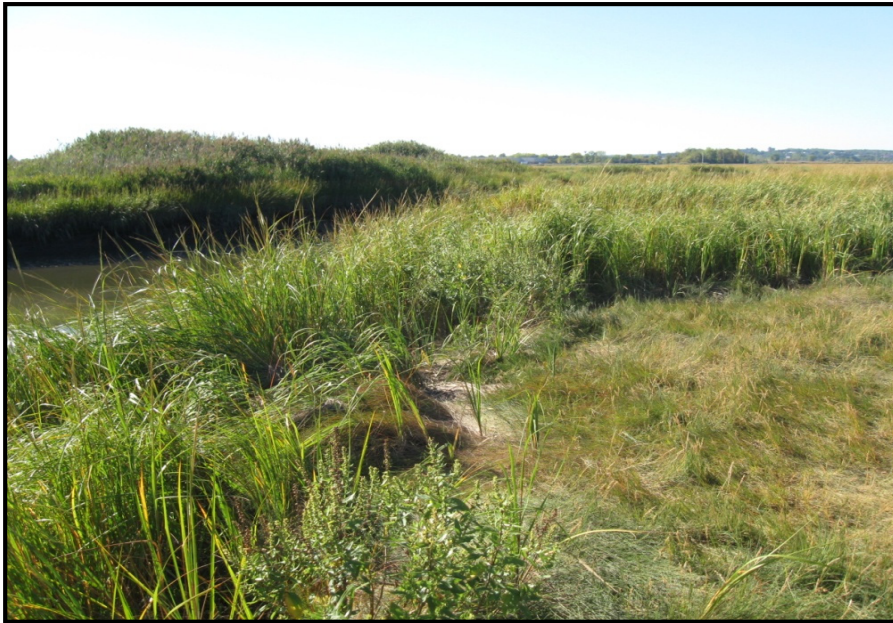
9

Photo #9: Reference Wetland Area 1, looking northwest.

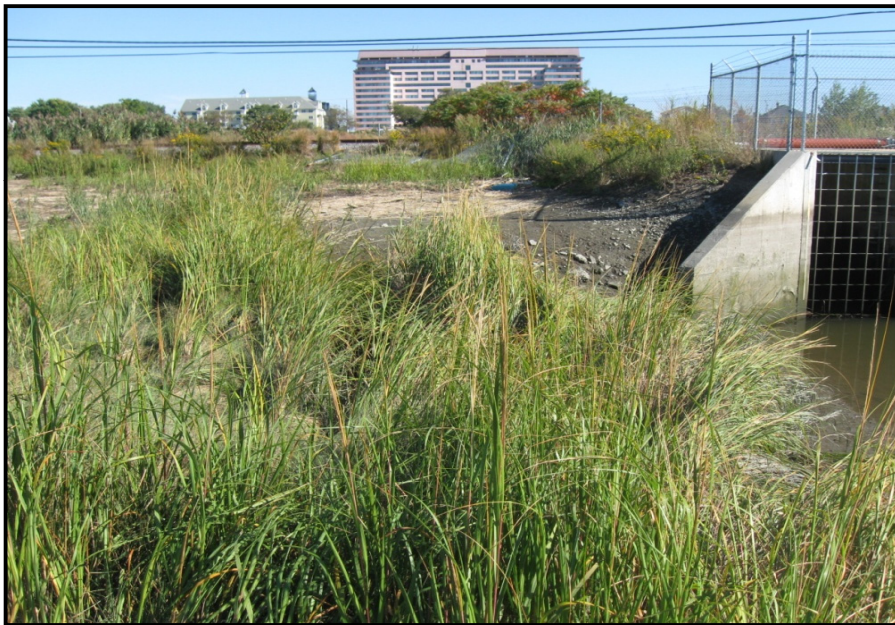
10

Photo #10: Reference Wetland Area 1, looking east.

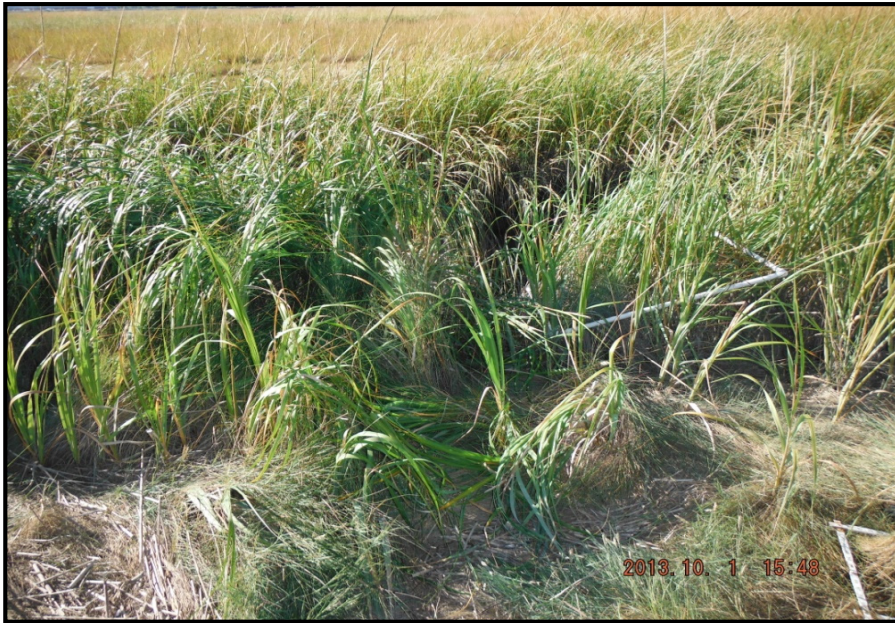
11

Photo #11: Reference Wetland Area 2, looking northwest.

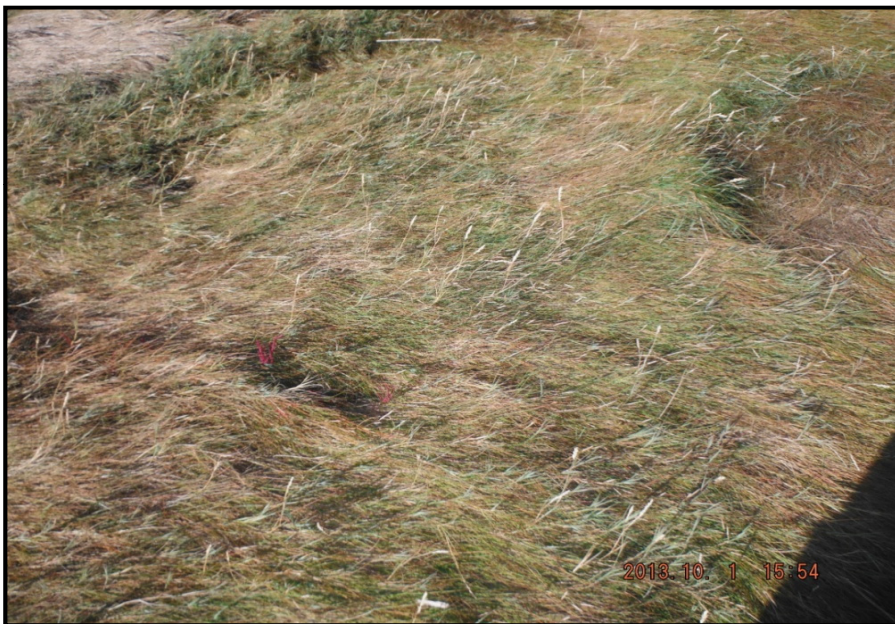
12

Photo #12: Reference Wetland Area 2, looking northeast.

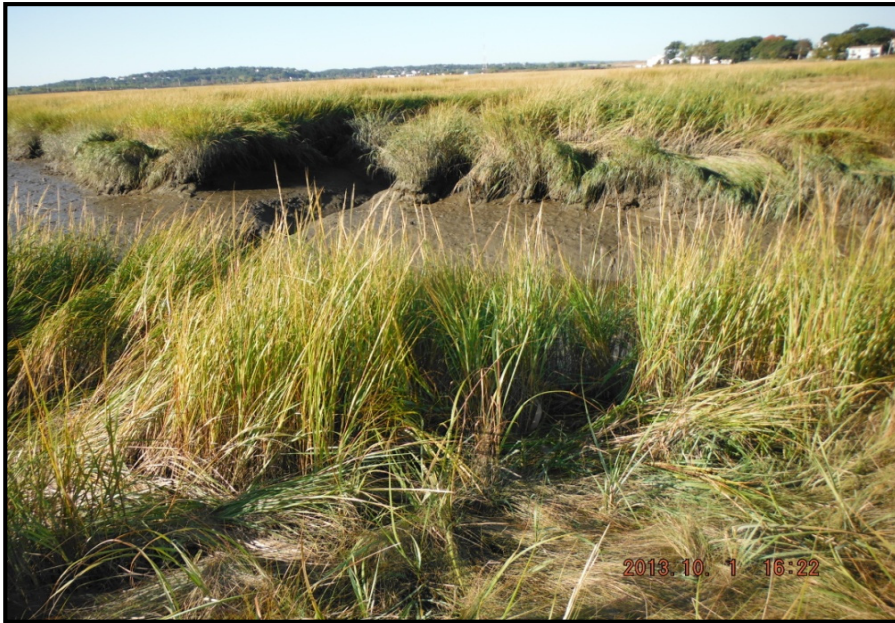
13

Photo #13: Reference Wetland Area 3, looking north.

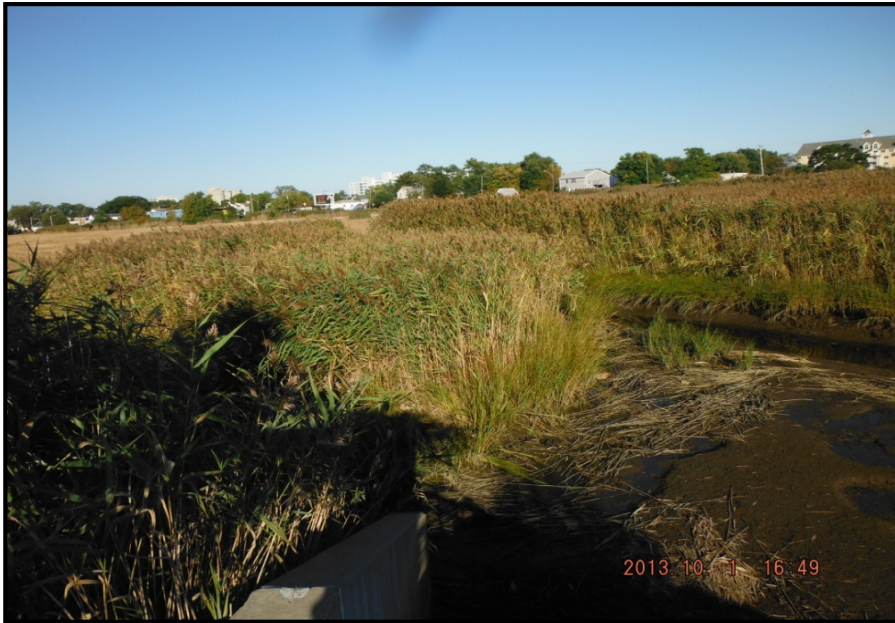
15

Photo #15: Reference Wetland Area 4, looking northeast.

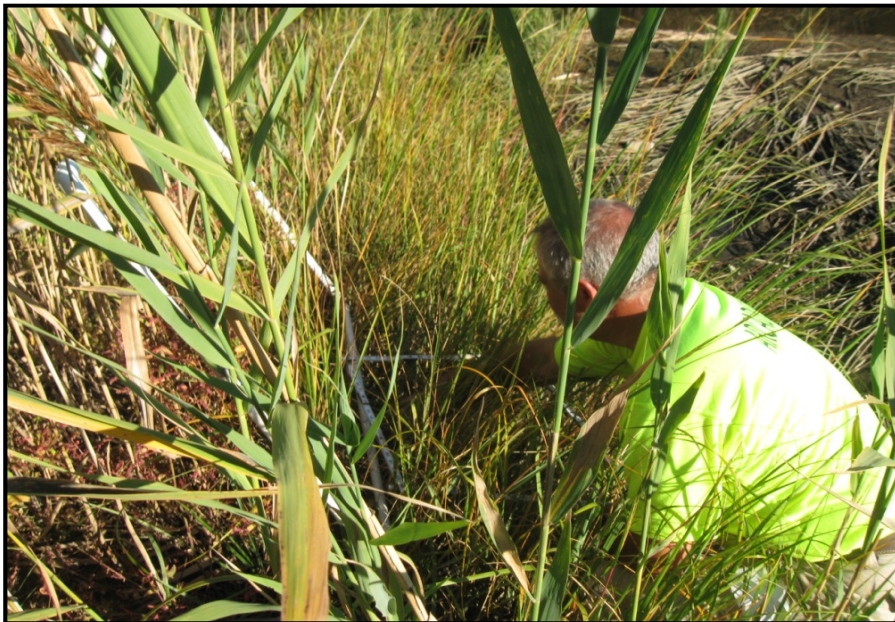
16

Photo #16: Reference Wetland Area 4, looking east.
